# INSPECTION REPORT

Sherlock Homes Inspection, Ltd.  
9629 Jadlos Dr.  
Findlay, OH 45840  
419-957-6142  
www.sherlockhomesps.com

**Property Address:** 465 Summit St., Upper Sandusky, OH      **Client(s):** Paul Wagner

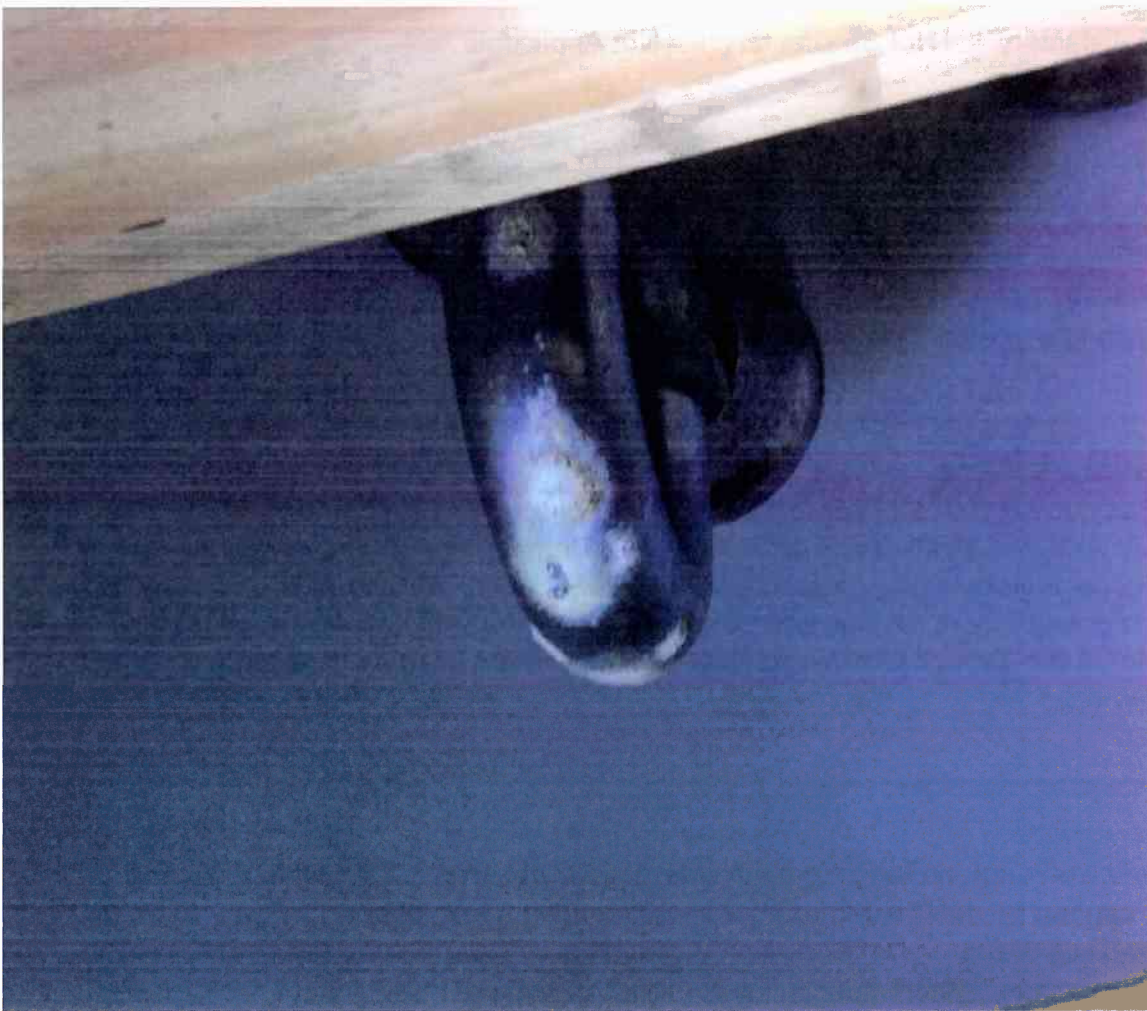
Comments: Deterioration was observed to piping inside the bathroom vanity cabinets, but no leakage was observed at the time of inspection. Occupant contents inhibited observation of some components. Blemishes were observed to the inside of sink bowls. Cracking, rust, and deterioration were observed to the underside of the basement sink drain, as well as corrosion to its knobs and drain piping. Dried moisture staining on the floor below the basement sink suggest past leakage, but no current leakage was observed at the time of inspection.

Hall bath sink drain deterioration.

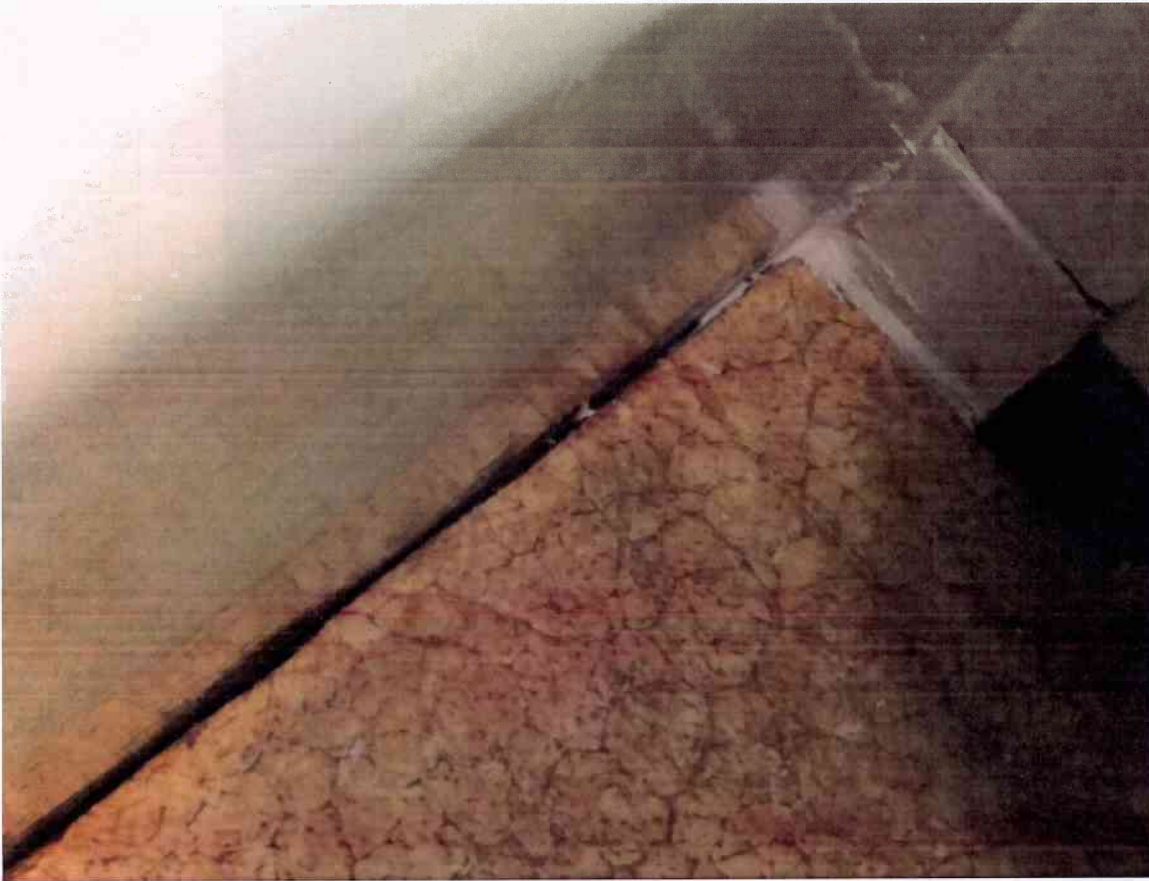
5. The base of the bathtubs lack caulking along the flooring, and the flooring in the area has begun to curl.
6. The chimney is missing its rain cap.
7. The installation of GFCI outlets in kitchen, bathroom, garage, laundry, basement, & exterior receptacles will increase the overall safety of the electrical system and is recommended but not required. Most outlets in the home are open ground. Grounded outlets were observed on the N and NW living room walls. Some light fixtures did not illuminate at the time of inspection (may lack bulbs or need fresh bulbs.) Open slots on the main electric panel are not properly covered. Some wall switches had no discernible effect when thrown. An unused 220-amp clothes dryer hookup was observed hanging from the basement ceiling. The exterior gang box was loose. An open electric junction was observed in the basement ceiling. A qualified electrician should be consulted when repairing or updating the electrical system in your home.

Gap lacking caulking at bathtub. Curled flooring.

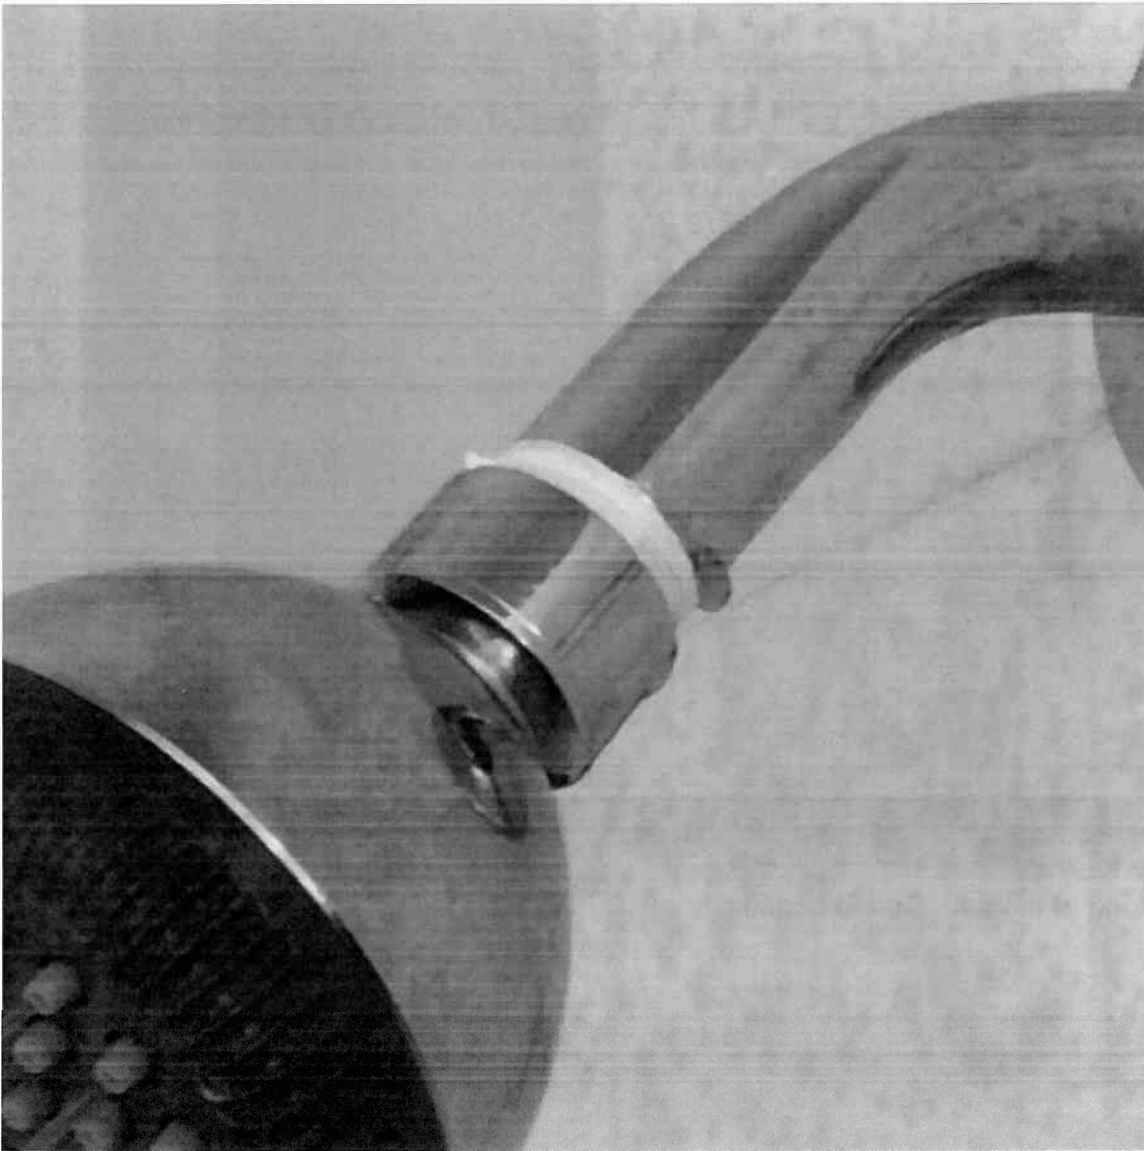
Comments: The base of the bathtubs lack caulking along the flooring, and the flooring in the area has begun to curl. Hot and cold are reversed in the master bathroom. Leakage was observed from the base of the showerhead and from the diverter knob during operation in the master bathroom. Shower fixtures in the basement were not tested due to the proximity of occupant contents.

Leakage at master showerhead.

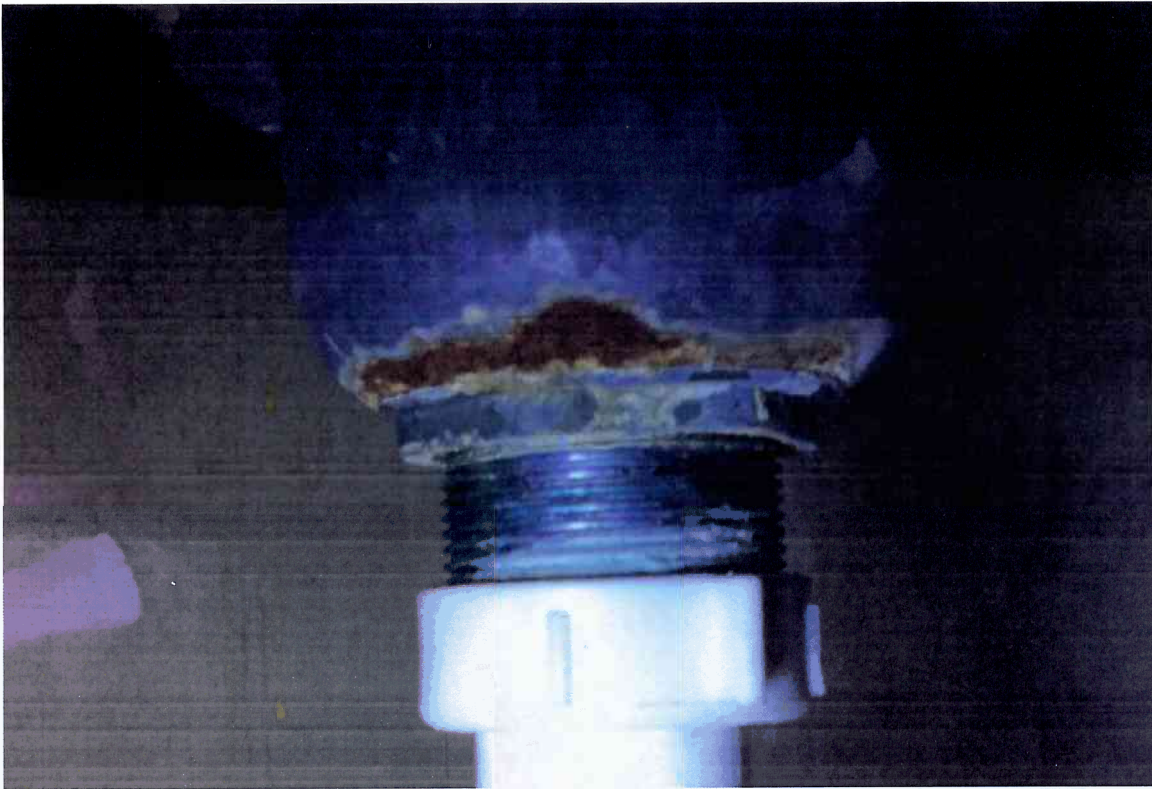
**Comments:** Occupant contents inhibited observation of some components. Deterioration/rust was observed to the underside of the left sink drain inside the kitchen sink base cabinet, but no leakage was observed at the time of inspection.

Kitchen sink drain deterioration.

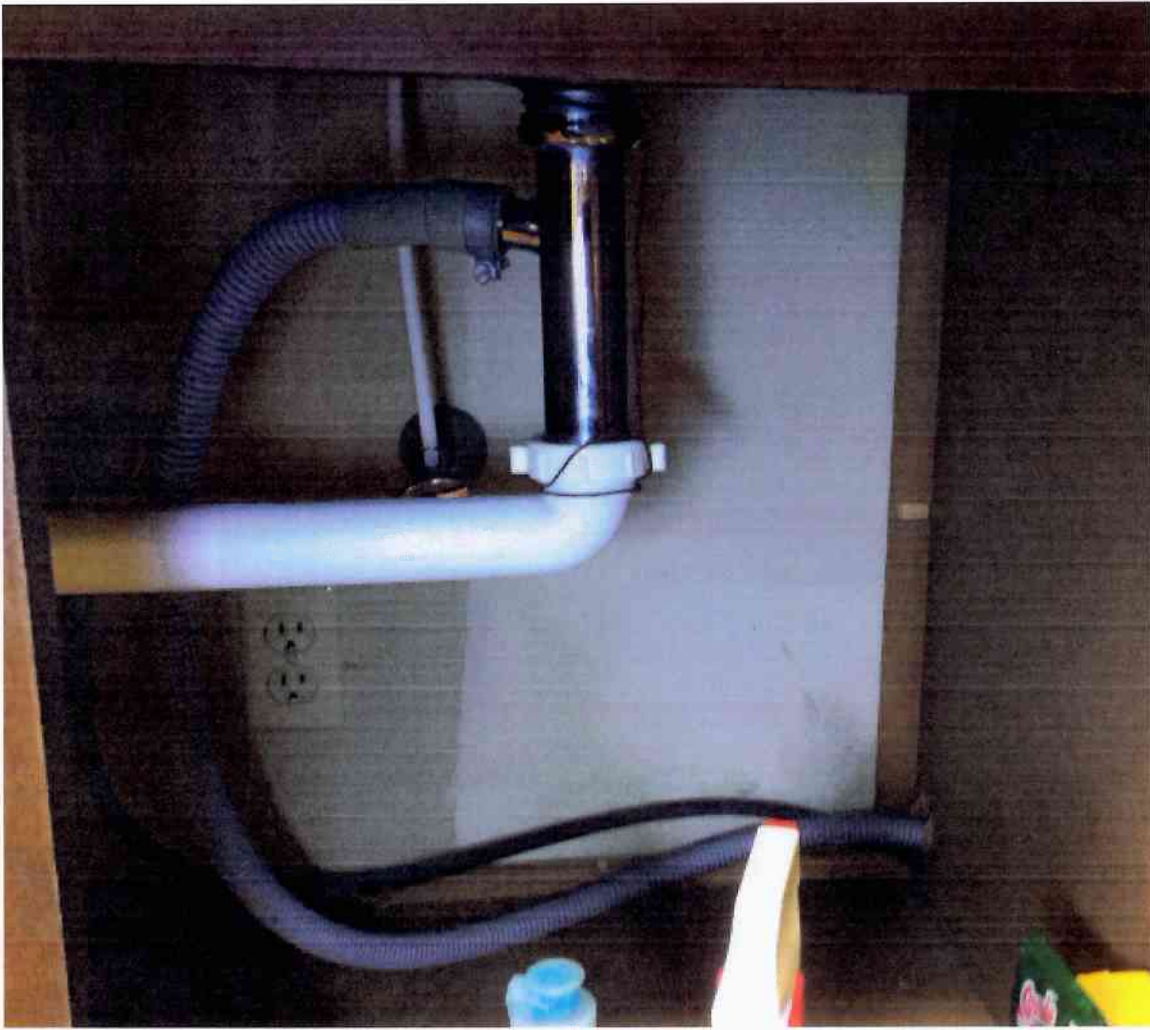
Lack of high loop in dishwasher drain hose.

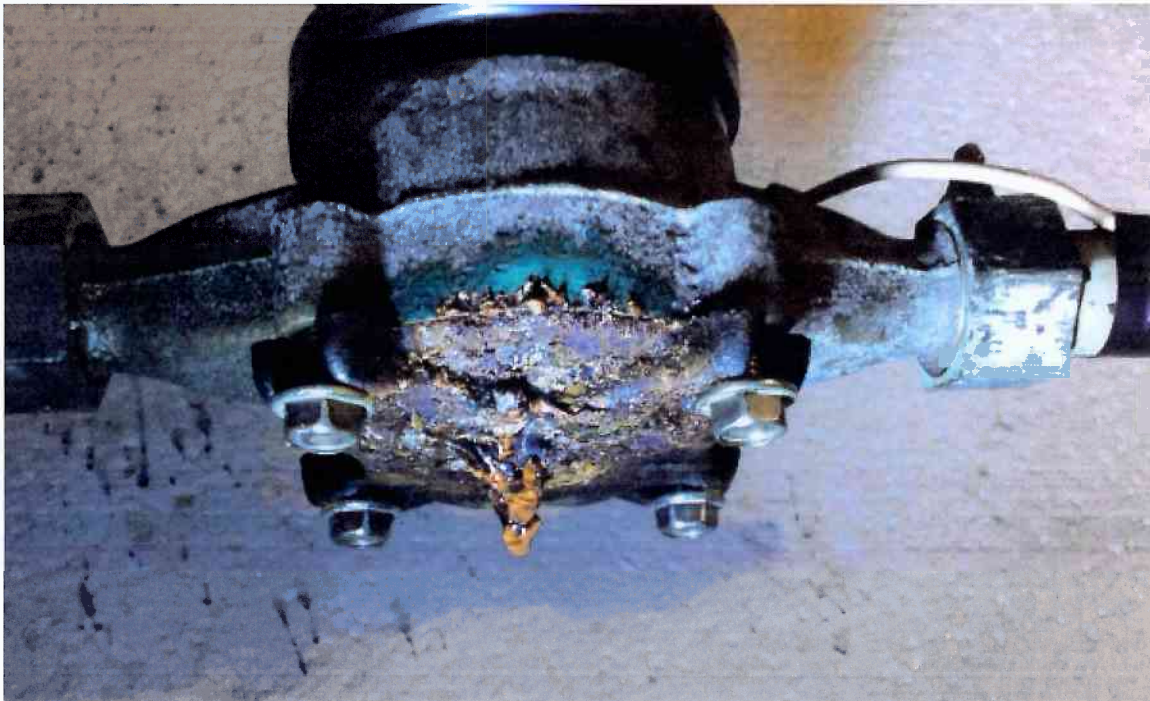
**Comments:** Deterioration and signs of past leakage were observed to the main water meter.

Deteriorated water meter.

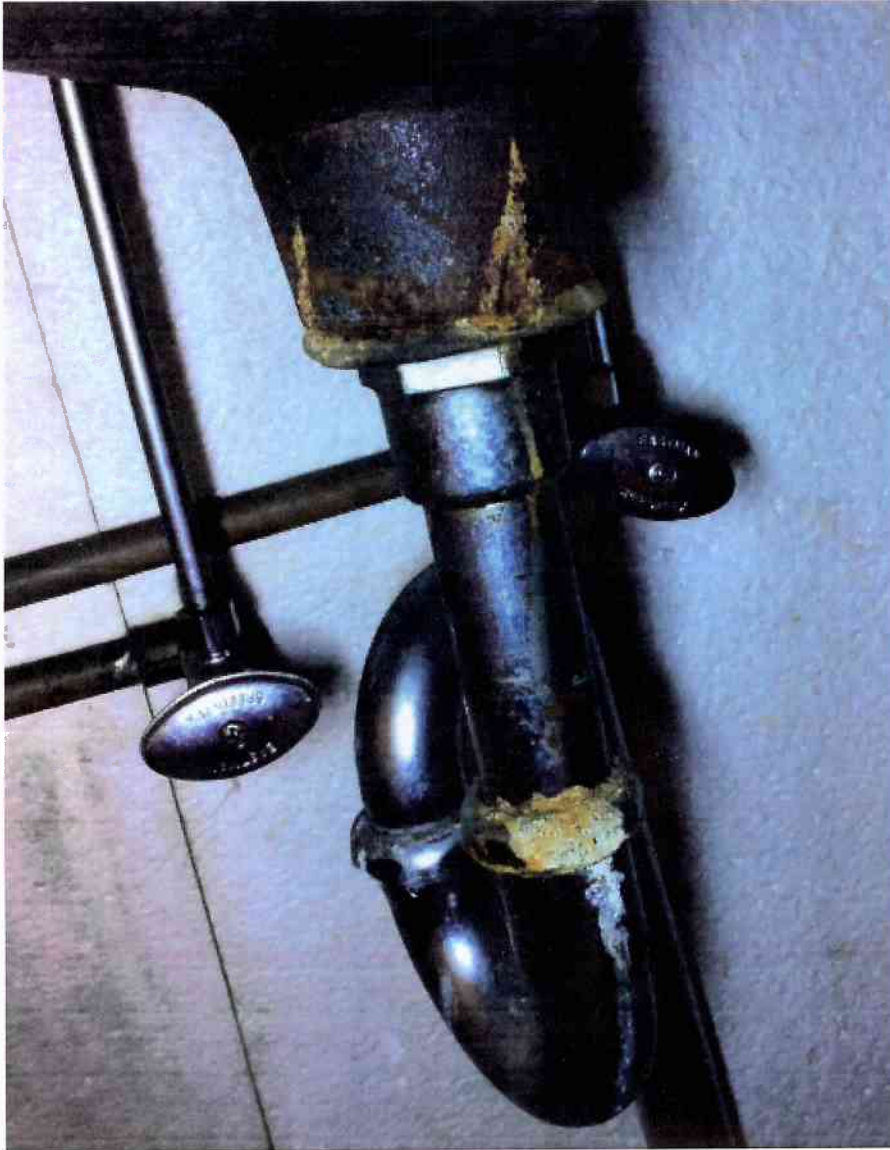
Rust/deterioration to basement bathroom sink drain.

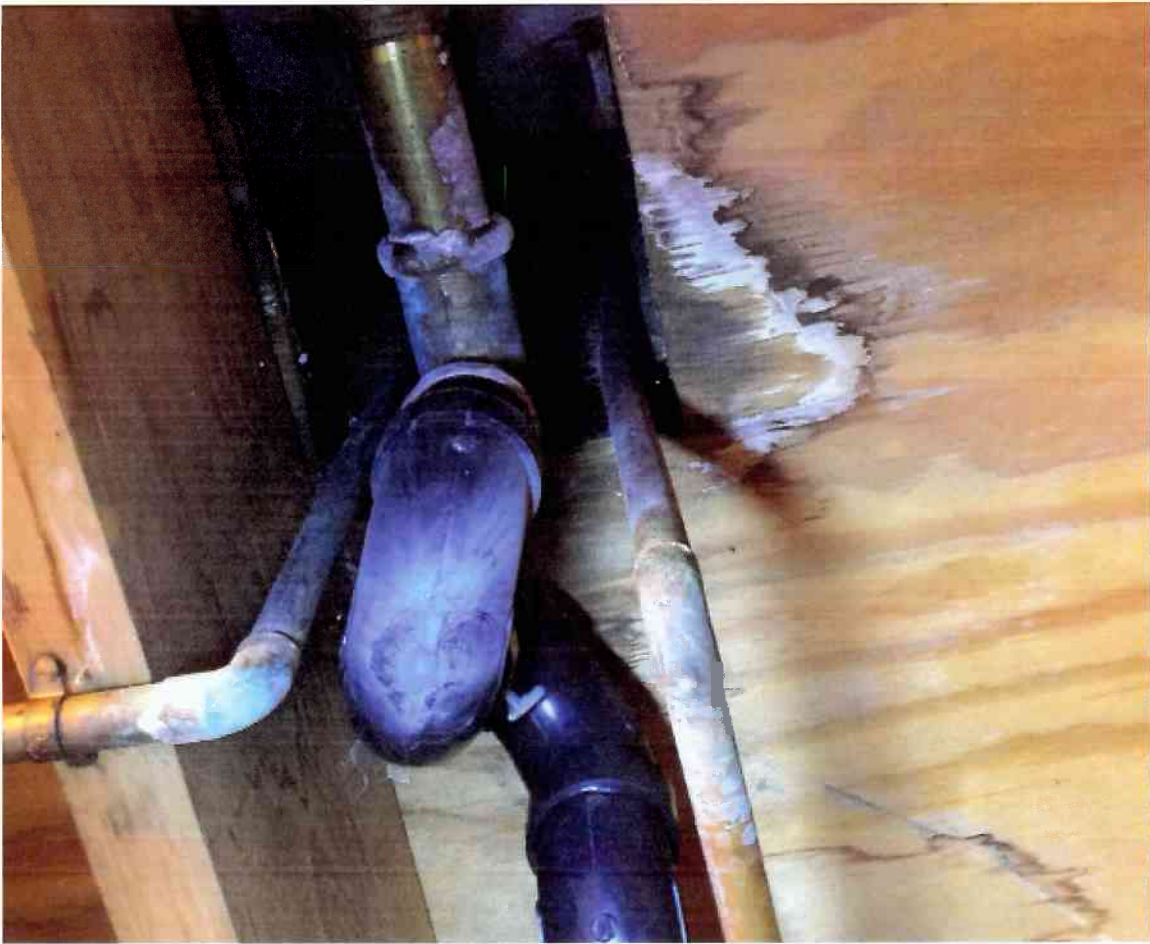
Comments: Signs of minor past moisture damage were observed below the master bathtub, but no current leakage was observed at the time of inspection.

Moisture staining below master bathtub.

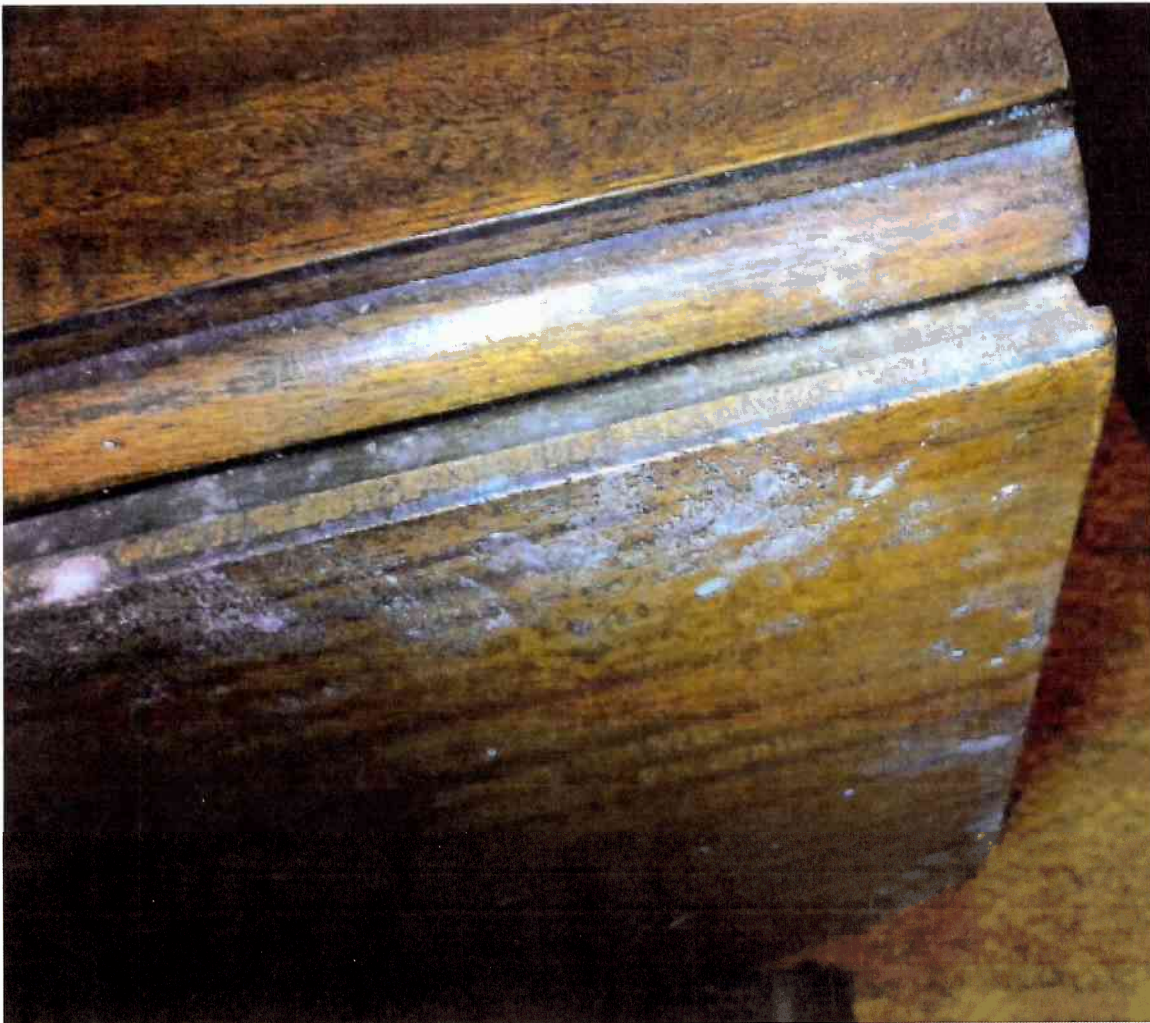
**Comments:** No dehumidifier was observed operating at the time of inspection. Minor fungal growth was observed on occupant contents. Minor fungal growth was observed on wood components in the basement. Minor fungal growth was observed on joists in the basement.

Fungal growth on basement contents.

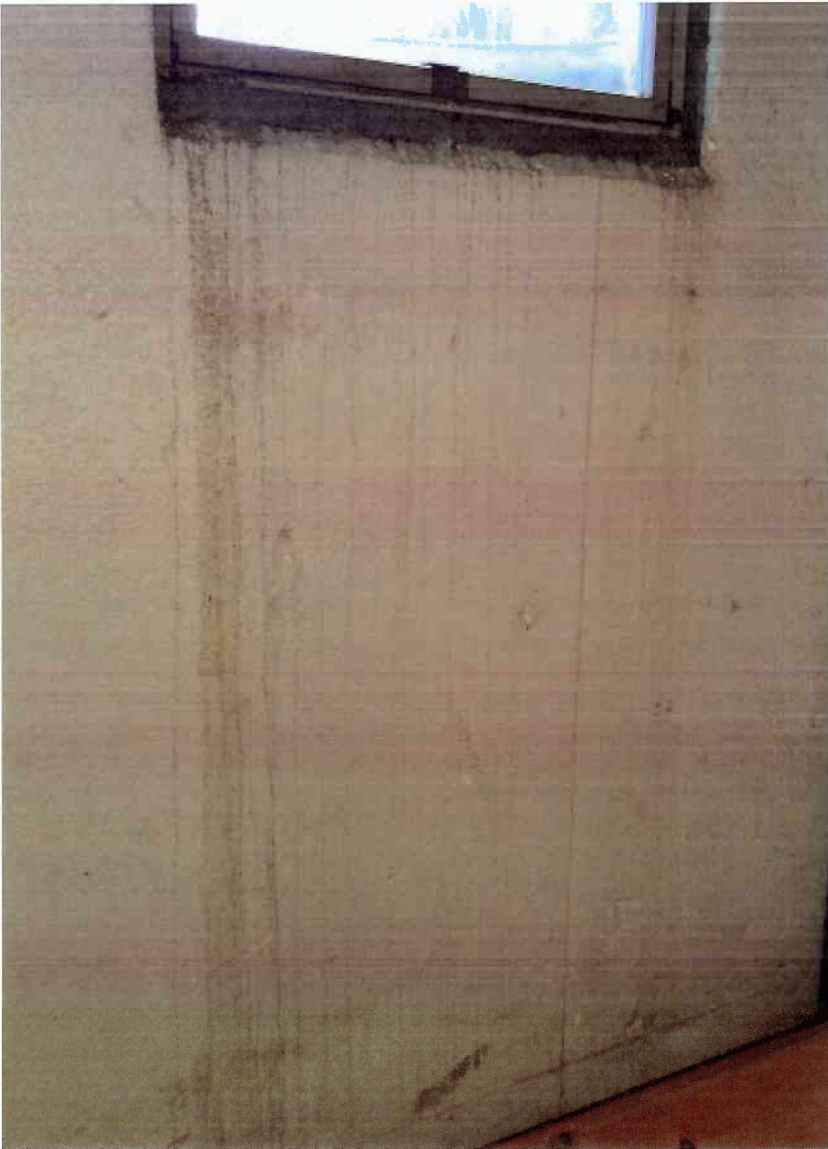
Comments: Signs were observed of past moisture infiltration to the E basement window. No current moisture was observed at the time of inspection. It is unclear whether infiltration is current/persistent issue, or whether the cause of any infiltration has been mitigated.

Moisture staining at E basement window.

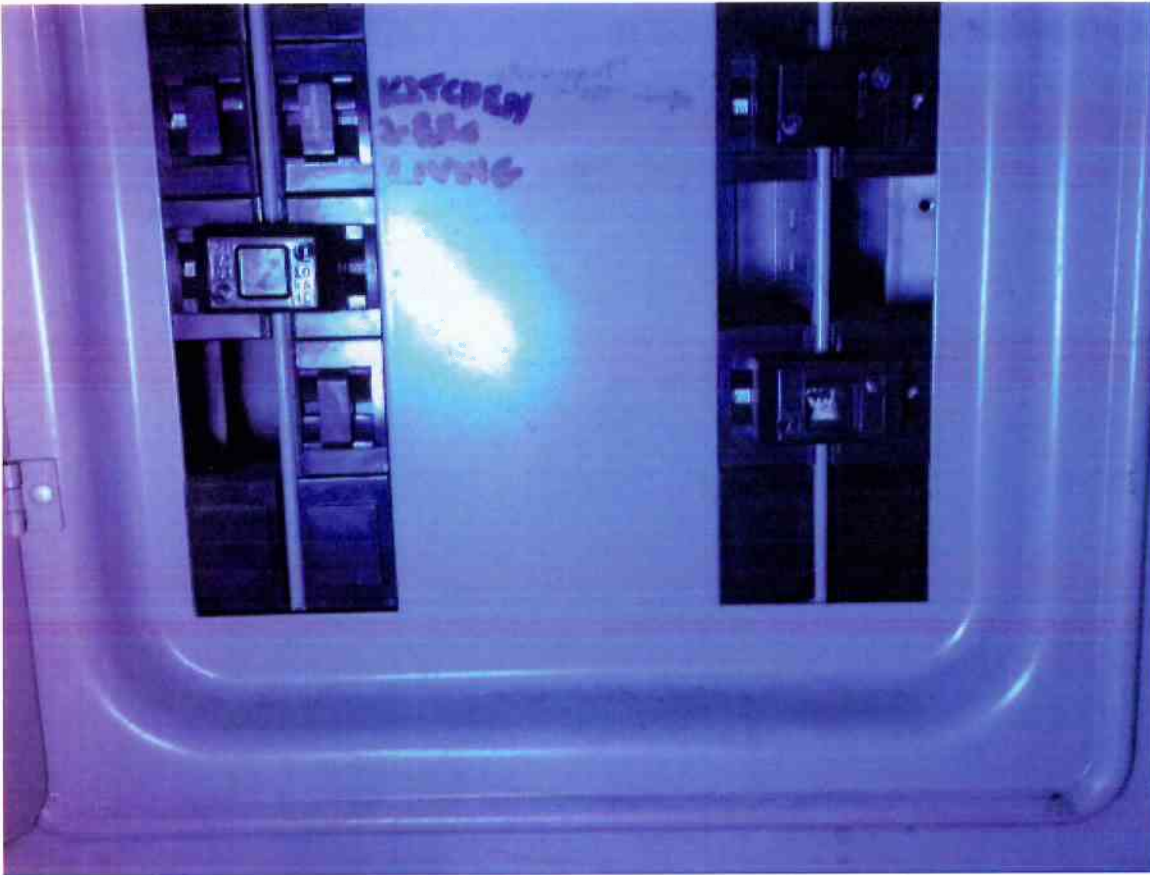
Location: Basement  
Capacity:  60 amp  100 amp  125 amp  150 amp  200 amp  Other  
 Circuit Breakers  Fuses  Labeled Circuits  Unlabeled Circuits  
Quantity: 33 of 36 slots used  
Condition:  Satisfactory  Not Satisfactory  
Comments: Open slots on the main electric panel are not properly covered.

Open slots in main panel.

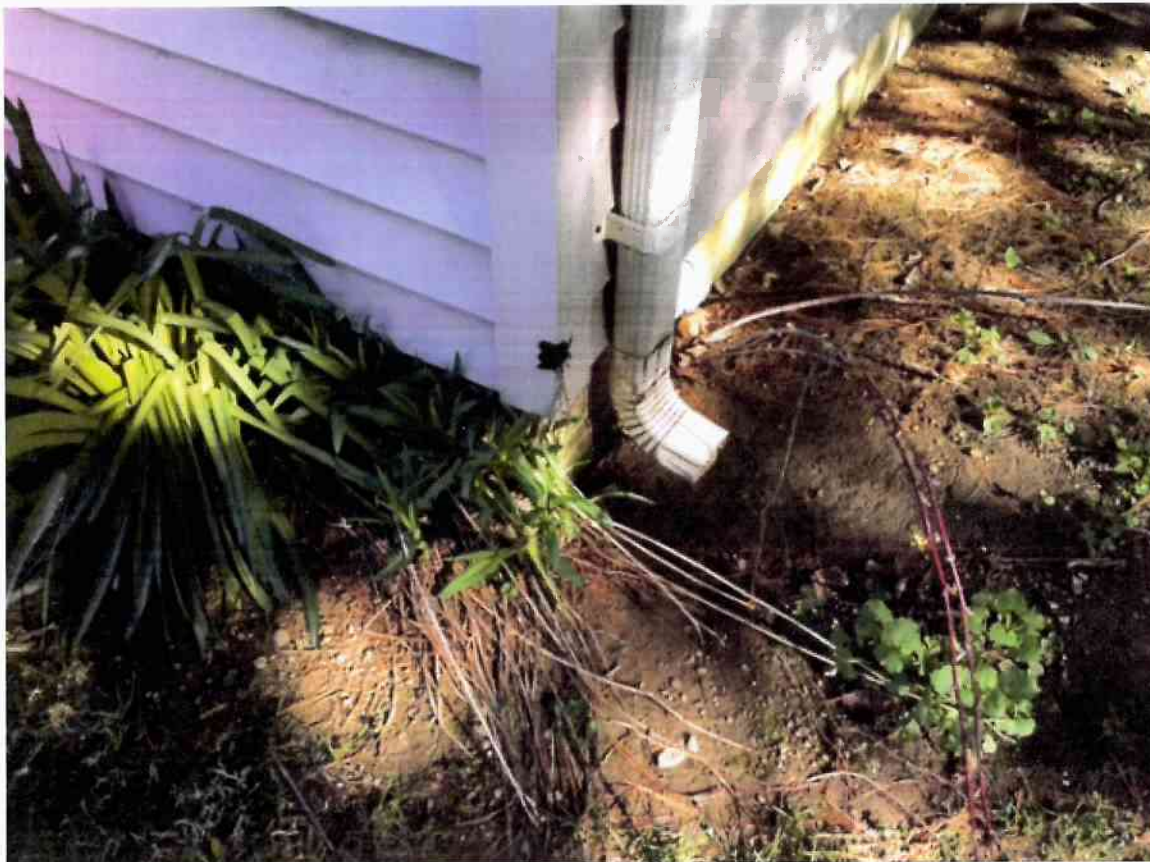
Comments: Some cracks were observed in the exterior foundation. Some open mortar joints were observed in the exterior foundation. Deterioration and soil erosion were observed in the NE corner.

**Comments:** Some gutters were observed to contain accumulated debris. Some downspouts do not extend properly to at least 36" away from the home's foundation. Some sections of gutter have loose or missing connections to the home. Soil depressions were observed near downspout termination points.

Soil erosion. Lack of downspout extension.

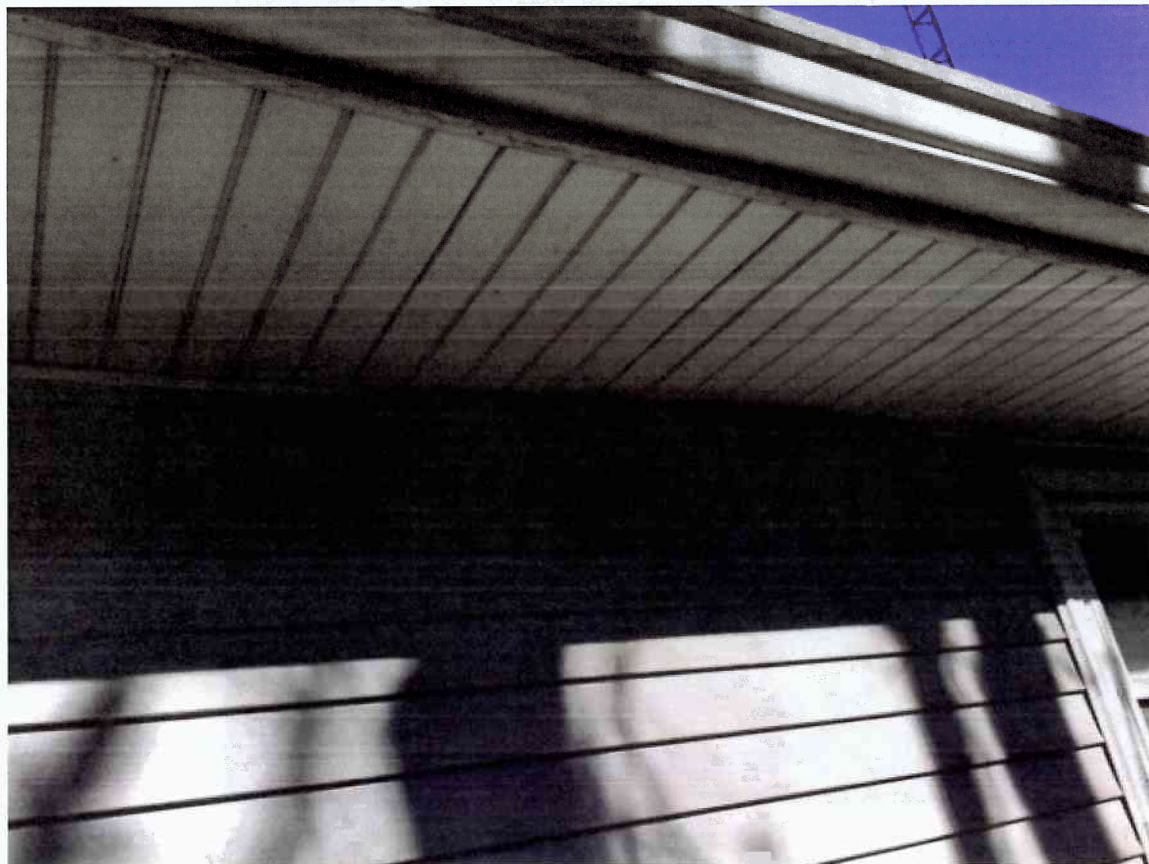
Comments: Some cracks were observed on exterior wall covering. A few damaged/broken siding corner pieces were observed. Sections of siding are displaced. Organic growth/moss was observed on some north wall covering.

Displaced siding.

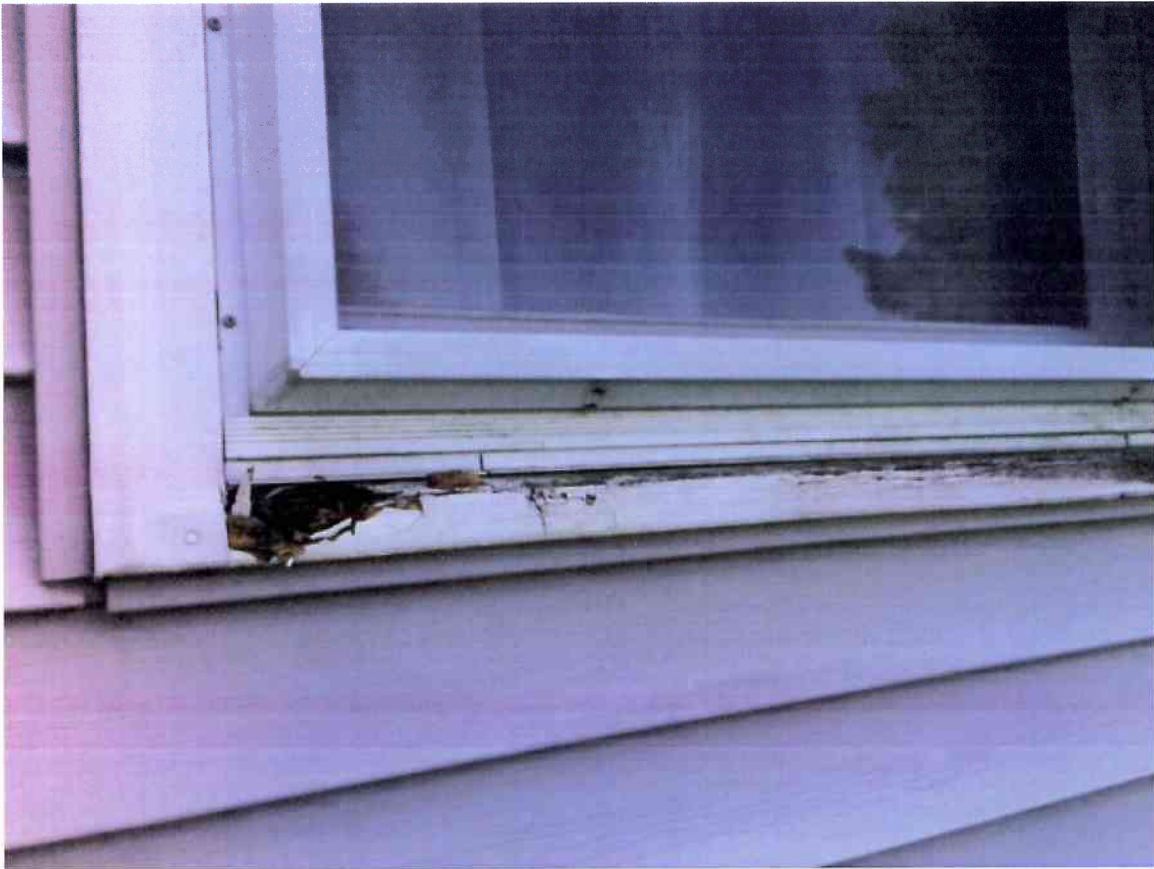
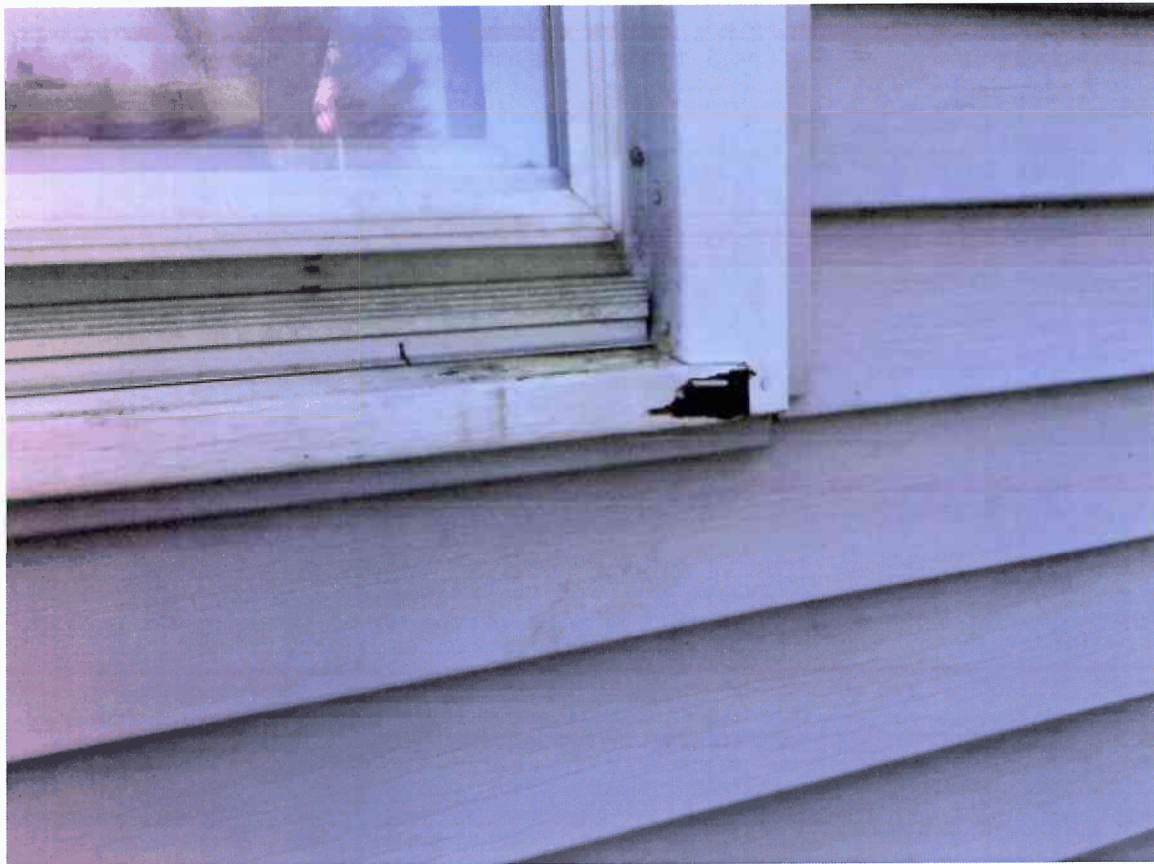
Comments: Wood deterioration/rot was observed on exterior window components (north). Minor chipping exterior paint was observed on exterior door components. The rear sliding glass door lacks a step down to ground level.

Wood rot.

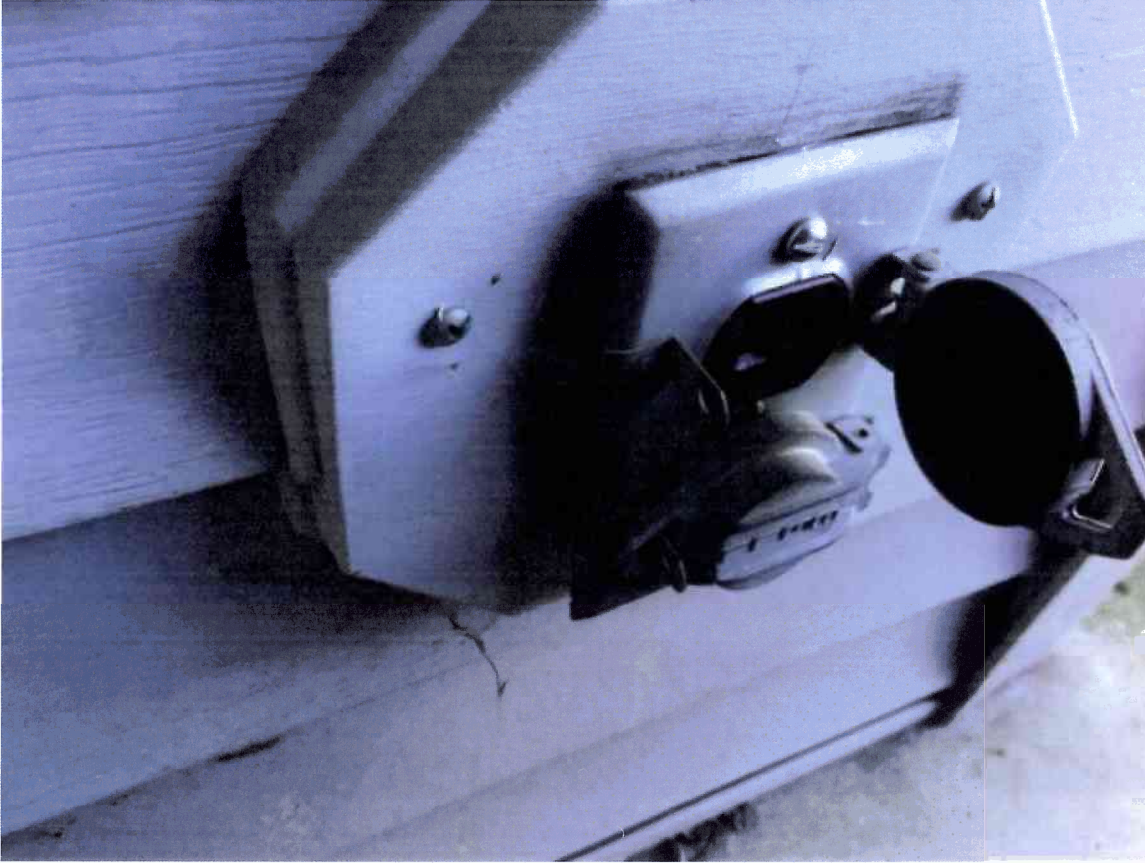
**Comments:** An ungrounded outlet was switched controlled on the front of the home. The exterior gang box was loose.

Loose gang box. Ungrounded outlet.

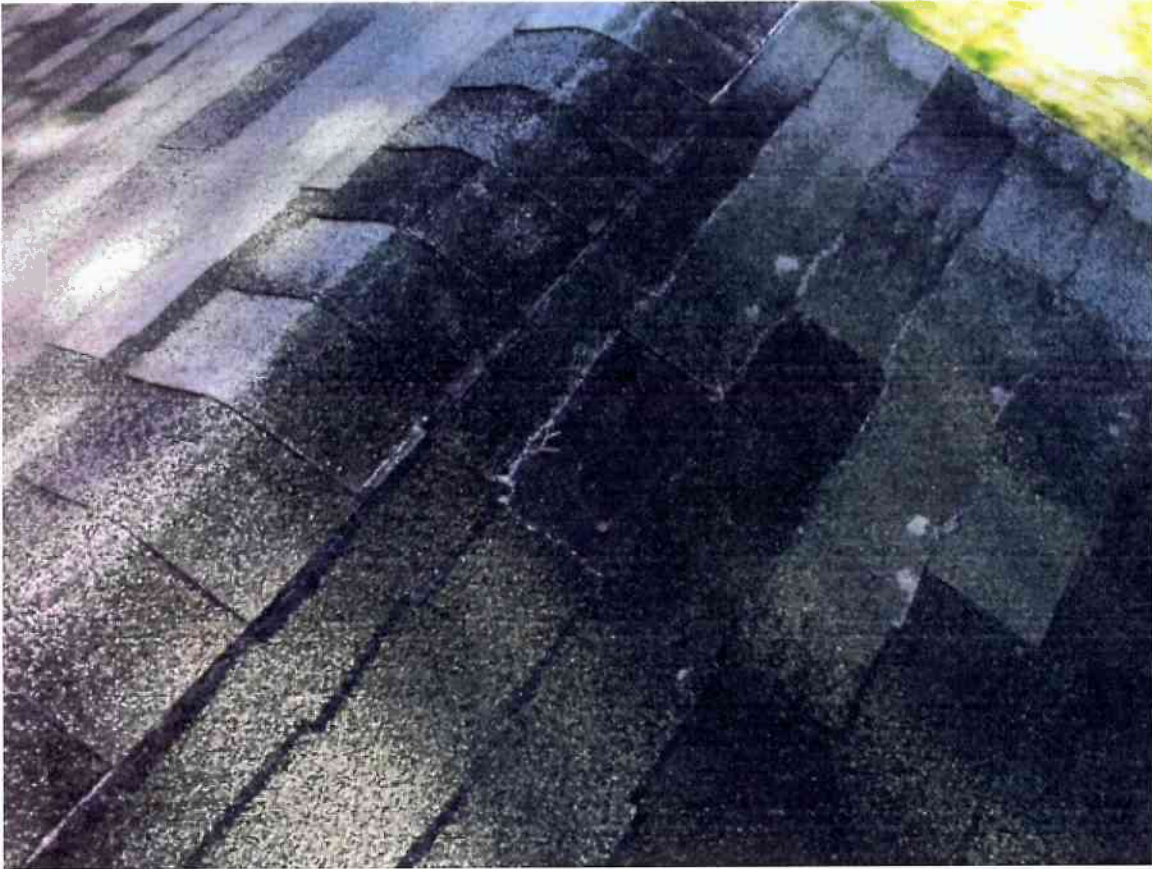
**Comments:** Some wear was observed on roof covering. Some moss growth was observed on roof covering. A torn/missing shingle was observed.

Missing/torn shingle

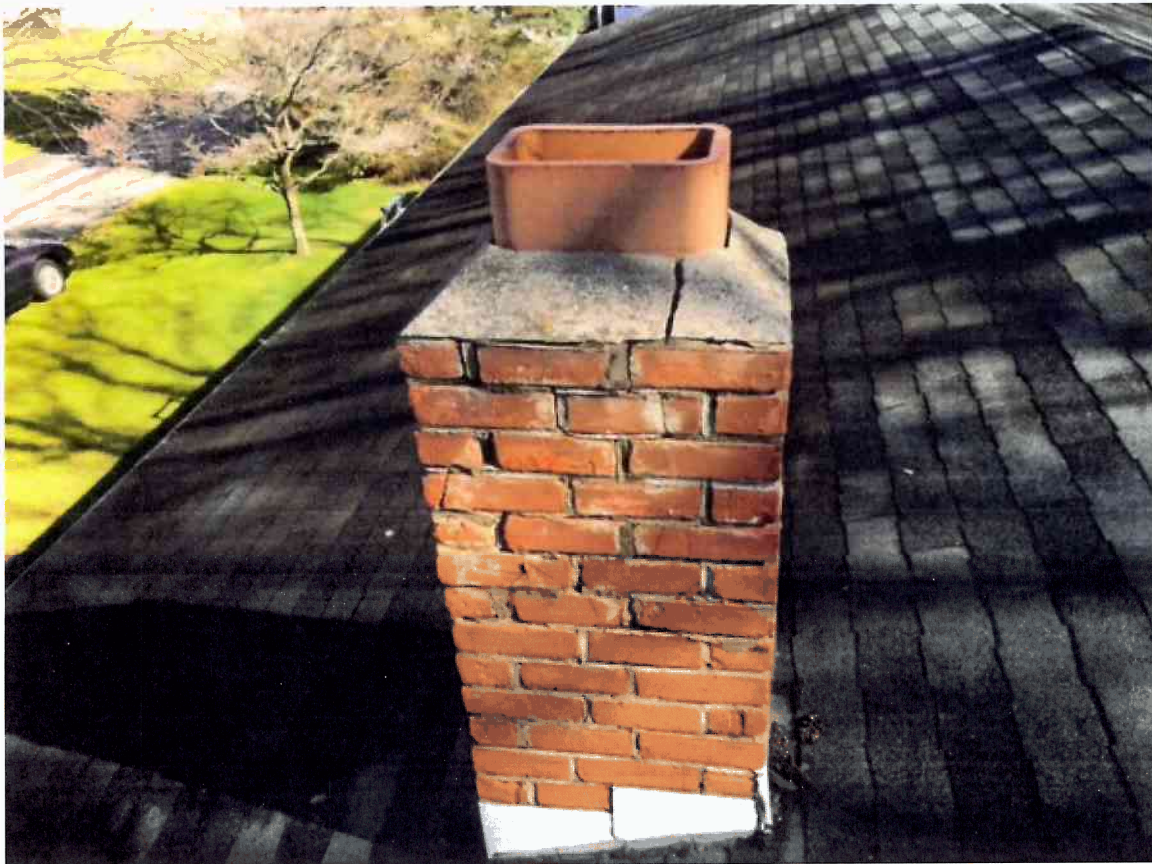
**Comments:** The chimney is missing its rain cap. Some open mortar joints were observed in the chimney. Cracking observed to the concrete atop the chimney. Signs were observed of previous repairs.

Open mortar joints. Missing rain cap.

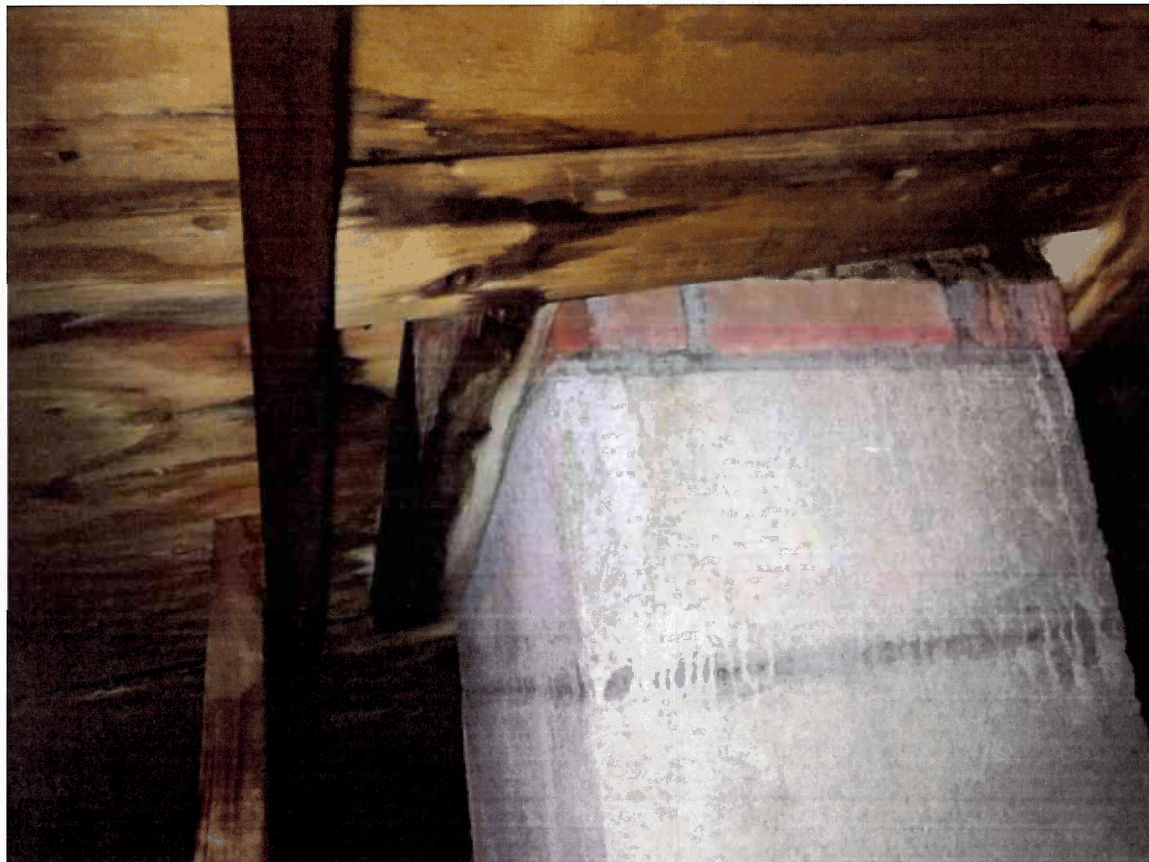
Comments: Signs were observed from the attic of moisture infiltration around the chimney.

Moisture in attic at chimney.

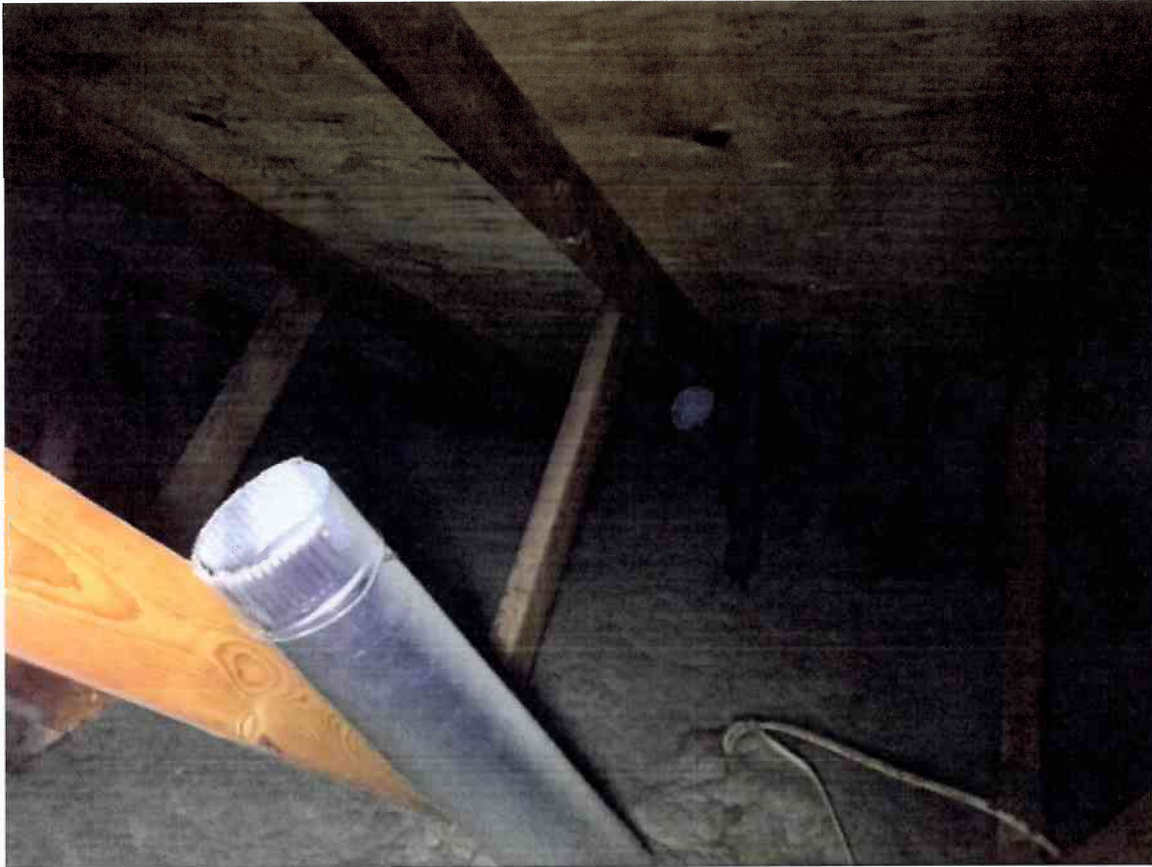
Comments: Signs were observed from the attic of moisture infiltration around the chimney. Piping for bathroom ventilation fans terminates improperly within the attic space, instead of on the home's exterior.

Improper bath vent terminus in attic.
