# INSPECTION REPORT

Sherlock Homes Inspection, Ltd.  
9629 Jadlos Dr.  
Findlay, OH 45840  
419-957-6142  
www.sherlockhomesps.com

**Property Address:** 465 Summit St., Upper Sandusky, OH      **Client(s):** Paul Wagner

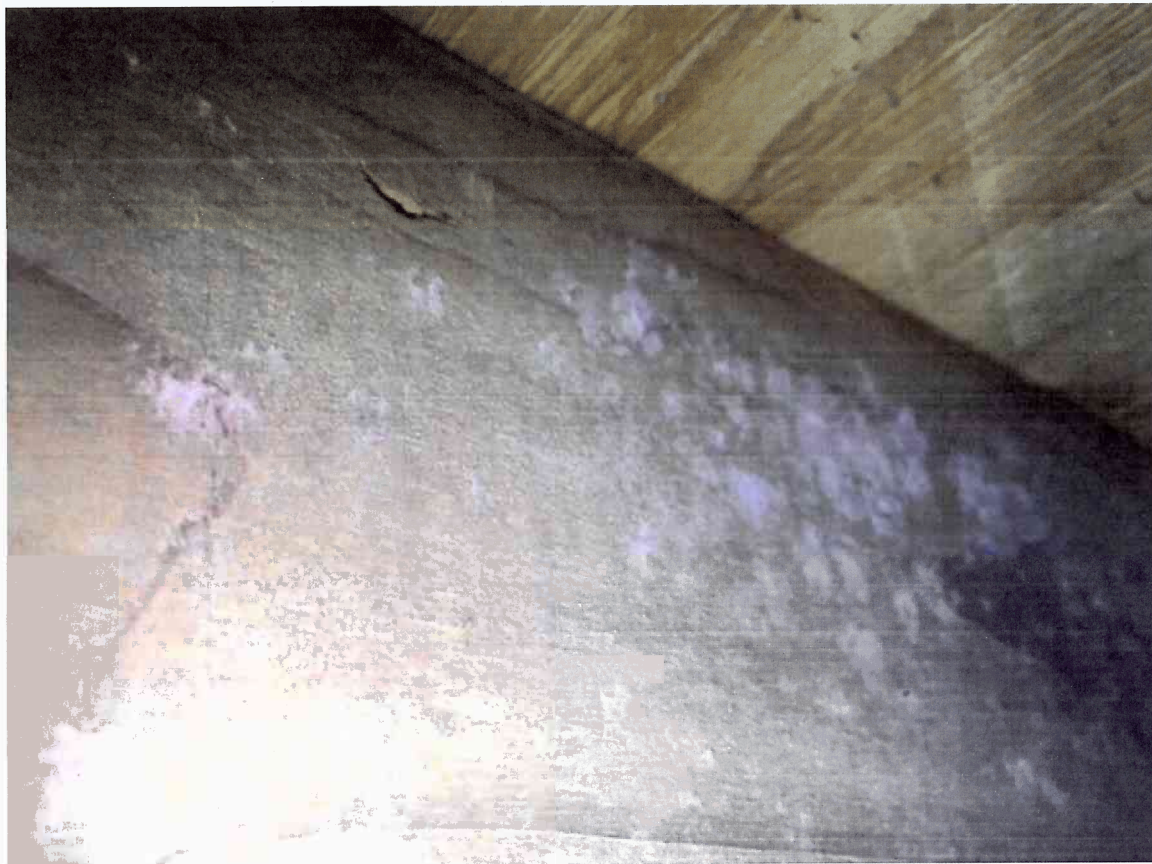
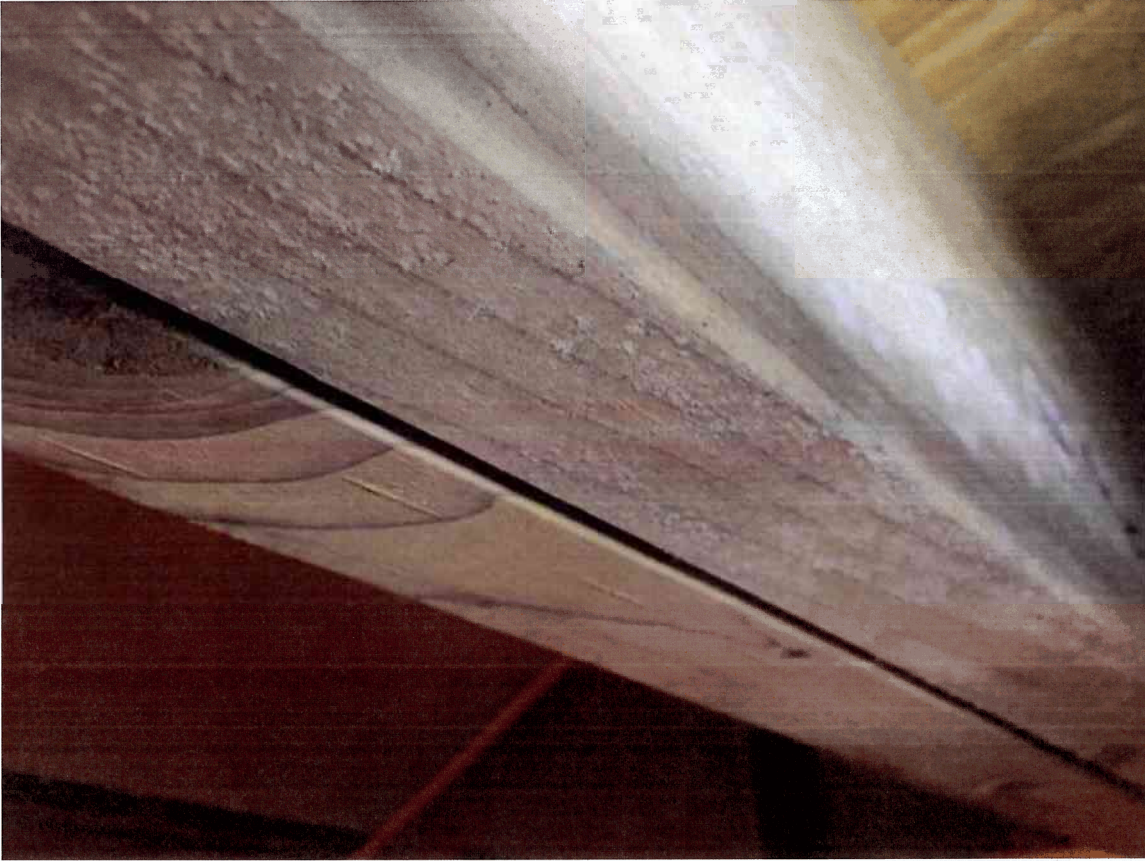
Comments: Minor fungal growth was observed on joists in the basement.

Fungal growth in basement.
