Building Information - North Ridgeville City SD (44537) - Fields Sweet Elementary School

Program Type	Expedited Local Partnership Program (ELPP)
Setting	Small City
Assessment Name	Fields Sweet Early Childhood Learning Center 2010 Assessment
Assessment Date	2010-08-16
Cost Set:	2010
Building Name	Fields Sweet Elementary School
Building IRN	11577
Building Address	8540 Root Rd.
Building City	N. Ridgeville
Building Zipcode	44039
Building Phone	216-327-4444
Acreage	6.97
Current Grades	PK
Teaching Stations	11
Number of Floors	2
Student Capacity	205
Current Enrollment	95
Enrollment Date	2010-06-01
Enrollment Date is the date in which the current enrollment was taken.	
Number of Classrooms	3
Historical Register	NO
Building's Principal	Mrs. Andrea M. Vance
Building Type	Elementary

Fields Sweet Early Childhood Learning Center is a two floor, 25,580 square foot school building located on a 6.97 acre relatively flat site is located in a small town residential setting with sparse tree type landscaping. The 1920 original construction is equipped with brick masonry foundation walls on concrete footings. The 1954 multi-purpose/classroom addition is equipped with cast-in-place concrete foundation

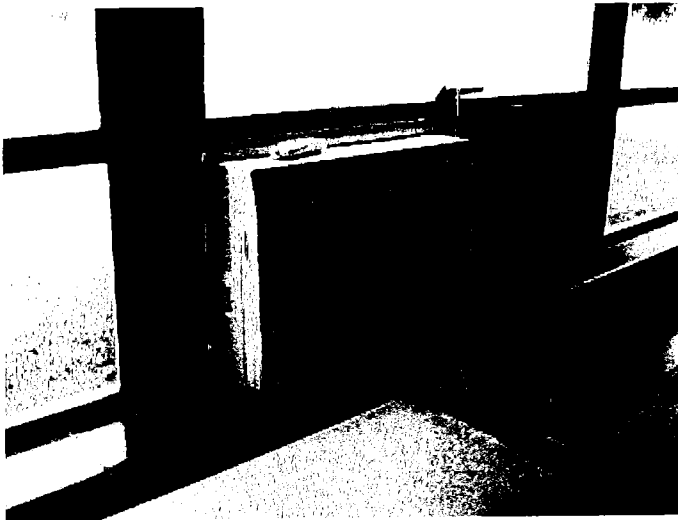
The existing heating system for the overall facility is a natural gas-fired hot water system. The boiler, manufactured by Steampak was installed in 1955 and is in fair condition and located in the 1920 original construction lower level. Heating water is distributed to terminal units consisting of classroom unit ventilators and fin-tube radiators. The existing controls are pneumatic. The existing overall facility does contain a partial air conditioning system consisting of window air conditioners in several classrooms and administrative areas. The system does feature individual temperature controls in spaces with unit ventilators as required by the OSDM. The overall system does not feature any central energy recovery systems. The ventilation system in the overall facility consists of unit ventilators and exhaust fans to provide outside air into interior spaces. The overall facility contains louvered doors for relief air venting. The system is not capable of providing the 15 CFM per person outdoor air requirements of the Ohio Building Code and Ohio School Design Manual. The 1920 original building contains 2x4 lay-in classroom ceilings at 10'-0" above finished floor and the average height of bottom of wood truss structure is 12'-8" above finished floor, allowing 2'-8" clear plenum space, which will allow for the installation of ductwork. The existing lay-in acoustic 2x4 corridor ceilings are 11'-6" above finished floor and the average height of bottom wood truss structure is 12'-8" above finished floor, allowing 1'-2" clear plenum space, which will allow for the installation of ductwork. The 1954 multi-purpose/classroom addition existing concrete plank classroom ceilings are 11'-1" above finished floor which would allow 2'-1" for the installation of ductwork above new a lay-in ceiling at 9'-0" above finished floor. The existing lay-in acoustic corridor ceilings are 9'-2" above finished floor and the bottom of concrete plank structure is 11'-1" above finished floor, allowing 1'-1" clear plenum space, which will allow for the installation of ductwork. The 1962 classroom addition existing direct glued acoustic classroom and corridor ceilings are 8'-4" above finished floor on the lower level and 10'-5" on the second level which will not allow for the installation of ductwork. The facility does not contain adequate restroom exhaust system. The existing restroom exhaust system is in poor condition. The facility does not contain a kiln for the art program.

Window air conditioning unit

Provide an air conditioning system throughout the overall facility to meet Ohio School Design Manual guidelines. Funding included in Item A - Heating System. Restroom exhaust system provided with complete HVAC system replacement.

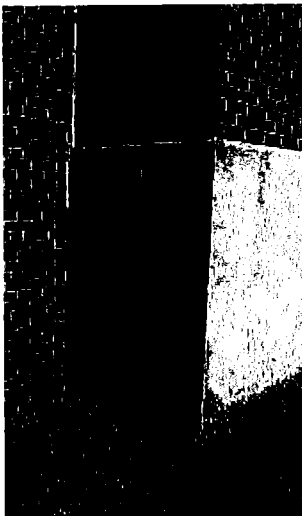
Description: The 1920 original construction is equipped with brick masonry foundation walls on concrete footings, which displayed no locations of significant differential settlement, cracking, or leaking, and are in good condition. The 1954 multi-purpose/classroom addition is equipped with cast-in-place concrete foundation walls on concrete footings, which displayed no locations of significant differential settlement, cracking, or leaking, and are in good condition. The 1962 classroom addition is equipped with concrete masonry unit foundation walls on concrete, which displayed no locations of significant differential settlement, cracking, or leaking, and are in good condition. The district reports that there has been minor leaking in the lower level mechanical room of the 1920 original construction. No grading or site drainage deficiencies were noted around the perimeter of the structure that are contributing or could contribute to foundation / wall structural deterioration.

Typical cast-in-place concrete foundation wall

Recommendations: Provide sprayed on waterproofing system in west wall of the mechanical room in the 1920 original construction.

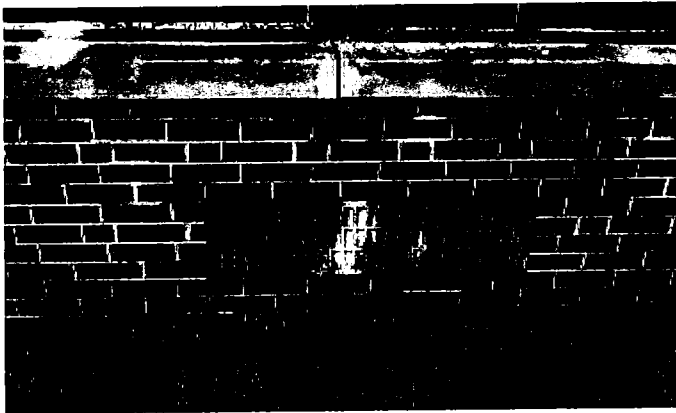
The overall facility has a combination of brick bearing and brick veneer on a masonry bearing wall system, which displayed locations of minor deterioration, and is in good to fair condition. The school does not contain expansion joints, and none are needed as there is no indication of exterior masonry cracking or separation. Brick veneer masonry walls are not cavity walls. Weep holes and vents are not provided or required. The exterior masonry has not been cleaned and sealed in recent years, and shows evidence of minor mortar deterioration throughout the overall facility. Architectural exterior accent materials consist of metal panels and stone, which are in good to fair condition. Exterior building fenestrations in the 1920 original construction represent 15.21% of the exterior surfaces. Exterior building fenestrations in the 1954 multipurpose/classroom addition represent 13.89% of the exterior surfaces. Exterior building fenestrations in the 1962 classroom addition represent 14.90% of the exterior surfaces. Installation of new HVAC systems will result in removal of any existing unit ventilators, necessitating the exterior masonry infill of associated exterior wall voids. Interior corridor and demising walls are a combination of concrete masonry units, glazed block, wood framed partitions with plaster and metal stud and wood framed partitions with gypsum board, project full height from floor to bottom of deck, and are in good condition. Interior masonry appears to have adequately spaced and caulked control joints in good condition. Soffits are in good to fair condition. The window sills are stone, and are in good to fair condition. The exterior lintels are steel, and are rusting. Chimneys are in good to fair condition. The school is not equipped with a loading dock.

Typical window sill condition

Provide tuckpointing in all areas of mortar deterioration. Provide masonry cleaning, sealing and caulking as required throughout the overall facility. Prepare and paint steel lintels throughout the overall facility. Repoint stone window sills through the overall facility. Provide masonry infill associated with the removal of old unit ventilators. Prepare and paint soffits in the 1920 original construction. Remove existing chimneys.

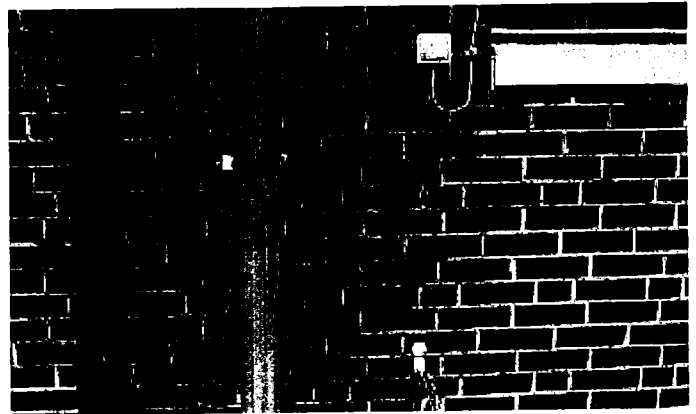
Exterior masonry condition requiring tuckpointing

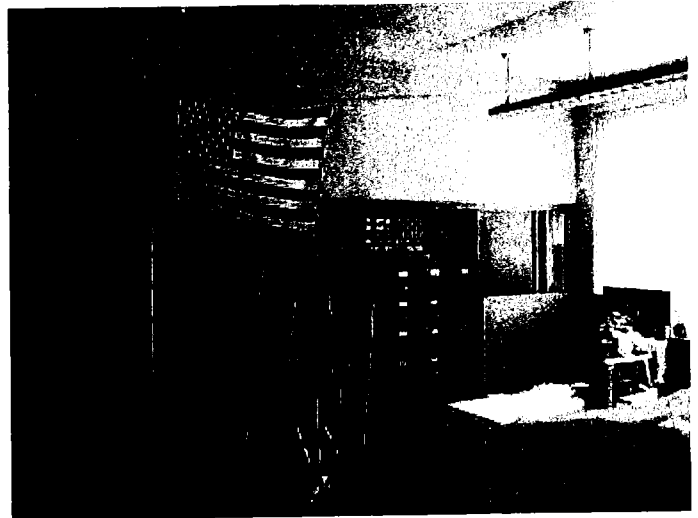
The overall facility features conventionally partitioned classrooms with VCT, VAT and a wood sleeper type flooring in only the 1920 original construction, concrete plank type ceilings with glue-on 12x12 acoustic tiles, as well as glazed block, painted block, and plaster type wall finishes, and they are in good condition. The overall facility has corridors with VCT and VAT type flooring, concrete plank and lay-in acoustic type ceilings, as well as glazed block, painted block and plaster type wall finishes, and they are in fair to good condition. The overall facility has restrooms with ceramic tile type flooring, acoustic tile type ceilings, as well as glazed block and painted block type wall finishes, and they are in good condition. Toilet partitions are metal, and are in poor condition. Classroom casework in the overall facility is wood type construction with plastic laminate tops, is inadequately provided, and in poor condition. The typical classroom contains an average of 10 lineal feet of casework. Classrooms are provided adequate chalkboards, markerboards, and tackboards, which are in fair condition. The classroom storage cubbies, located in the 1954 classrooms are adequately provided, and in fair condition. The art program is not equipped with a kiln and a kiln is not required as it is not a part of the program. The facility is equipped with wood louvered interior doors that are flush mounted without proper ADA hardware, and in poor condition. The multi-purpose space has VCT type flooring, 2x4 lay-in type ceilings, as well as painted block wall finishes, and they are in good condition. Gymnasium telescoping stands are provided. Fixed basketball backboards are provided. The existing kitchen has been turned into a custodial area as the building serves only half-day preschool students and no kitchen is required.

Typical classroom

Provide complete replacement of finishes and casework due to installation of systems outlined in Items A, C, D, E, K, L, M, N, T, U. Funding for replacement of interior doors is provided in Item O, including doors here noted as being in poor condition. Provide for replacement of toilet partitions due to work outlined in Item O. Provide for replacement of toilet accessories due to age and condition. Provide lightweight concrete floor infill at wood floor removal in the 1920 original construction.

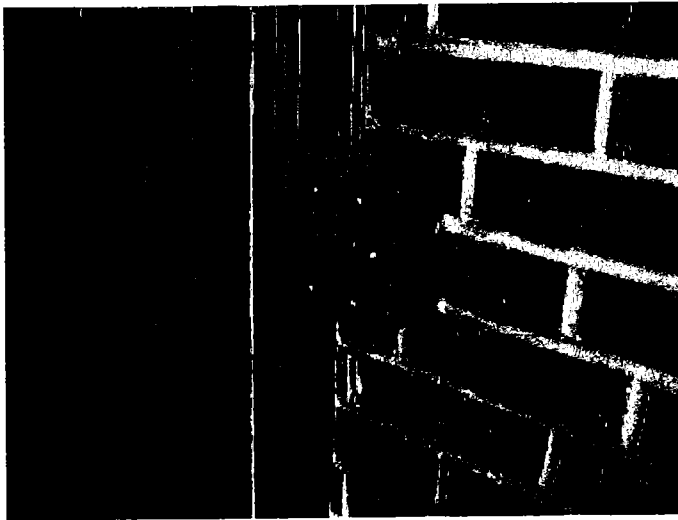
Description: The overall facility contains a security system consisting of security cameras, door contacts, electric door strikes activated from a remote area and monitored by a security camera and door buzzer, and motion sensors). The existing security system is in fair condition. The exterior security lighting consists of wall and pole mounted fixtures. Exterior security lighting is in poor condition and provides inadequate coverage.

Exterior door intercom

Recommendations: Provide upgrade to security system to meet Ohio School Design Manual guidelines. Provide new exterior security lighting system to meet Ohio School Design Manual guidelines.

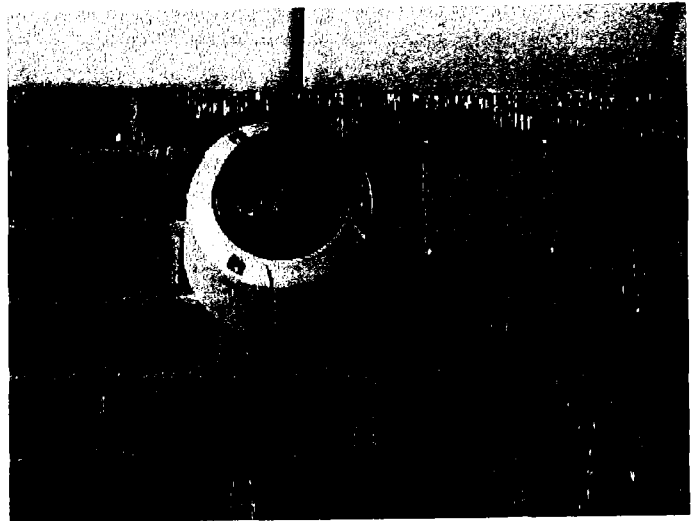
Exterior security camera

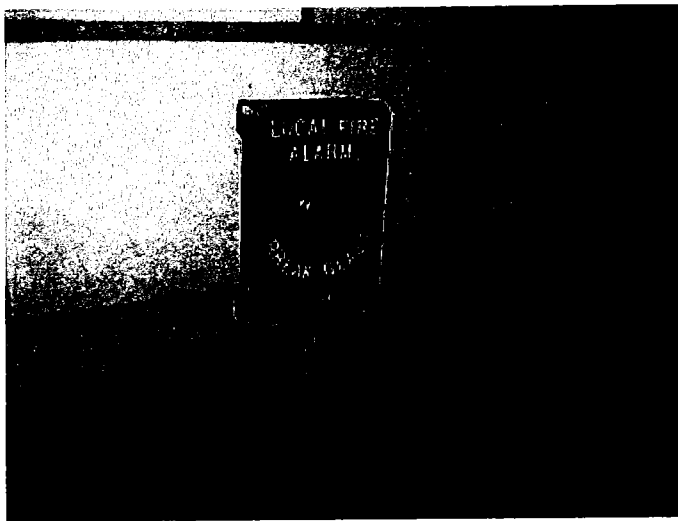
Description: The overall facility contains a fire alarm system in poor condition. Manual pull stations are mounted in corridors and the multi-purpose room. Manual pull stations are mounted at exits. Horns and strobes are not mounted in classrooms, all corridors, assembly areas, or mechanical areas. Mechanical equipment does not contain automatic fire alarm devices. The system does not have additional zone capabilities. The system is not adequately provided throughout the facility. The fire alarm system does not meet NFPA requirements and Ohio School Design Manual guidelines.

Corridor mounted manual fire alarm

Recommendations: Provide complete replacement of fire alarm system consisting of manual fire alarm pull stations mounted at required heights, remote annunciator panels, automatic fire detection devices in all air devices and mechanical equipment, and horn/strobe devices located in all occupied spaces to meet Ohio School Design Manual guidelines.

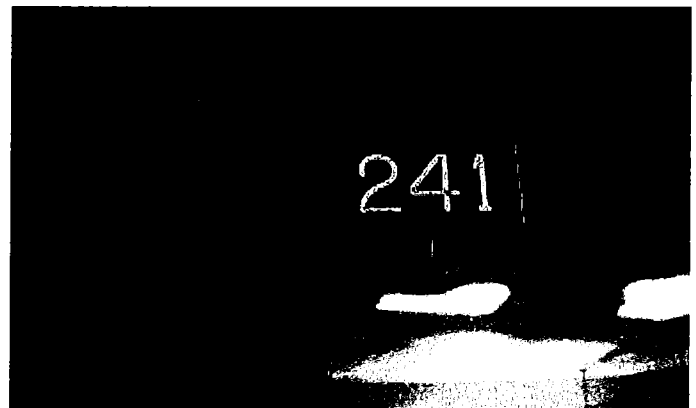
Typical signage

Recommendations: Provide ADA-compliant signage, new power assist door openers, chair lifts and ramps, elevator, electric water cooler, toilets, lavatory sinks, urinals, and ADA-compliant toilet partitions. Replace doors and frames and rework narrow door openings to facilitate meeting of ADA requirements. Parking issues are corrected in Item P. Exterior door hardware issues are corrected in Item S. Toilet accessory deficiencies are corrected under Item J. Stair railing deficiencies are corrected under Item U.

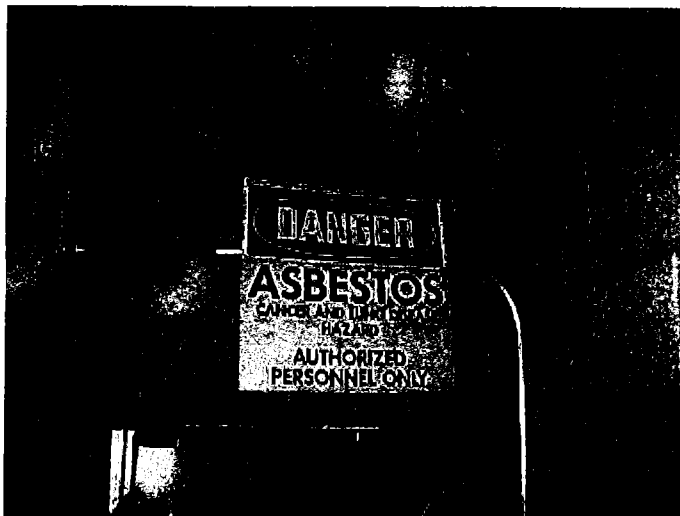
Hazardous material signage

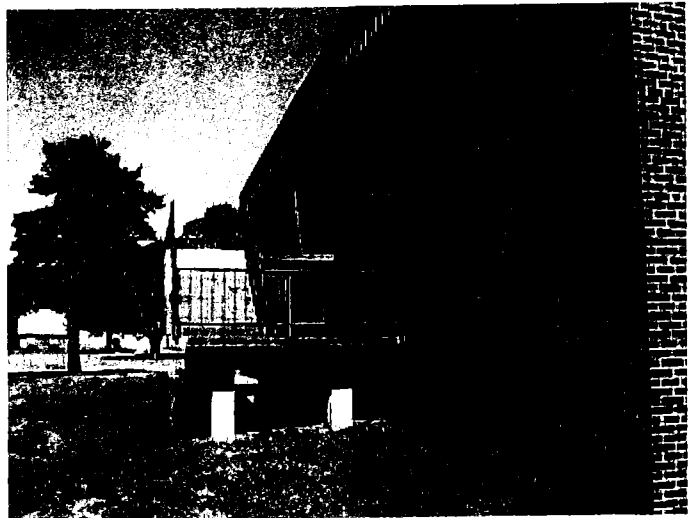
Open exterior egress stair
