# Home Inspection Report

637 Woodbine Ave SE, Warren, OH 44483

Sunday, April 11, 2021

04112021-03

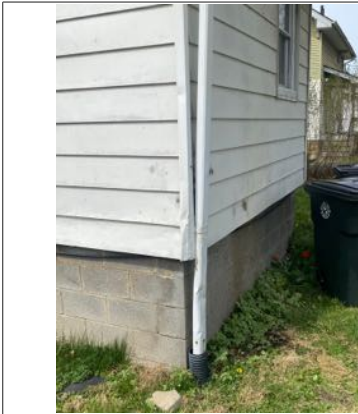
-Downspouts had some visible damage , recommend repair/replacement of the damaged sections.

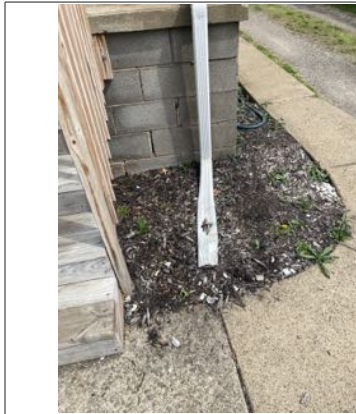
-Downspouts had some visible damage , recommend repair/replacement of the damaged sections.

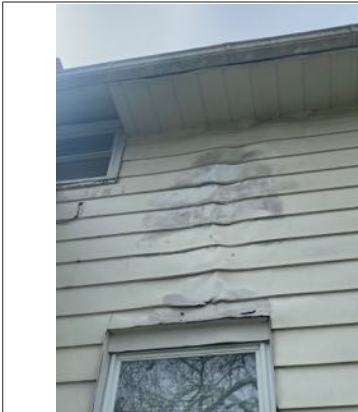
-Siding had some damage, recommend repairing/replacing damaged sections.

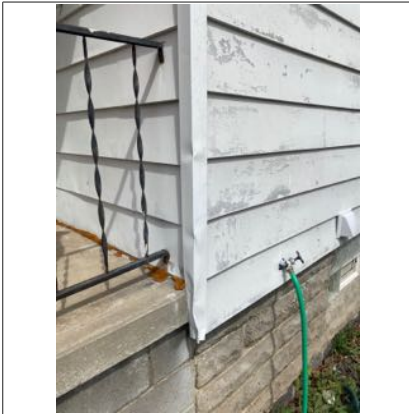
-Recommend repair of damaged trim by a qualified contractor.

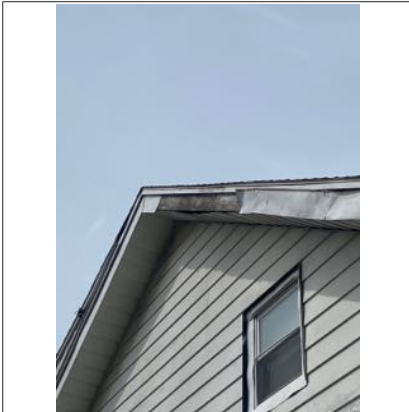
-A section of fascia was missing. Repairs/replacement recommended at the affected area.

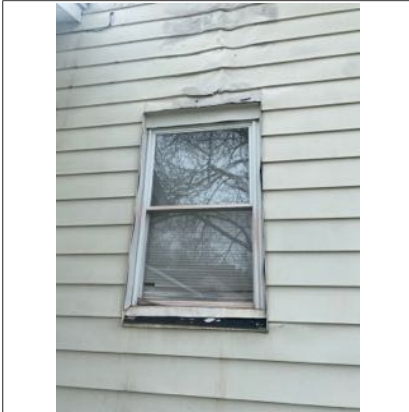
-The rear window framing is damaged and missing trim. Further review from a qualified contractor is recommended.

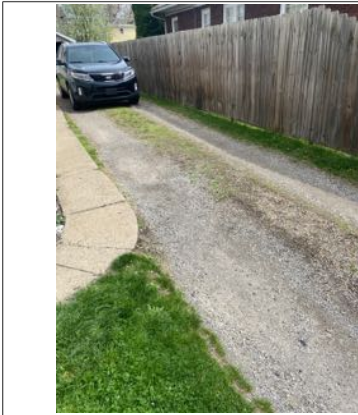
-Driveway was in poor condition recommend repair and/or replacement.

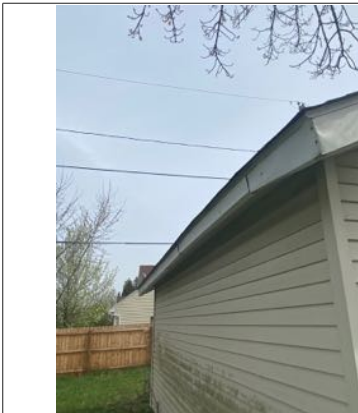
-Recommend installing gutters and/or downspouts at the garage.

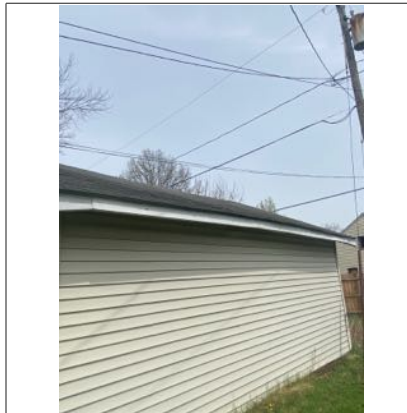
-Recommend installing gutters and/or downspouts at the garage.

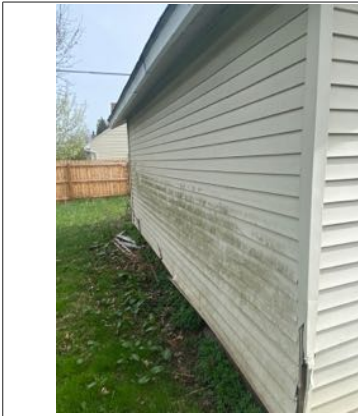
-The garage Siding has moss present. This should be considered a minor defect, power washing or removing the moss is recommended.

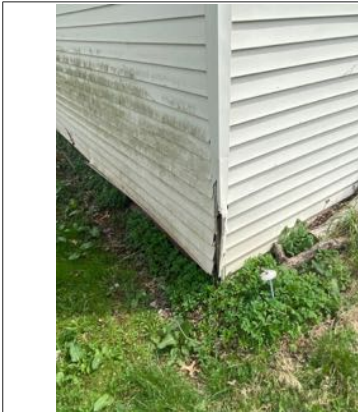
-Garage trim had some damage recommend repair.

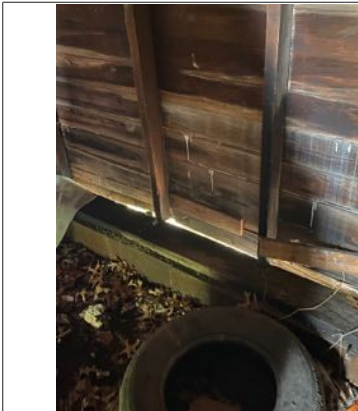
-Missing siding at the garage is leaving the interior exposed to weather conditions and critters. Repair(s) recommended.

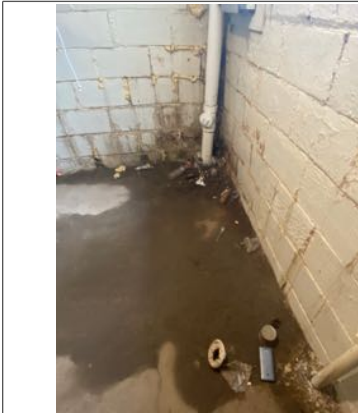
-Foundation walls were showing efflorescence and some moisture. This should be considered common for basements in this climate that do not have a waterproofing system. Maintaining a proper soil pitch at the exterior perimeter of the foundation, as well as keeping the gutters & drain tiles clean will give rainwater its best opportunity to move away from the foundation. Informational item.

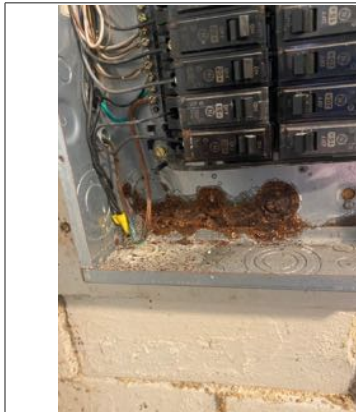
-Evidence of rust in panel. Further review from a licensed electrician is recommended.

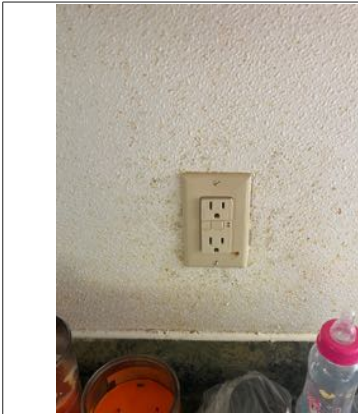
-Outlets at the kitchen wall and counter are not functional. Repairs/replacement recommended.

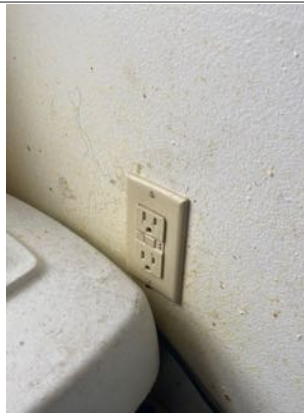
-Outlets at the kitchen wall and counter are not functional. Repairs/replacement recommended.

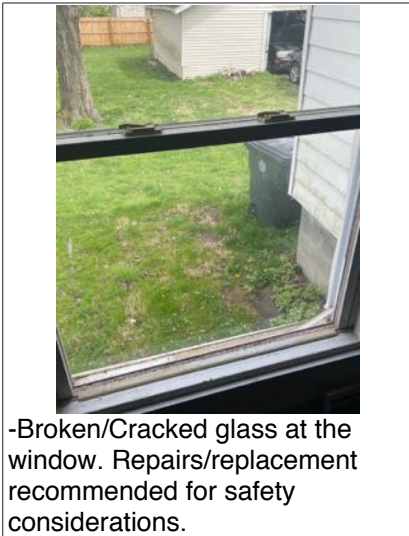
**Comments** -Broken/Cracked glass at the window. Repairs/replacement recommended for safety considerations.

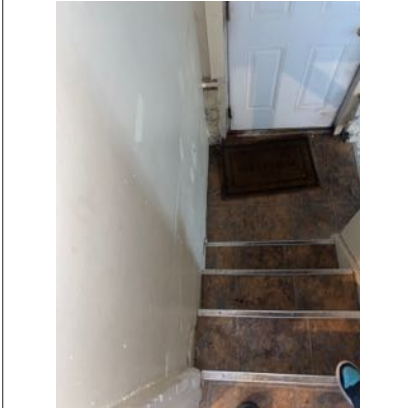
-Handrail missing, potential safety issue. Recommend installing handrail.

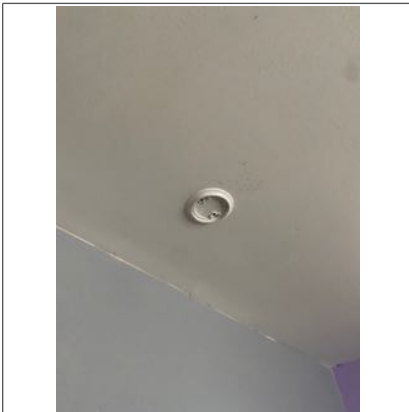
-Smoke detector not visible on this level. Replacement recommended for safety considerations.

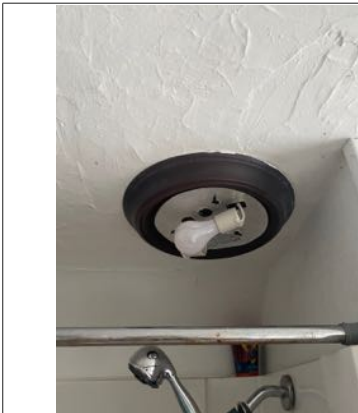
-The bathroom overhead lighting was not functional. Repairs/replacement recommended.

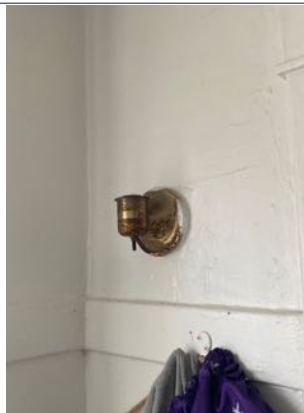
-The bathroom overhead lighting was not functional. Repairs/replacement recommended.

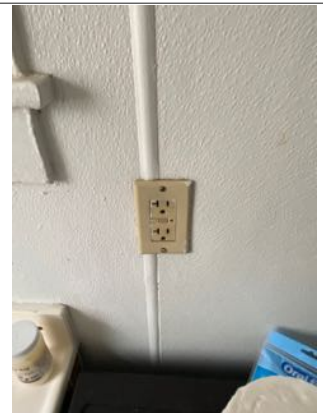
-The bathroom outlet was not functional. Repairs/replacement recommended.
