April 29, 2021

RE: Basement CMU Wall Bowing
220 North Maple Ave, Fairborn, Ohio 45324
Tri-Tech Job Number: 21706E

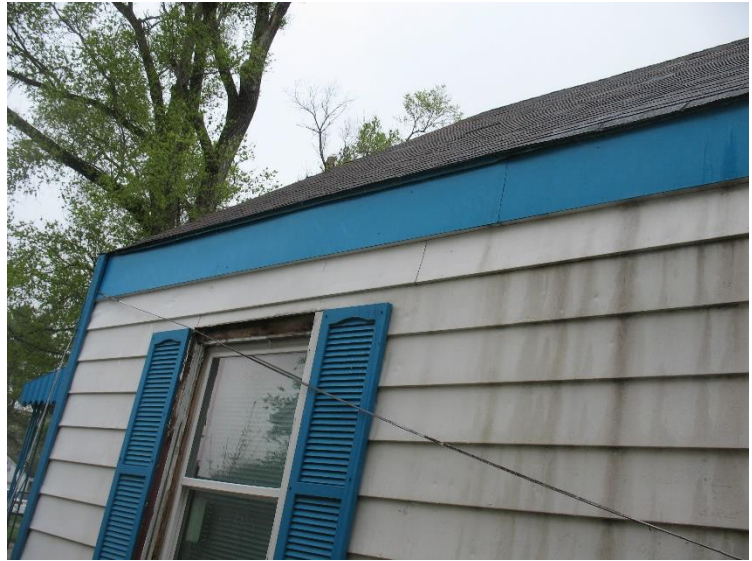
- The roof had very little to no overhang of the exterior walls. There are no rain gutters on the home.

Water from the roof is not directed away from the foundation walls by gutters and down spouts. This creates a higher hydrostatic pressure at the foundation wall.

Gutters should be provided with down spouts extending away from the home’s foundation. The sump pump discharge line should be routed away from the home.

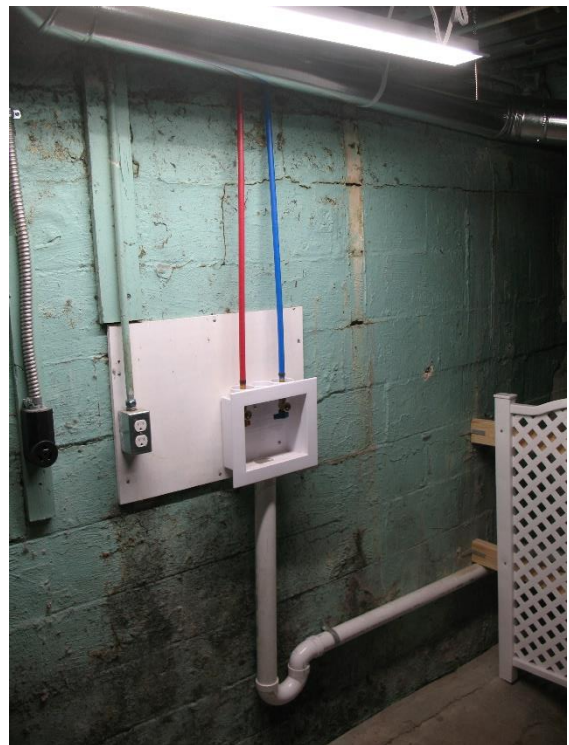
- The North wall of the basement has several cracks at mortar joints. This includes the stair step cracking and two horizontal cracks. In addition, this wall is bowed due to soil and hydrostatic pressure acting on the wall.

The damage to the basement walls can be attributed to soil and hydrostatic pressure from outside the home pushing on the walls and water penetrating the blocks themselves. The water damaged the mortar joints allowing the external forces to crack the joint and bow the walls.

The basement walls should be repaired or replaced prior to the home being occupied. Repair may be possible, but the design is beyond the scope of this investigation. Results of a Google search for companies that design and install foundation repairs yielded the following: Dwyer Company, located in the Cincinnati area, phone number 877-399-3726, A-1 Concrete Leveling and Foundation Repair, located in the Dayton area, phone number 937-832-1291, and Olshan Foundation Repair, located in the Cincinnati area, phone number 513-286-2543. Tri-Tech has not worked with or for any of these companies and offers no endorsement of their services.

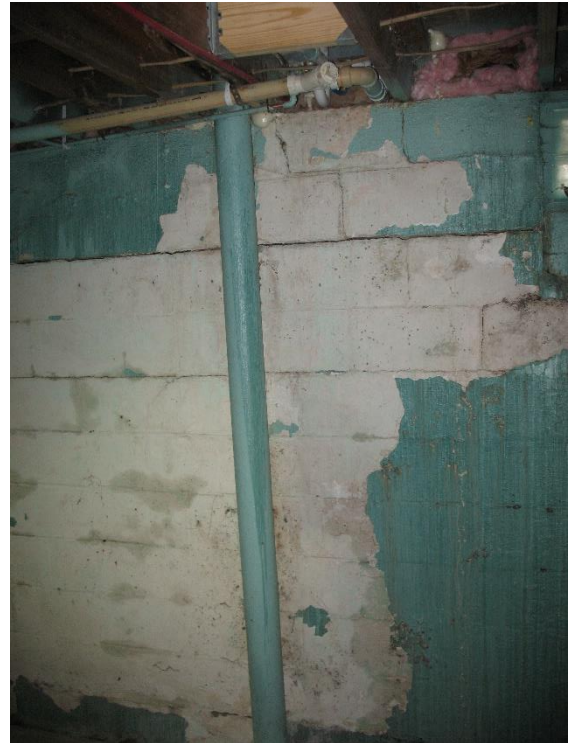
- The upper crack in this photo is between the ninth and tenth course of block and is approximately at the exterior grade. The lower crack is between the seventh and eighth course, approximately 32 inches below grade. This pipe appears to be an attempt to stabilize this wall. However, it is not connected to the wall, is out of plumb by 1.5" in four feet, and has no connection at the top to resist the movement.

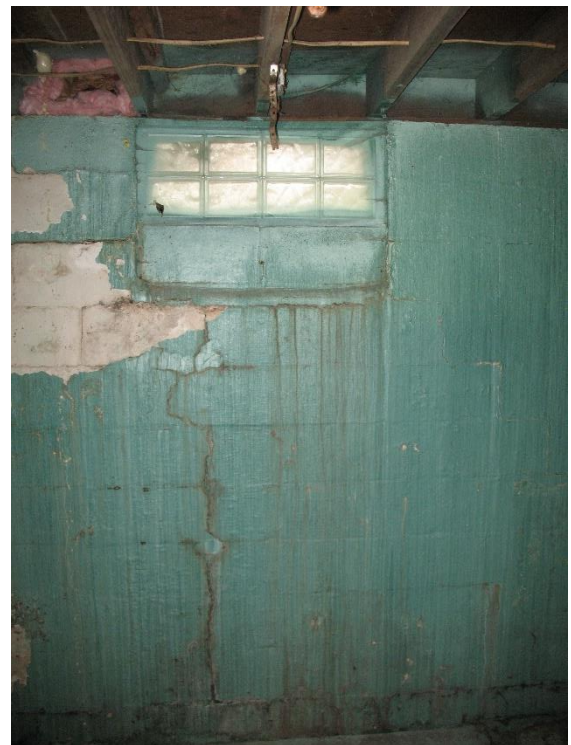
- The upper crack follows the mortar joint down to the course below and connects to a vertical crack that extends to the top of the first course.

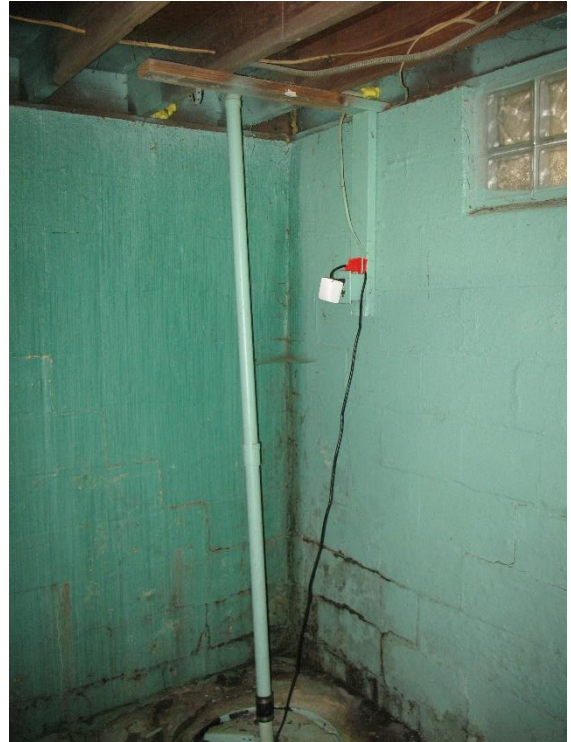
- This photo is of the North East corner of the basement. There is cracking of the mortar joints and water infiltration into the basement. Note the stair step cracking below the window.

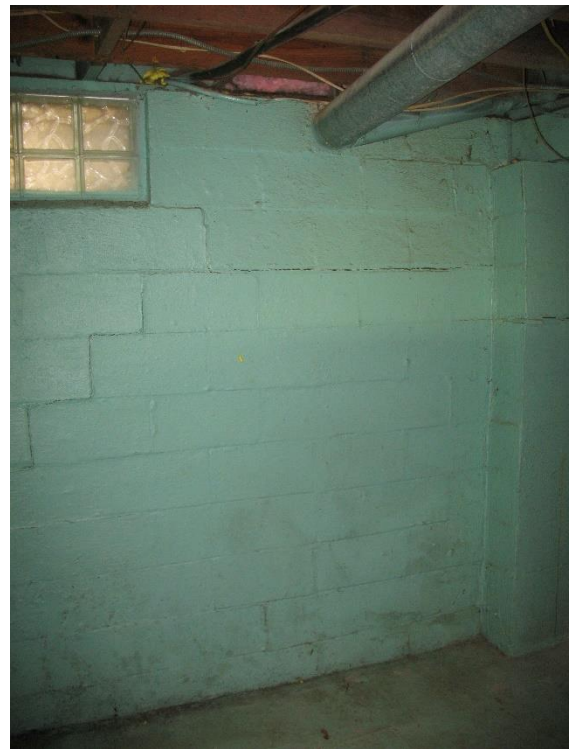
- The stair step cracking continues along the East wall.

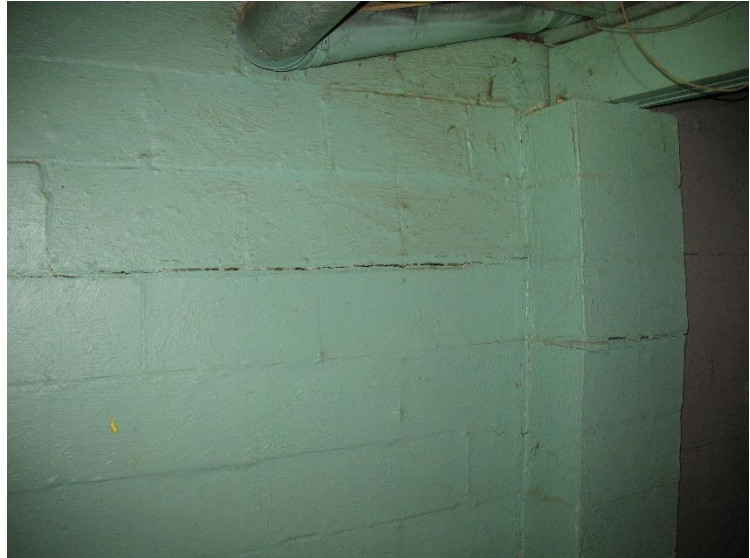
- This photo shows the condition of the pilaster in the East wall. Below the crack, the wall and pilaster have been displaced by ground and hydrostatic pressure. The top three courses haven't moved due to the girder being attached. This girder is resisting the forces acting on the wall.

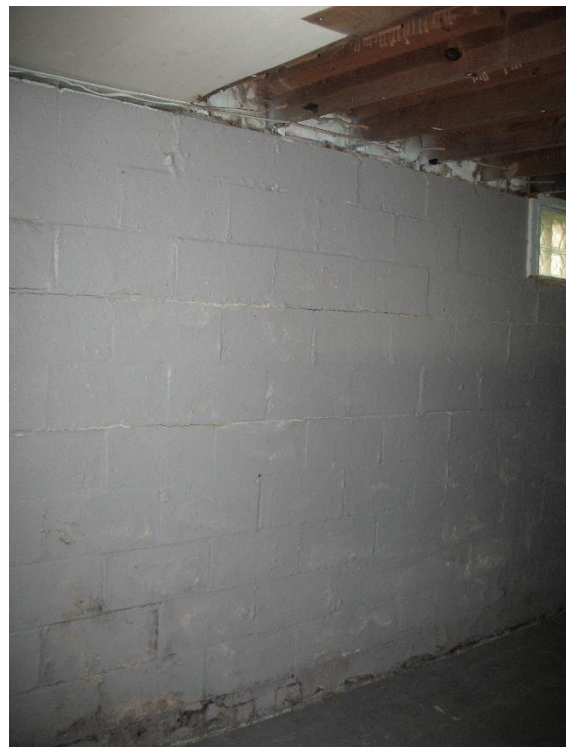
- This photo of the South wall shows similar conditions as the North wall, but to a lesser extent. In addition to the wall bowing, there is effervescence on the surface of the wall behind the paint.
