Disclosure Packet

**Included are all known reports and disclosures
for 7860 Jonell Square, New Albany, Ohio**

**7860 Jonell Square
New Albany, OH 43054**

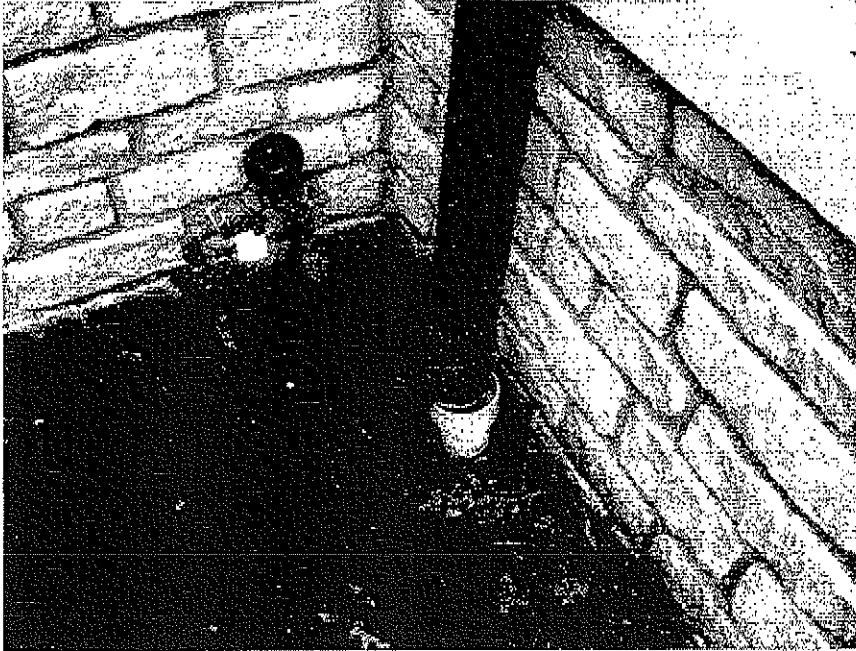
Line Item #: **R12**

**Down spout is misaligned
from connection to sub
surface drain.**

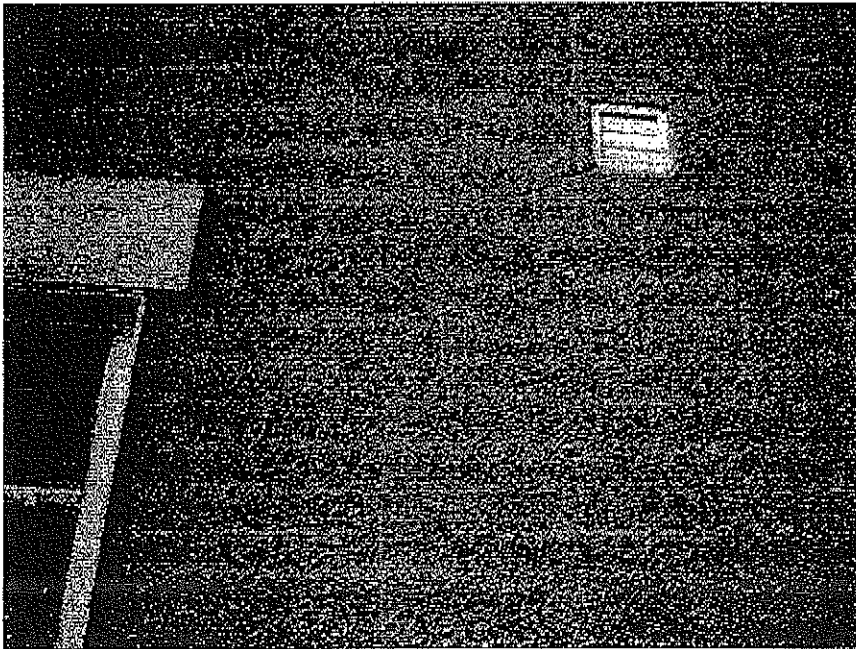
Line Item #: **ES1**

**Crack in stucco above
generator.**

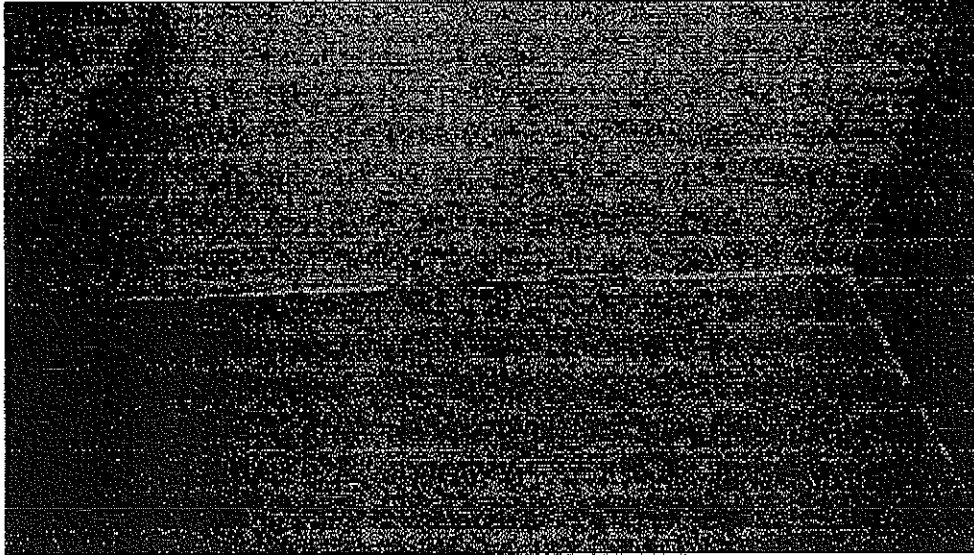
Line Item #: **P10**

Grout/caulk is missing from tile joint in master shower.

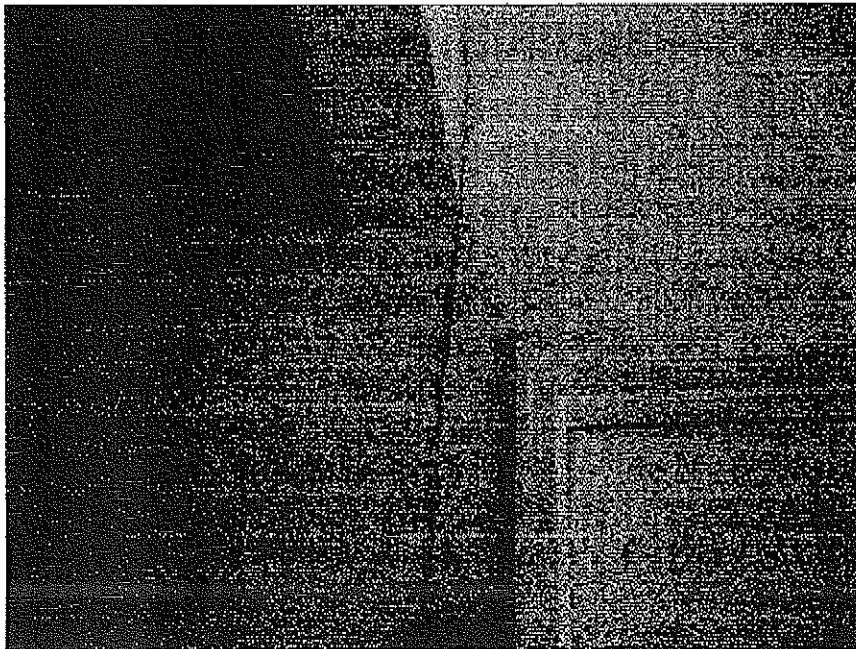
Line Item #: **RD1**

NOTE: Settlement crack noted in garage wall.

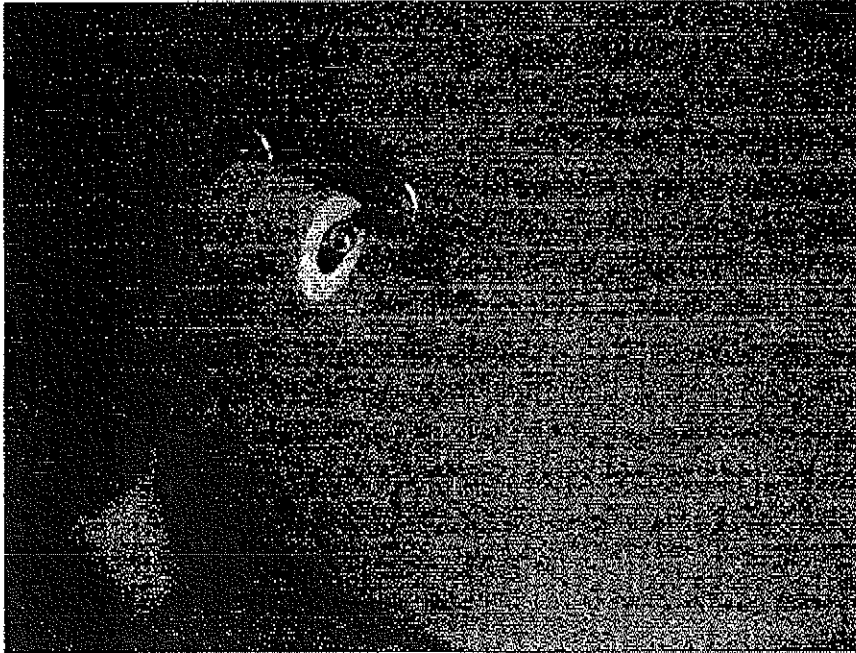
Line Item #: **RD1**

NOTE: Drywall damage was noted on master bathroom wall. Maintenance

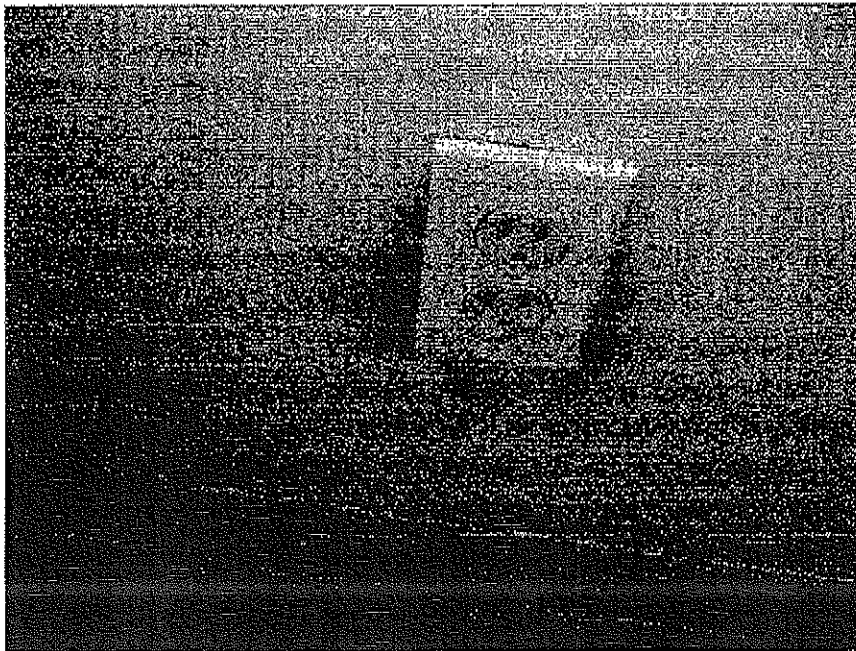
Line Item #: **ENV3**

Suspected mold has been found on wall around receptacle beneath window in the den. General clean up and repairs are needed to help prevent future concerns. See attached RAL Indoor Air Quality (mold/fungus) disclaimer. This area test dry at time of assessment. Past and future performance is unknown.

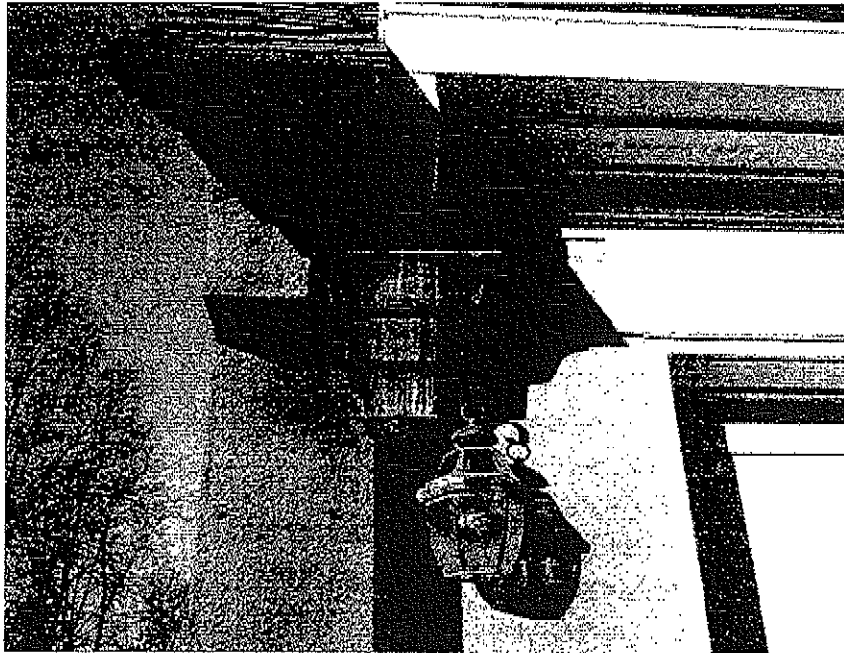
- *Our inspector believes the flashing and gutters are capable of handling drainage in this area. He indicated that it appears that this gutter has been clogged at the top by bird nesting material and also at the bottom where it drains below grade. It is his opinion that this is the cause of the water overflow. We recommend the gutter, downspout, extension and underground lines be cleaned. This can be considered homeowner maintenance.*

Gutter downspout showing staining and some nesting material to left side.

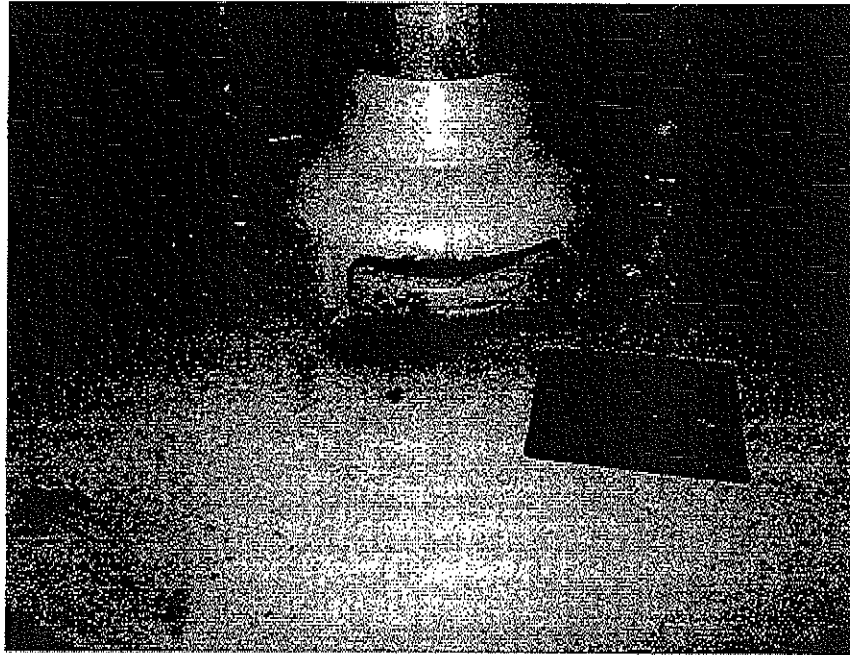
Top of water heater showing slight melting of bushings.
Other staining is oily residue, but not corrosion.

9. Repair damage to the water heater flue pipe. Appears some back-drafting here at draft diverter, plastic bushings at supplies, melted, both sides, should be checked with furnace flue and fireplace issues by licensed and qualified contractor.
 - *Our inspector indicated he did not observe any moisture on the pipe or on top of the tank. He said that the flue appeared to be pulling smoke up in an acceptable manner. The bushings likely suffered the minor melting as a result of the soldering performed at the piped just above. This is not an uncommon condition. He did not feel there is sufficient evidence of a concern here, and only a qualified HVAC/plumbing contractor could determine otherwise.*

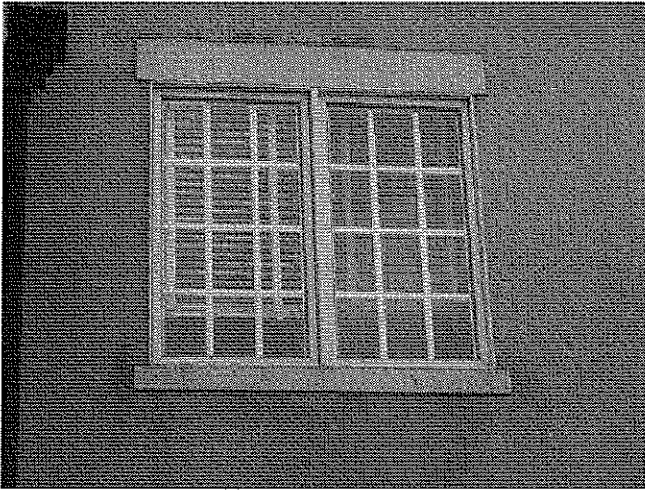
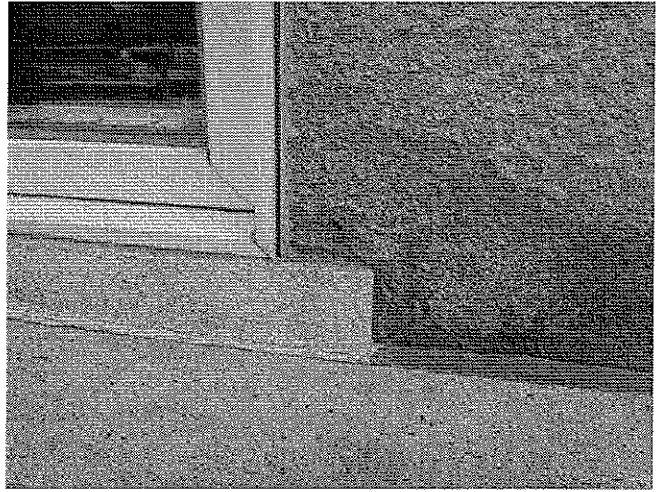
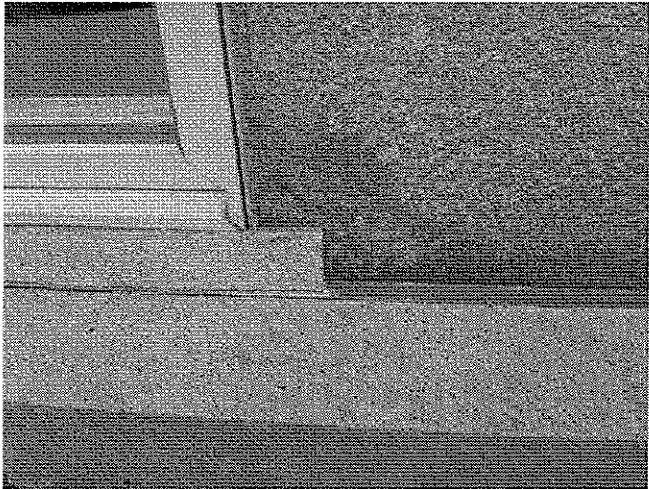
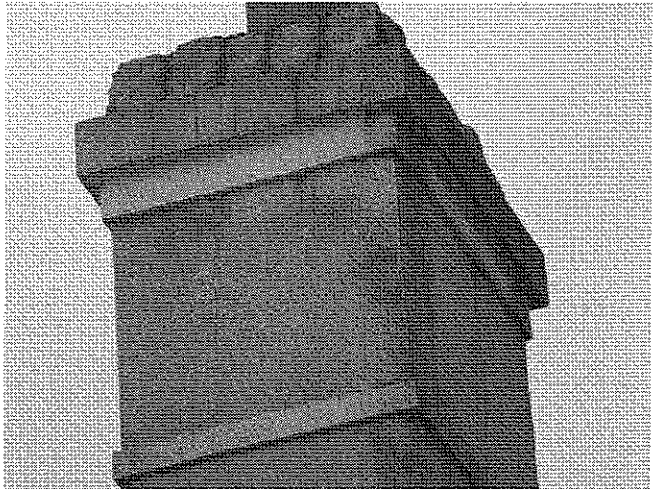
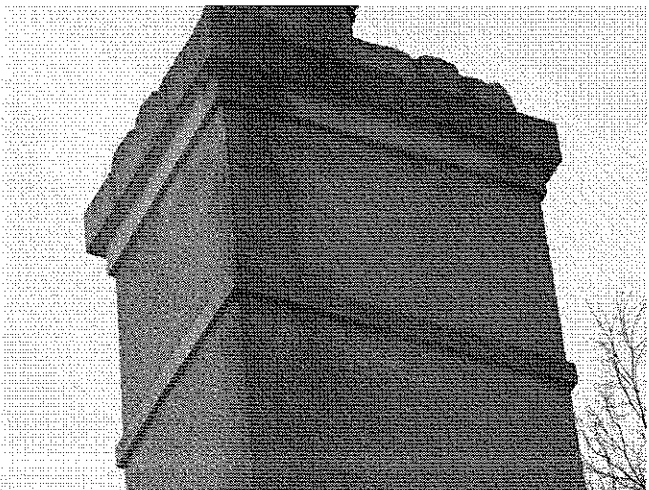
Item 1. Moisture staining around windows.

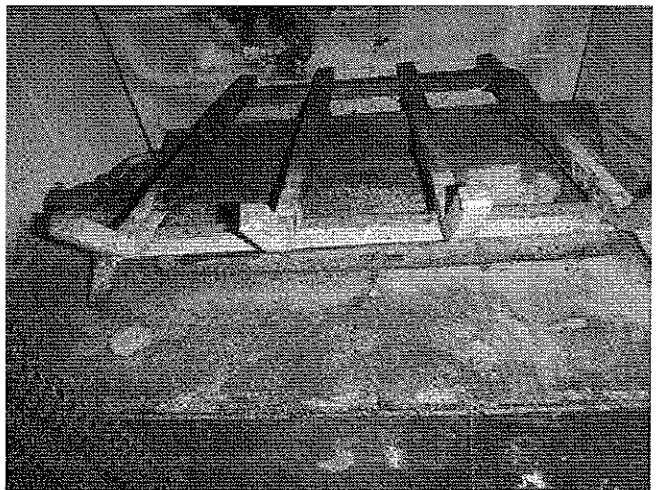
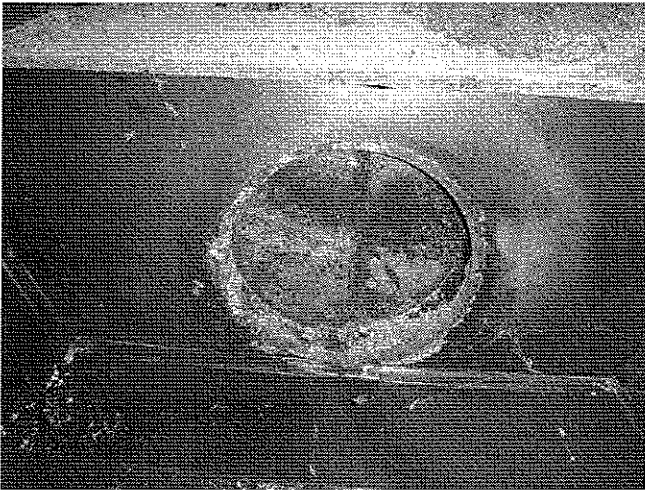
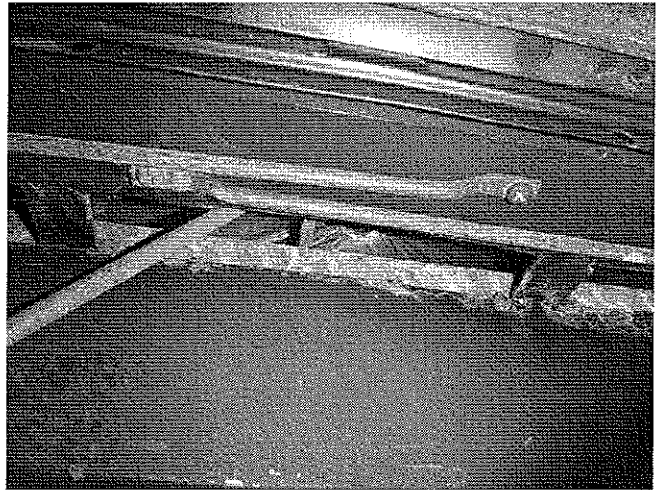
Item 6. Basement fire place firebox showing signs of issues with moisture.

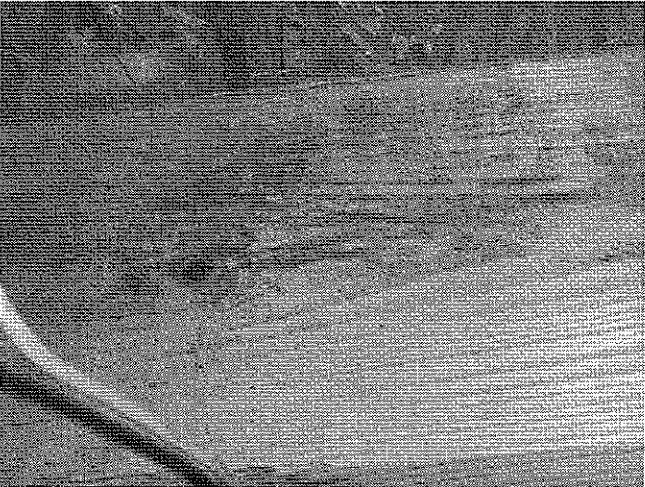
Item 7. Areas of mold on floor joist in basemetn area.

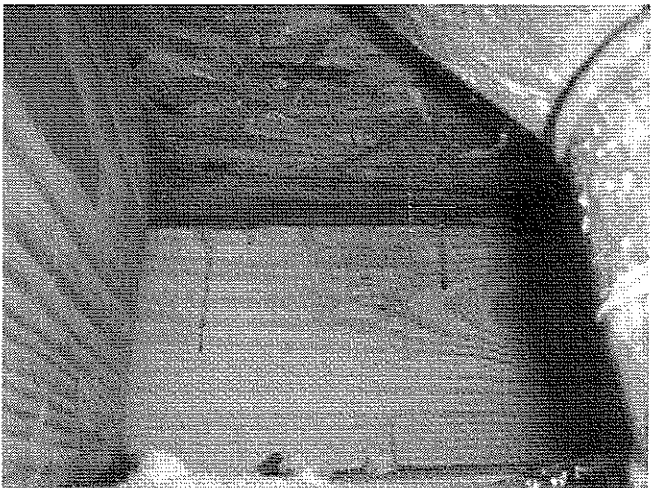
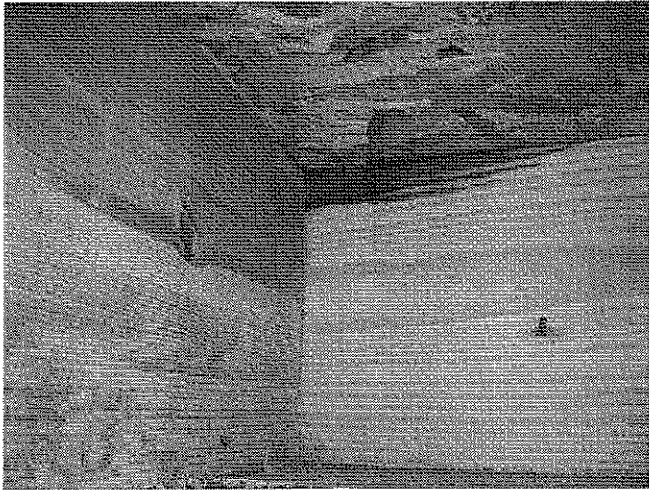
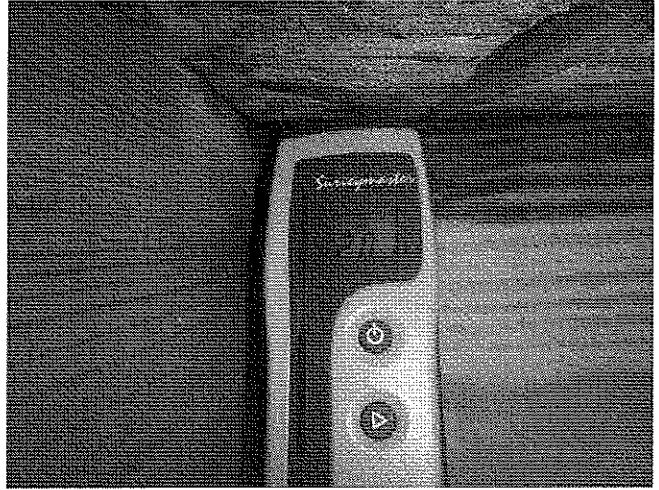
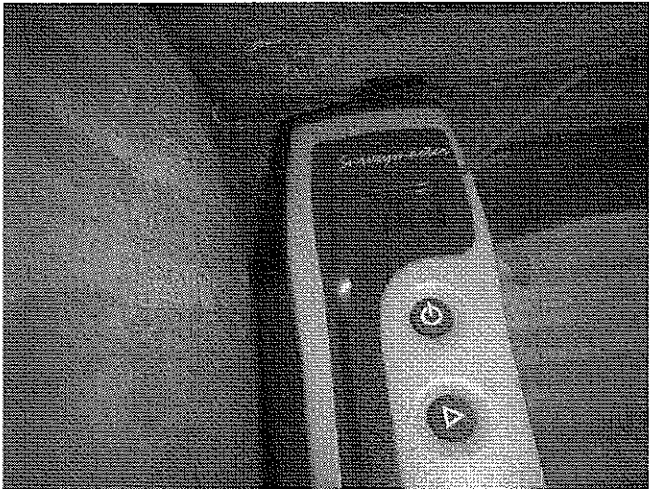
Item 10. Moisture staining on band joist under den/office window.

Item 10. Moisture staining on band joist under den/office window. 18.4%

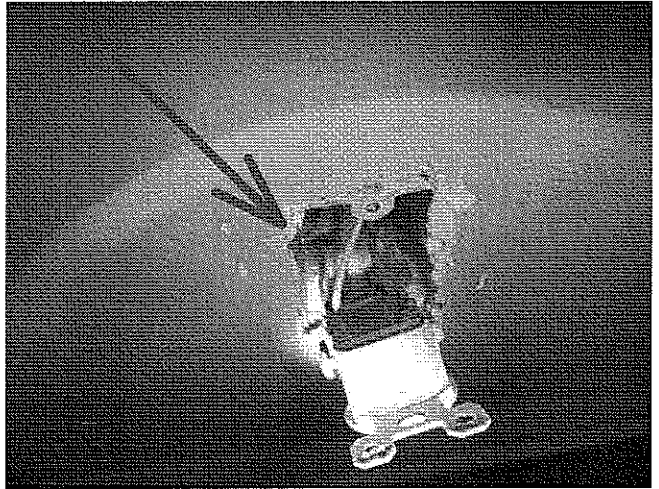
Item 10. Rust staining inside outlet under den/office window.

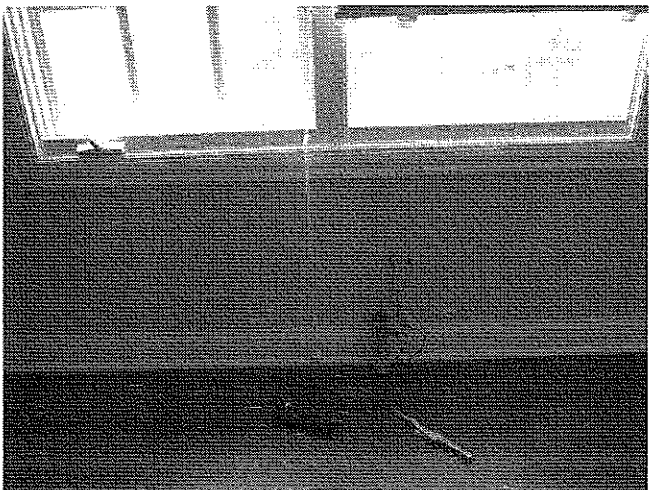
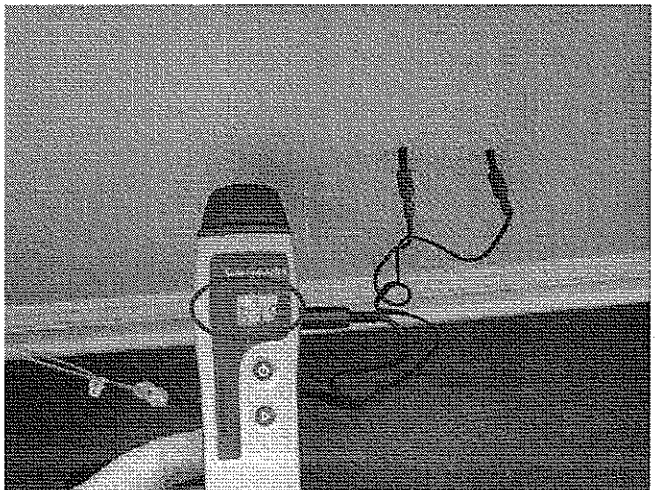
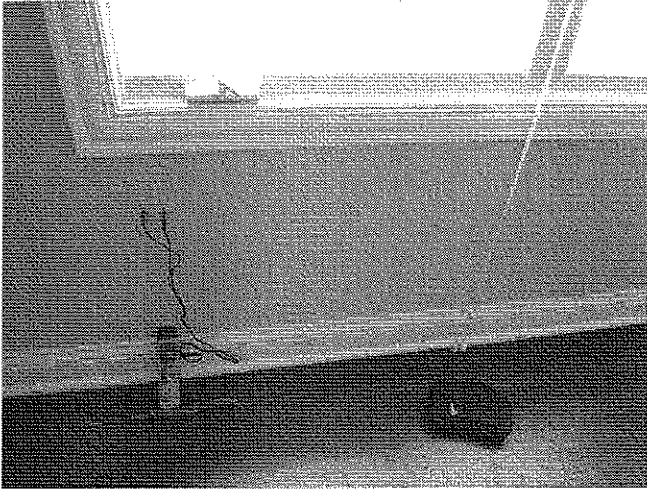
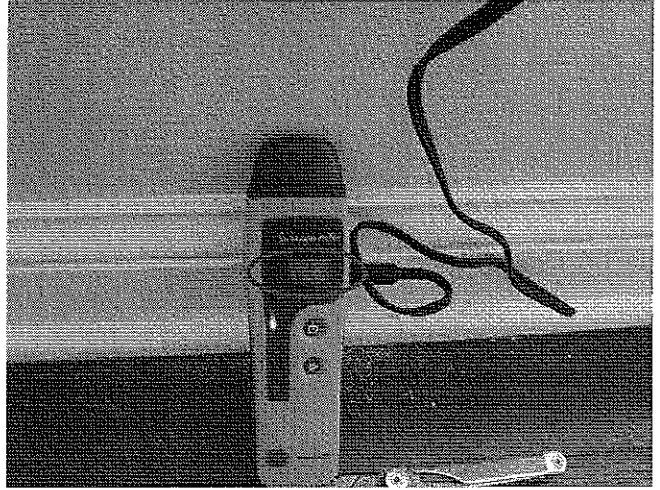
Item 11. Moisture test under master bedroom window.

Item 11. Moisture test under master bedroom window. Middle of window.

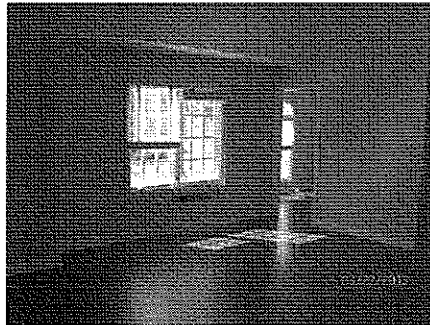
MASTER BEDROOM [Northwest Corner]

Wall is actively wet and retaining moisture.

Actively Wet Materials within the Exposed Wall Cavity

Moisture Content: Wet

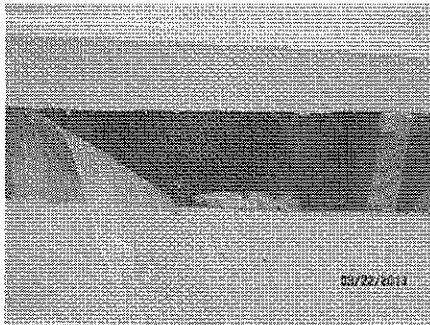
MASTER BEDROOM (WALL CAVITY) [Northwest Corner]

Suspect mold-like growth was observed.

Exposed Wall Cavity Wood Rot and Mold Like Growth

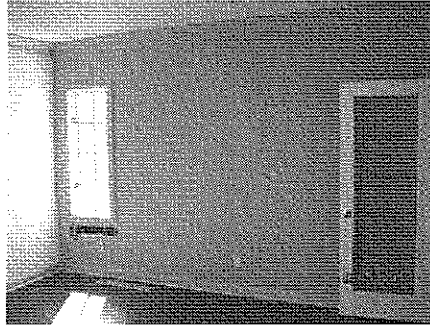
DEN [Southwest Corner]

Wall is actively wet and retaining moisture.

Actively Wet Materials within the Exposed Wall Cavity

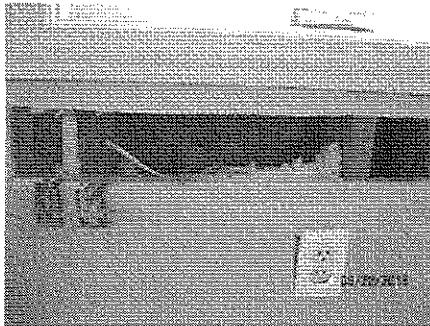
DEN (WALL CAVITY) [Southwest Corner]

Suspect mold-like growth was observed.

Exposed Wall Cavity Wood Rot and Mold Like Growth

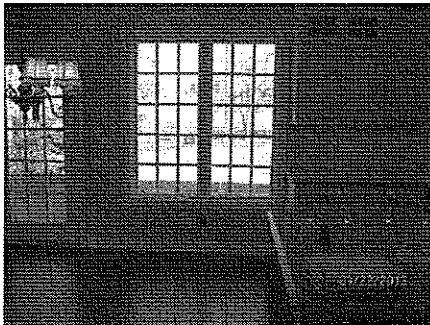
KITCHEN [North Side]

Wall is actively wet and retaining moisture.

Actively Wet Materials within the Exposed Wall Cavity

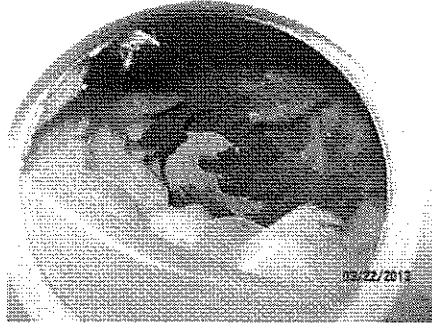
KITCHEN (WALL CAVITY) [North Side]

Suspect mold-like growth was observed.

Exposed Wall Cavity Wood Rot and Mold Like Growth

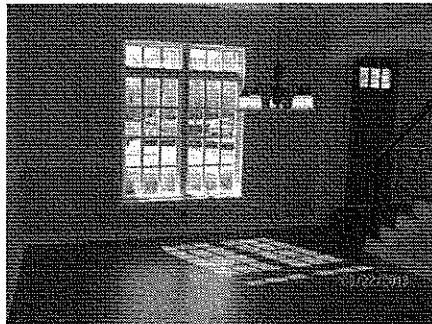
DINING ROOM [South Side]

Wall is actively wet and retaining moisture.

Actively Wet Materials within the Exposed Wall Cavity

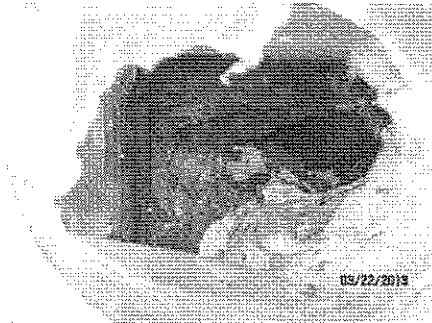
DINING ROOM (WALL CAVITY) [South Side]

Suspect mold-like growth was observed.

Exposed Wall Cavity Wood Rot and Mold Like Growth

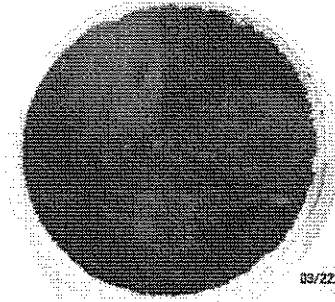
GARAGE (WALL CAVITY)
[Southeast Corner]

Suspect mold-like growth was observed.

*Exposed Wall Cavity Wood Rot and
Mold Like Growth*

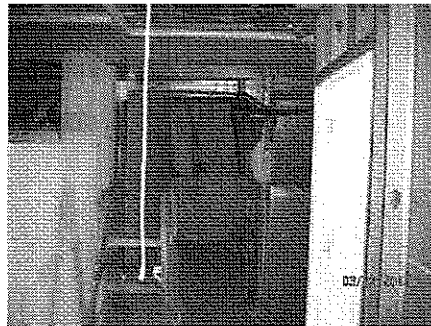
UNFINISHED BASEMENT
[Northwest Corner]

Suspect mold-like growth was observed.

*Mold Like Growth On Joist and
Exposed Crawlspace*

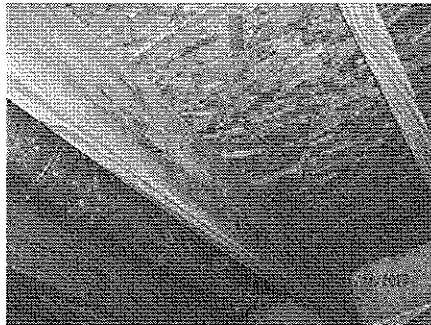
UNFINISHED BASEMENT (JOIST)
[Northwest Corner]

Suspect mold-like growth was observed.

*Mold Like Growth on Joist. No Water
Source Detected in the Area, Possible
Pre-Construction Growth.*

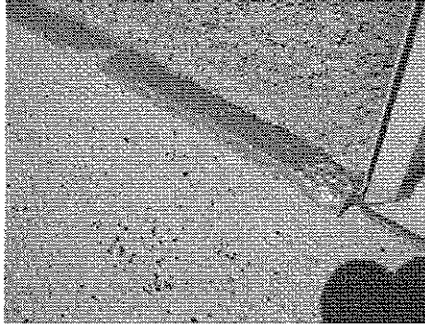
GROUNDS [South Side]

Openings/cracks in exterior walls were observed.

Exposed Opening in Stucco

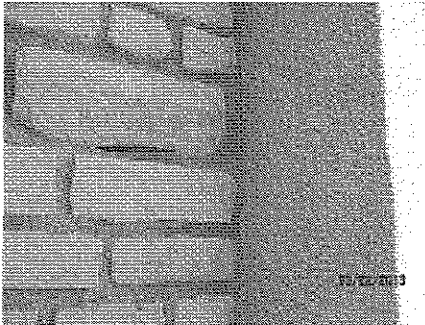
GROUNDS [South Side]

Openings/cracks in exterior walls were observed.

Cracks in Stucco and Mortar

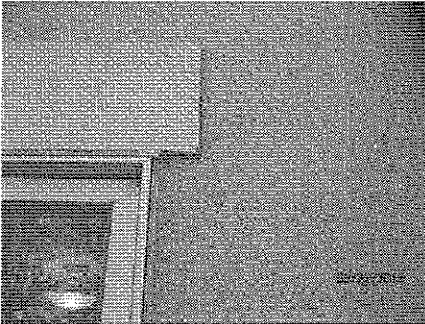
GROUNDS [North Side]

Openings/cracks in exterior walls were observed.

Cracks in Stucco

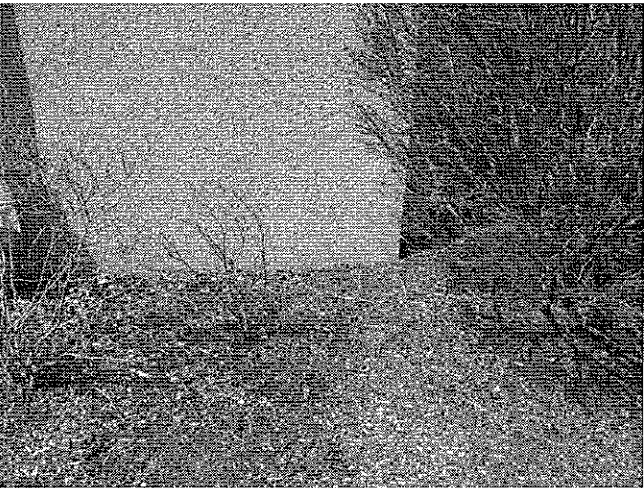
Photo # 5 / Typical cement stucco termination at grade.

- Note that cement stucco weep screed has not been installed at the sill plate juncture with the masonry foundation as required.

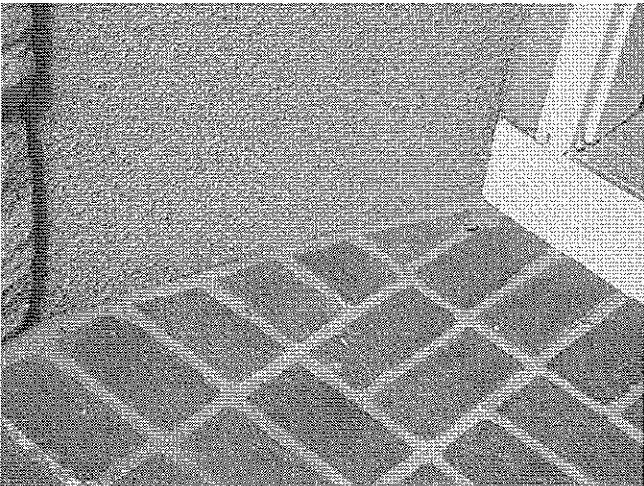
Photo # 6 / Typical cement stucco termination at brick front porch and rear patio.

- Note that the cement stucco has not been terminated above hard surfaces with weep screed as required.

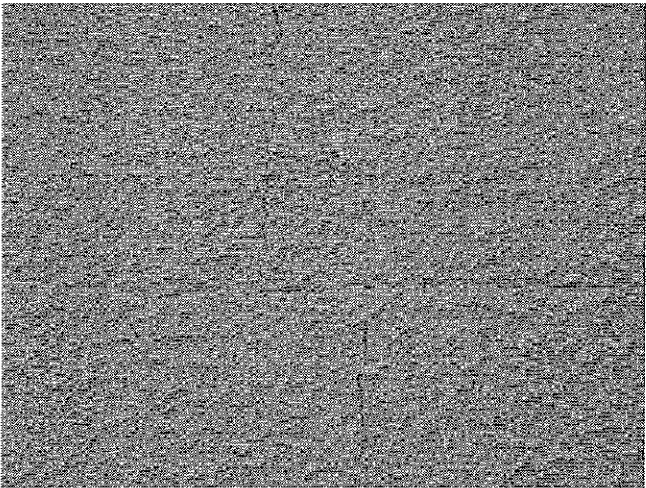
Photo # 11 / Rear elevation cement stucco cracking at chimney.

- Note that the cement stucco cladding has static and dynamic cracking in numerous locations.

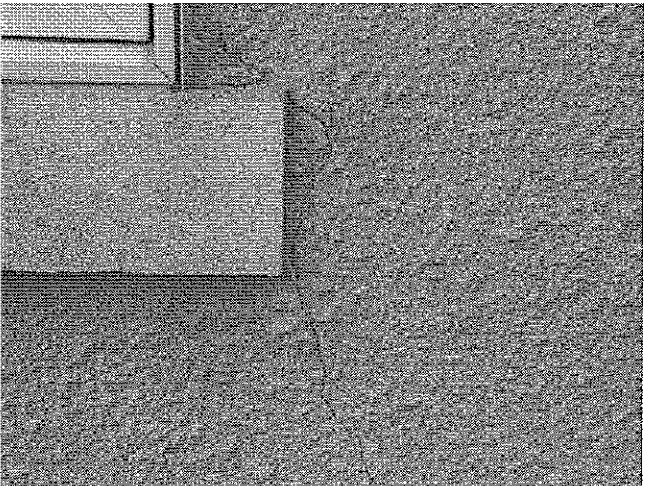
Photo # 12 / Rear elevation cement stucco cracking at window openings.

- Note that the cement stucco cladding has static and dynamic cracking in numerous locations.

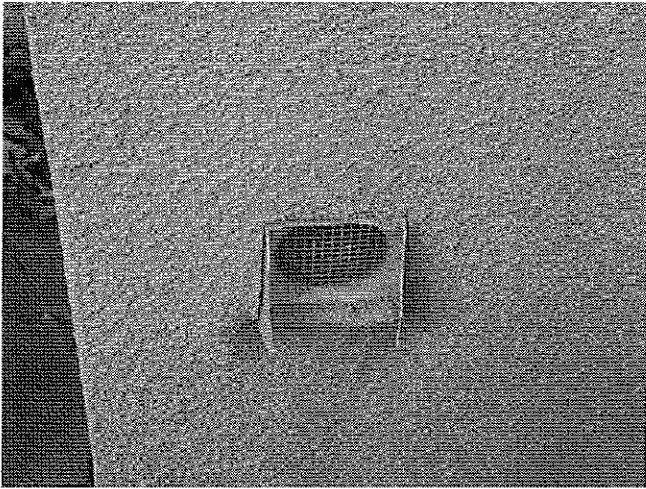
Photo # 13 / Rear elevation vent penetration.

- Note that proper flashing has not been installed at top of vent penetration as required.
- Note that proper backer rod and sealant has not been installed at penetration.

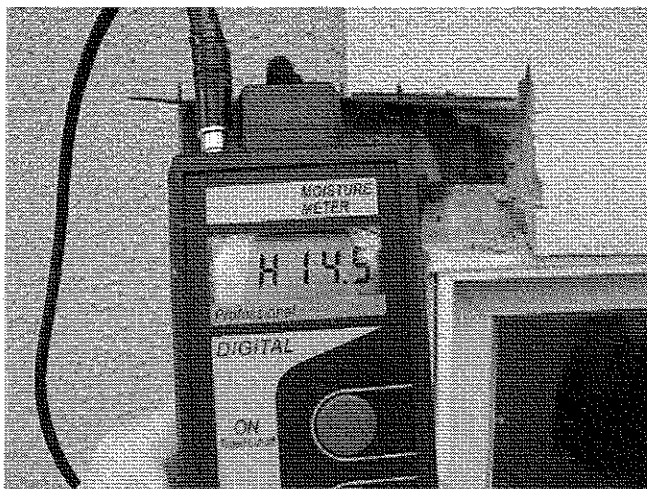
Photo # 19 / Rear elevation 1st floor window head and jamb.

- Note that the OSB wood sheathing has a moisture content of 14.5%.
- Note that moisture intrusion is visible at this destructive opening.

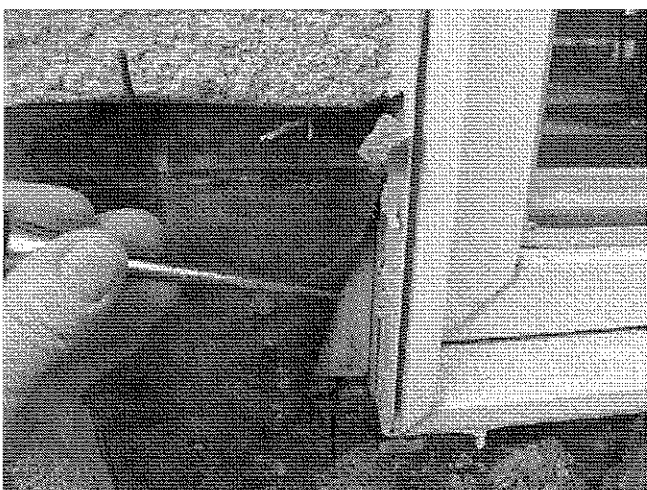
Photo #20 / Rear elevation 1st floor windowsill and jamb.

- Note that the single layer 15# building paper has not been returned into the window jamb rough opening per the manufacturer's installation instructions as required.
- Note that the windowsill rough opening flashing tape has not been installed per the manufacturers installation instructions as required

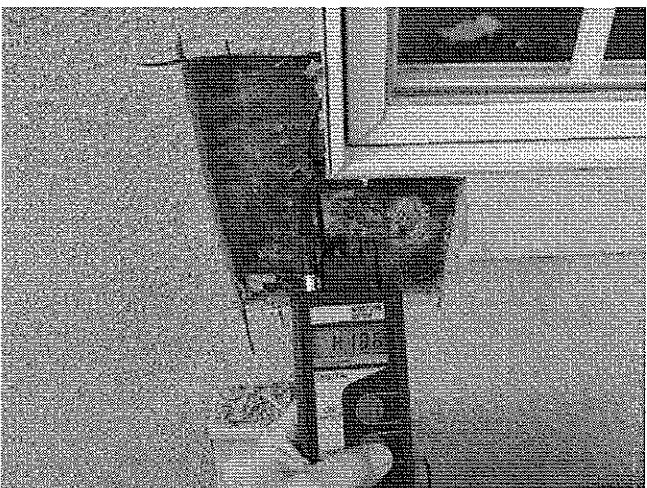
Photo # 21 / Rear elevation 1st floor windowsill and jamb.

- Note that the OSB wood sheathing has a moisture content of 10.6%.
- Note that the OSB wood sheathing is moisture damaged on the exterior face and interior side of this window opening.

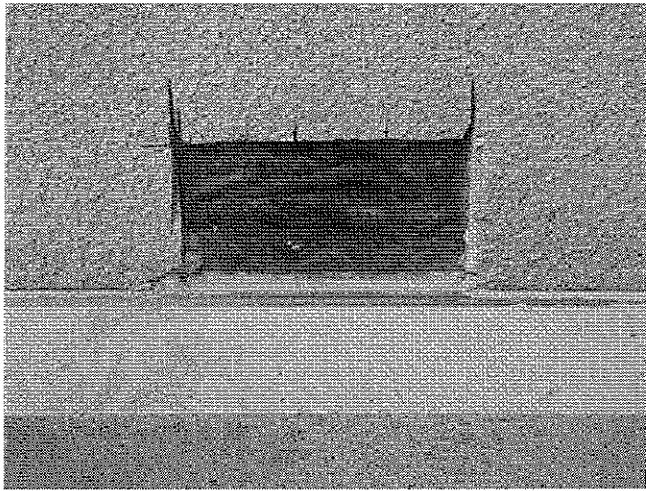
Photo # 22 / Front elevation cement stucco termination at horizontal lime stone cap.

- Note that the single layer 15# building paper has not been returned over the galvanized metal flashing nailing flange as required.
- Note that the horizontal lime stone caps have not been properly sloped to direct water away from the vertical wall surface to the face of the stone veneer as required.

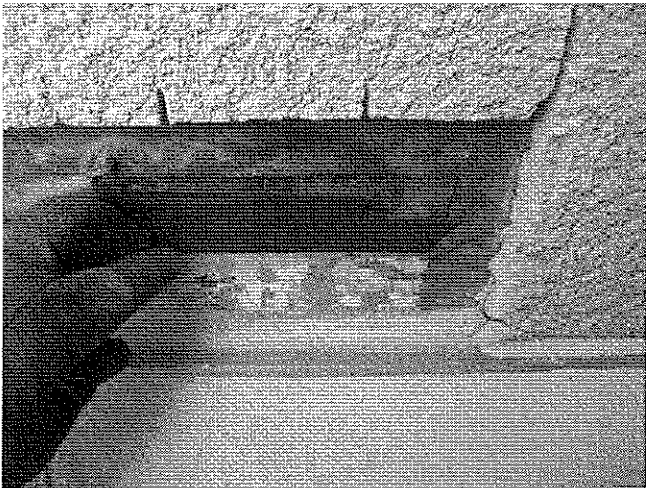
Photo # 23 / Front elevation cement stucco termination at horizontal lime stone cap.

- Note that the stone veneer single layer 15# building paper has been extended under the galvanized metal flashing nailing flange as required.
- Note that moisture intrusion is visible at this destructive opening.

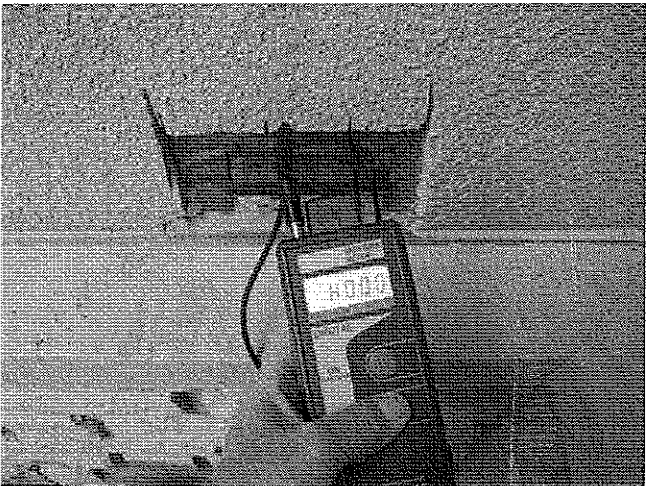
Photo # 24 / Front elevation cement stucco termination at the horizontal lime stone cap.

- Note that the OSB wood sheathing has a moisture content of 0.0%.
- Note that the OSB wood sheathing is moisture damaged on the exterior face and interior side of this elevation.
