UST CLOSURE
GOODYEAR DEALER EXPANSION # 4075
MICHIANA TIRE OF GOSHEN, INC.
410 WEST PIKE STREET
GOSHEN, INDIANA 46526

JULY 1995

EXECUTIVE SUMMARY

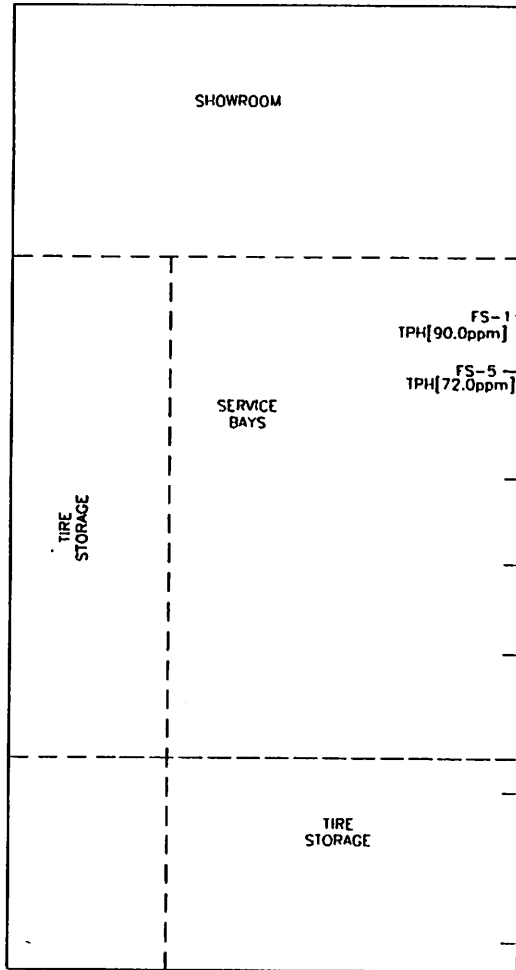
The six (6) soil samples were collected as duplicates of FS-1 through FS-6, described above, for field screening prior to backfilling of the excavation. Duplicate samples were subjected to field screening utilizing a BUCK TPH Analyzer. A portion of the screening sample was removed from each sample and processed, using a modified field version of EPA Method 418.1. Once the sample was processed, the extraction fluid was analyzed on the BUCK to determine the TPH concentration. The results of the field TPH readings were noted and recorded in the environmental technicians field notebook. Table 2 summarizes the field TPH readings, and the location of the field samples are shown on Figure C95104-3.

TPH[2.074ppm]
 SILVER[0.1ppm]
 BARIUM[2.6ppm]
 ALL OTHER TCLP METALS[ND]
 TOLUENE[0.014ppm]
 ALL OTHER VOC's[ND]
 BIS(2 ETHYLHEXYL) PHTHALATE[2.6ppm]
 ALL OTHER SVOC's[ND]
 PCB's[<0.02ppm]
 FS-2

FS-1
TPH[90.0ppm]

The six (6) confirmation soil samples and one (1) stockpile soil sample were analyzed for TPH using EPA Method 418.1 by SET. Two samples, FS-2 (North Wall) and FS-4 (West Wall) contained concentrations of TPH greater than the 100 ppm action level; requiring that these two (2) samples be analyzed for the Tier II criteria. The results of TPH analyses for samples FS-1 through FS-6 are presented in Table 3. Table 3 also summarizes the Tier II analytical results for the confirmation soil samples described below. Figure C95104-3 in Exhibit B shows the locations of the confirmation soil samples. A copy of the laboratory data report and *Associated's* completed Chain-of-Custody form are included as Exhibit E.

Samples FS-2 and FS-4 were analyzed for the Tier II criteria, consisting of TCLP metals, VOCs, SVOCs and PCBs. PCBs were not detected in the two samples submitted for analysis. The only TCLP metals detected were barium (in both FS-2 and FS-4) and silver (in FS-2 only), which were not detected above the TCLP Maximum Contaminant Level (MCL). VOCs were not detected in sample FS-4 (East Wall). Toluene was the only VOC detected in sample FS-2 (North Wall) at a concentration of 0.014 ppm.

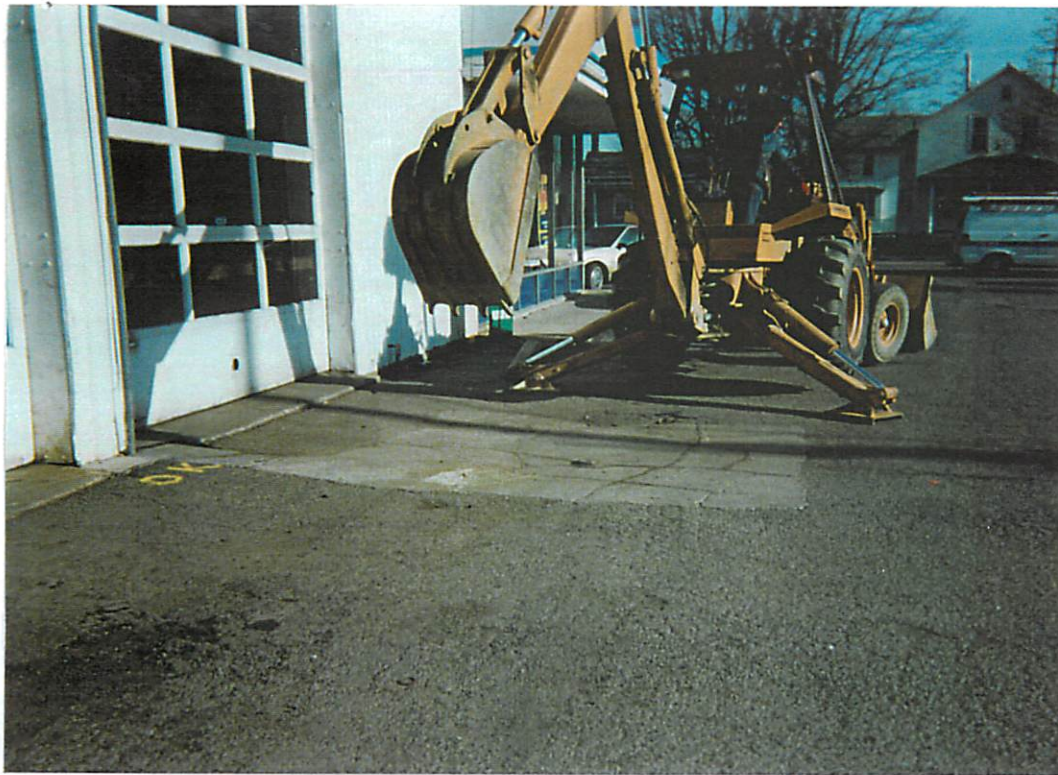
Site conditions prior to excavation activities. Used oil UST is located beneath the concrete pad. (view to North)

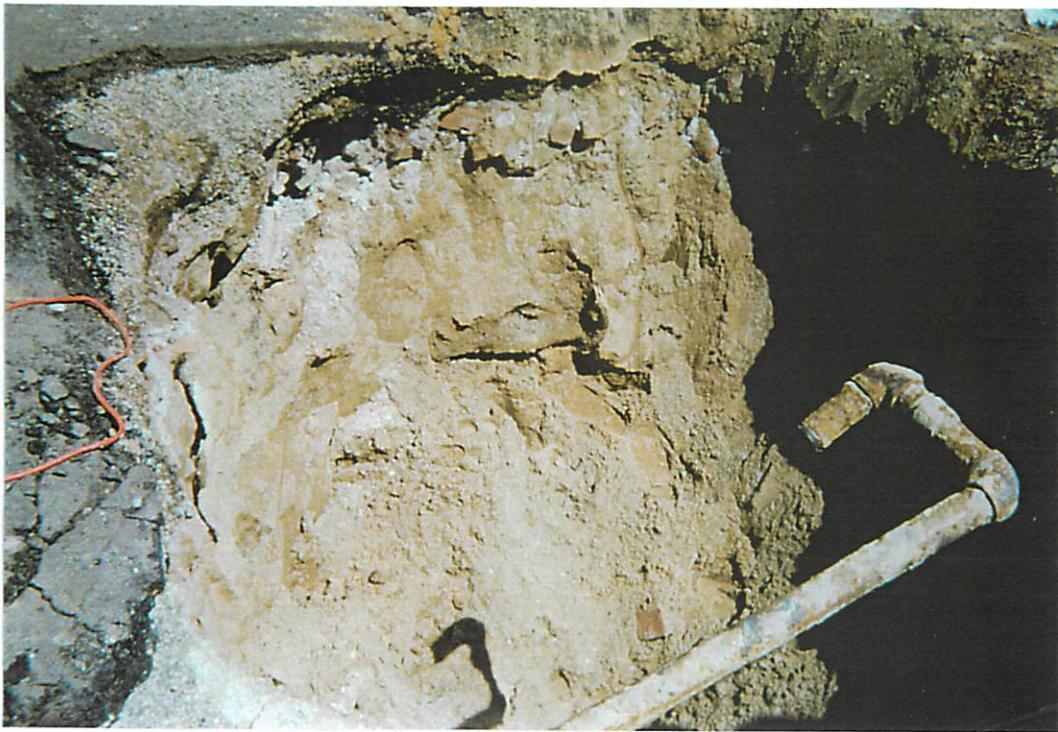
View of north wall of UST excavation. Note fill pipe from west, and brick/concrete foundation.

Re-excavation and re-sampling is not practical at this site due to the presence of the brick foundation encountered along the north, east, and west walls of the UST excavation. Based on the analytical results obtained for the confirmation soil samples, a "No Further Action" may be warranted for the site.

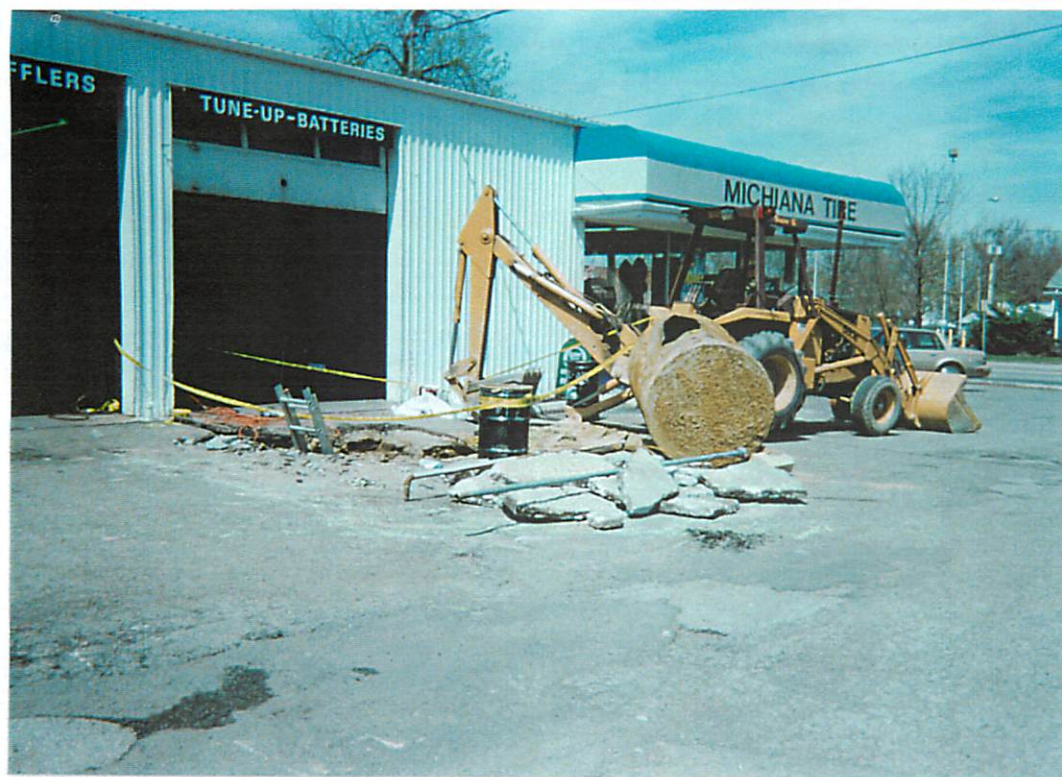
View of tank pit after removal of the used oil UST. Note: deformation caused by UST removal operations. (view to Northwest)

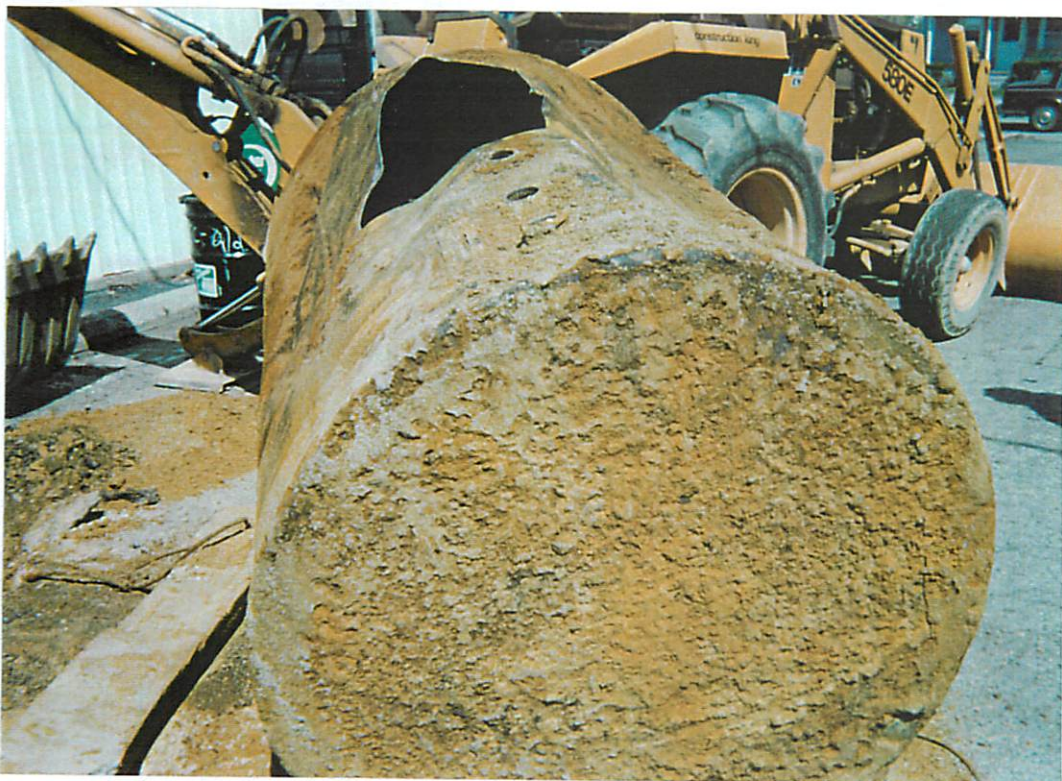
Visual inspection of the excavation and removed soils did not show any sign of petroleum staining. Site soil surrounding the UST consisted primarily of sand. The UST was in good condition and did not exhibit signs of leakage. No petroleum odors were noted during the excavation activities at the site. The limits of the UST pit were defined to the north, east, and west by a brick foundation reportedly the remains of a former school building on the site. Groundwater was not encountered during excavation and removal of the used oil UST.

Former 550-gallon used oil UST. Note UST was in good condition when removed from ground.

The former UST tank systems was removed from site on 24 April 1995, and transported to K & F Industries, Inc. of Indianapolis, Indiana for destruction. The UST was rendered unfit for reuse on 25 April, 1995. A certificate of destruction is included as Exhibit F.

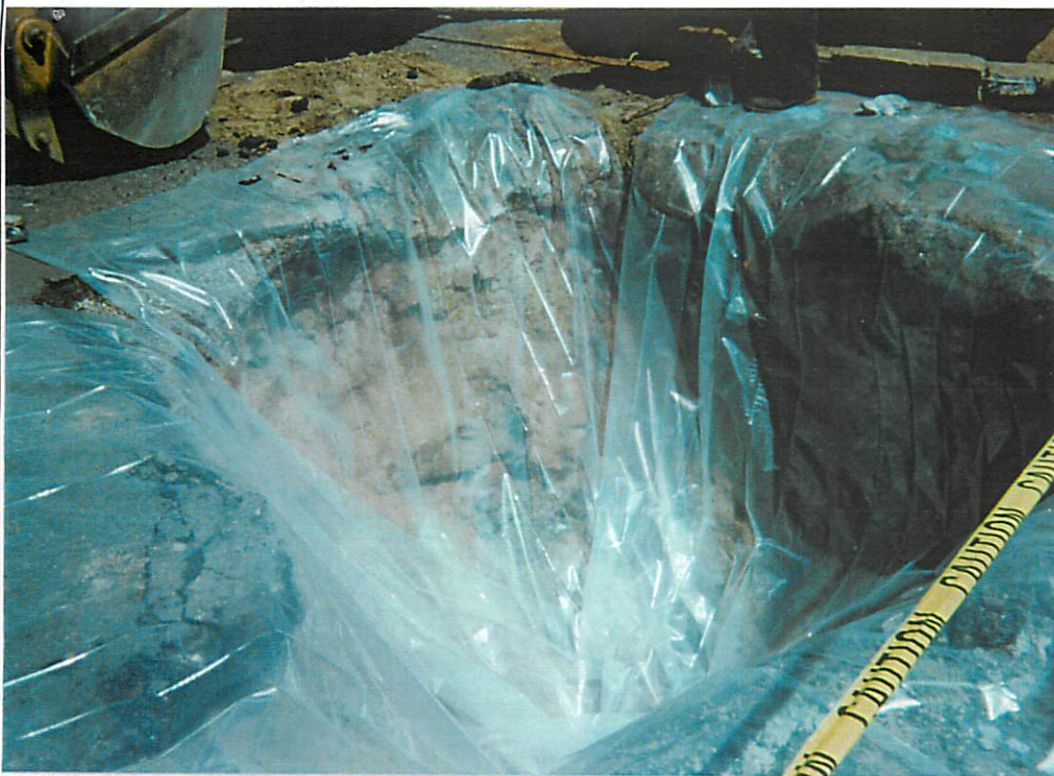
Former used oil UST tank pit lined with 6-mil poly ethylene sheet prior to backfilling (view to Northeast).

The excavation was backfilled after collection of confirmation soil samples, on 24 April 1995. Prior to backfilling, the excavation was lined with a 6-mil poly tarp to segregate the fill from "native" soil. Backfill materials consisted of the excavated soil surrounding the former UST and additional fill to account for the volume of the UST. The backhoe was utilized to place and compact the imported backfill material in the excavation. Approximately 4.40 cubic yards of new backfill material was added to complete the backfilling of the excavation. A replacement concrete slab was scheduled for installation over the excavation, once *Associated* received the analytical results for the confirmation soil samples. However, given the results of the confirmation sampling, the replacement of concrete has been post-poned, awaiting IDEM's review of the Closure report.

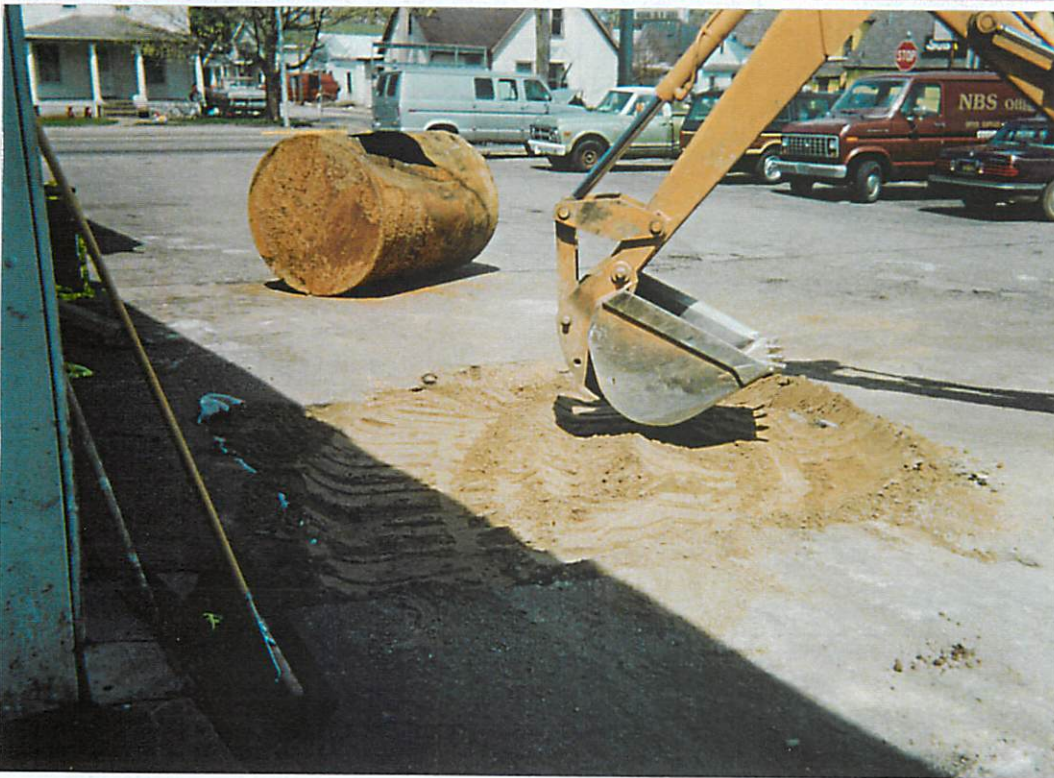
Excavation backfilled to approximately 6" below grade. Excavation was finished to grade with #304 stone (view to Northeast).
