HOME INSPECTION REPORT

1110 Nunnery Dr
Miamisburg, OH 45342

Anthony J Digiorgio Trust
APRIL 6, 2022

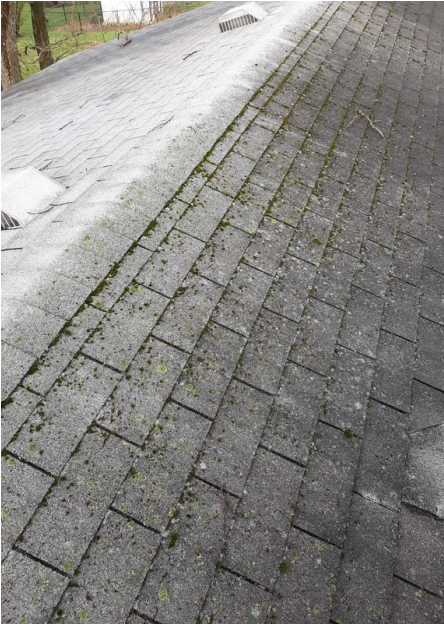
Roof: Stains - Algae

The roof shingles were noted with streaks or discolored which can be caused by moisture, moss/algae, or soot. Common cause is tree cover and debris. Keeping trees thinned and remove fallen debris to allow roof to dry.

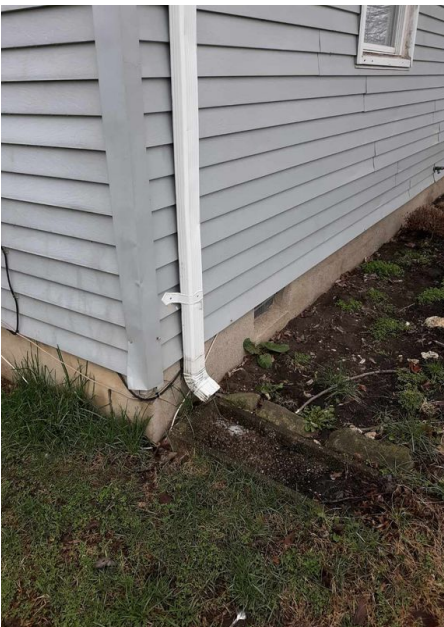
Roof Drains: Add Extensions

Its important to maintain downspout extensions to help keep water away from the structure. Extensions should extend 8-10 feet to avoid erosion and ground saturation.

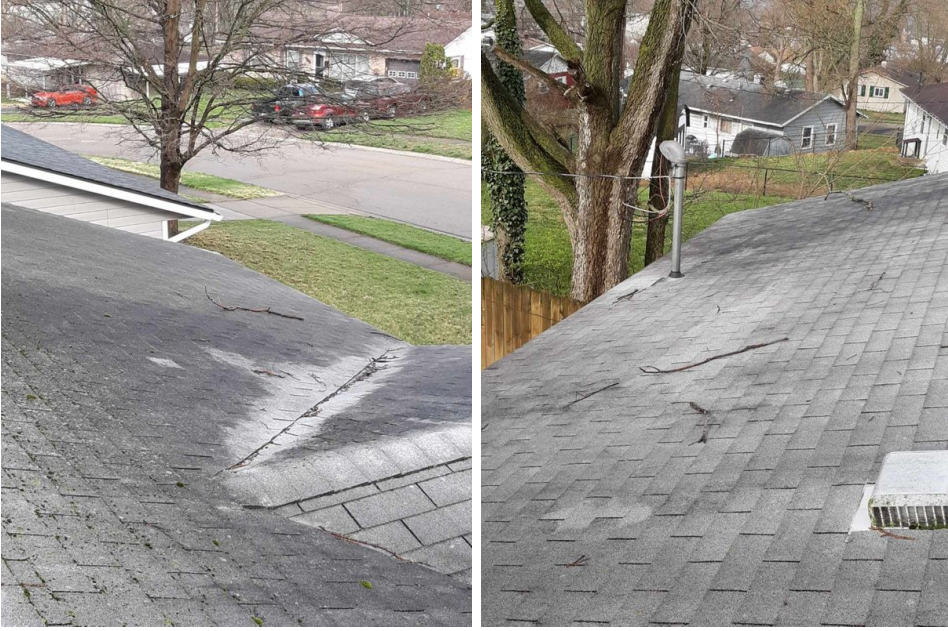
2.1.1 Roof

The roof has excessive tree debris on it. This can cause improper drainage to gutters and downspouts. Recommend clearing debris from roof and gutters.

Contact a handyman or DIY project

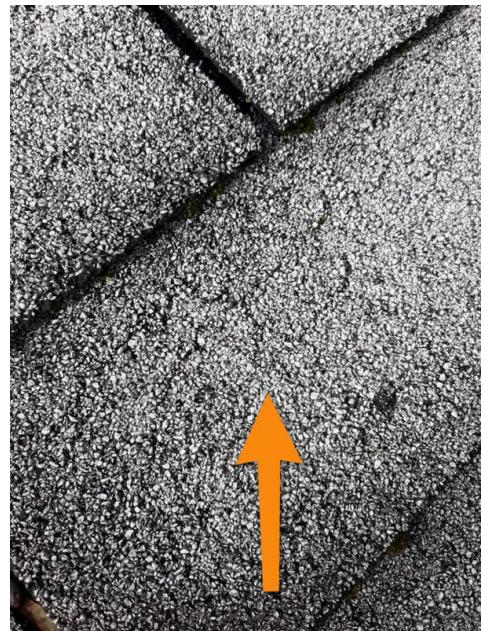
THERMAL CRACKING

Thermal cracking visible in the roof surface of the shingles. This can be caused by heat, age, or material defects. This can shorten the life span of the roof. Recommend additional evaluation by a qualified roofing contractor.

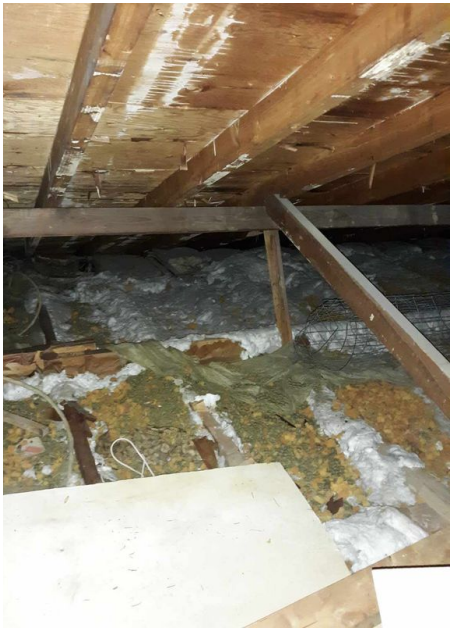
Insulation: Insulation Recommended

We recommend budgeting for additional insulation in the future due to previous displacement or settlement to increase comfort and efficiency. This is for your information.

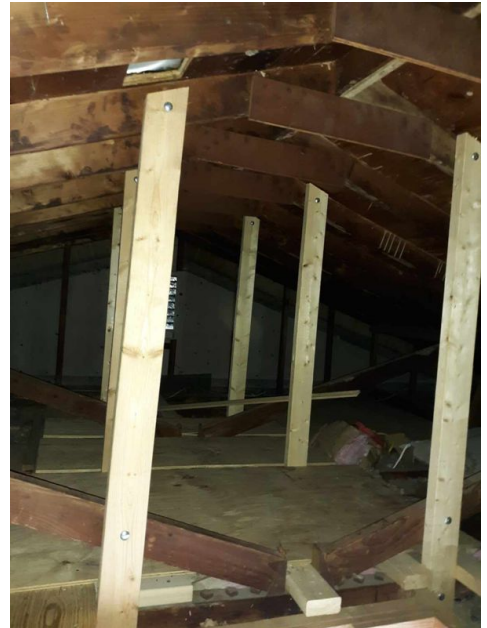
Modifications to roofing structure above the garage area. This appears to have been added due to use for storage. No concerns. This is for your information.

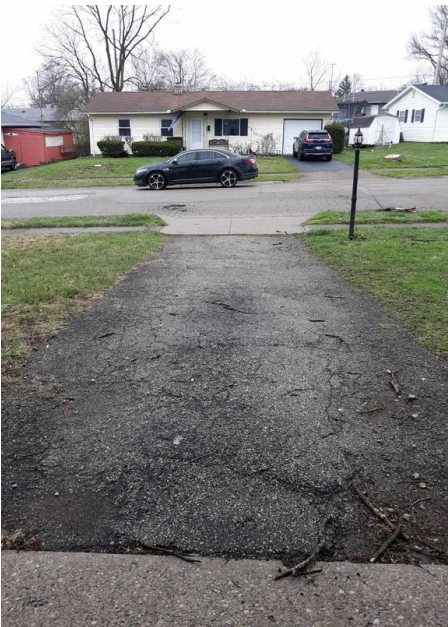
Walkways, Patios & Driveways: Asphalt Driveway-General

The driveway was noted with surface cracking, tire ruts and deterioration due to seasonal conditions and age. Surface is working as designed and the conditions were noted for your information.

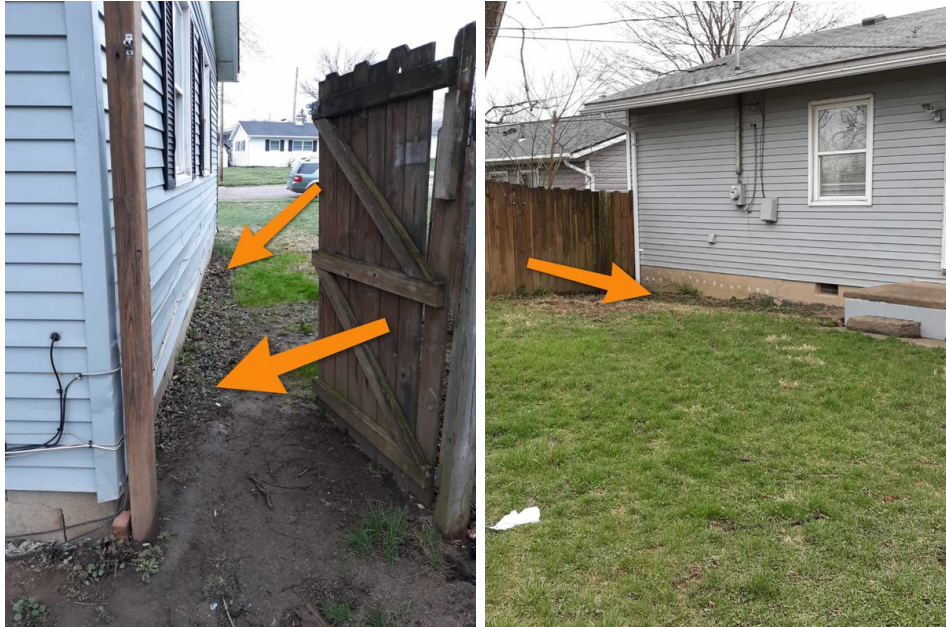
4.1.1 Vegetation, Grading, Drainage & Retaining Walls

Grading is sloping towards the home at the noted locations. This can lead to water intrusion and foundation issues. We recommend qualified landscaper corrects to help direct surface water away from home.

Contact a qualified landscaping contractor

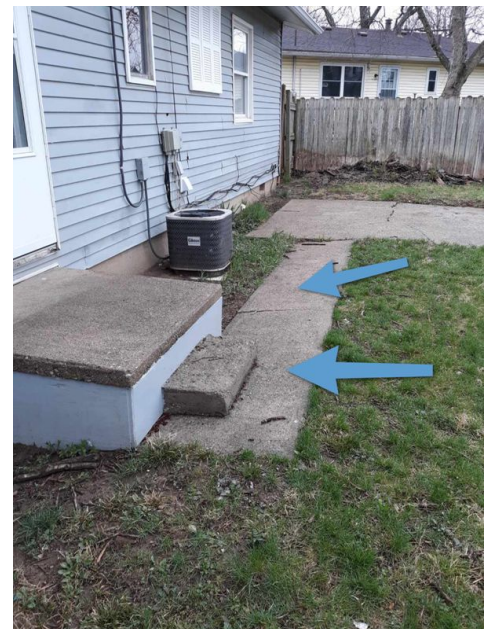
WALKWAY NEGATIVE SLOPE

Walkway has a negative slope directing surface water towards the foundation. Surface should be corrected to drain away. We recommend a concrete leveling company to correct the slope.

Contact a qualified professional.

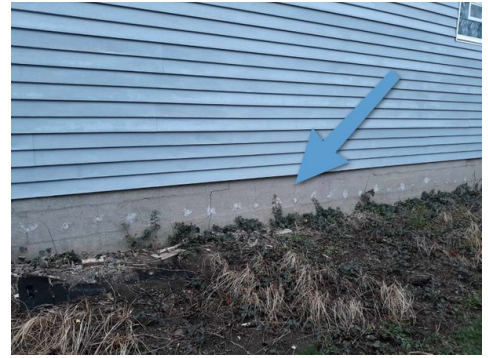
SIGNS OF PAST TERMITE TREATMENT

The home had visible markings on the foundation from possible spot treatment for previous termites. This is for your information. No other indicators were visible. We recommend obtaining a valid Wood Destroying Insect Report for records.

Contact a qualified pest control specialist.

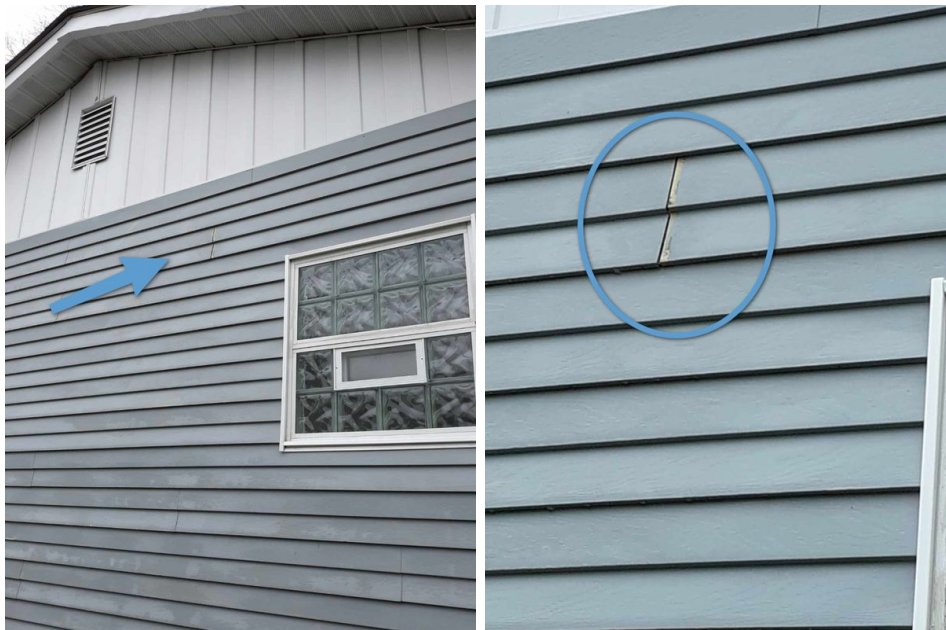
SIDING ADJUSTMENT

The exterior siding has moved out of place, cut short or missing. The siding typically needs adjusting to overlap to prevent insect nesting behind the material. We recommend the repairs be made by the homeowner or a handyman.

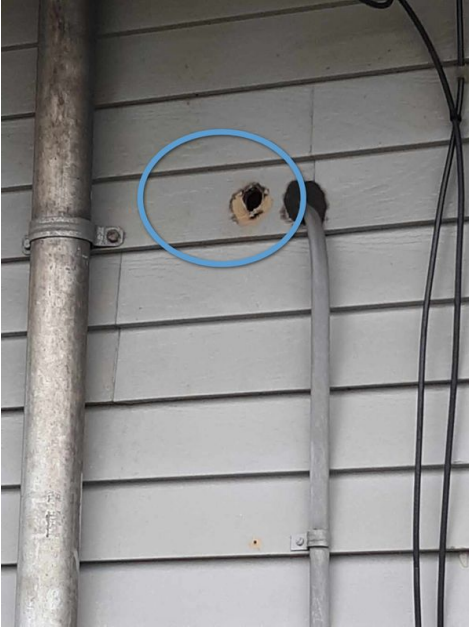
SEAL OPENINGS

Exterior openings should be sealed to prevent moisture or insects.

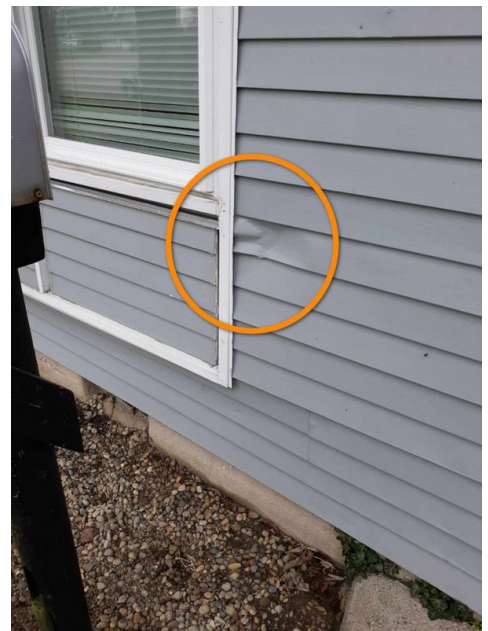
SIDING REPAIRS

The exterior siding found loose or damaged allowing a water or insect entry point. The exterior is recommend for repair or replacement for protecting from moisture damage.

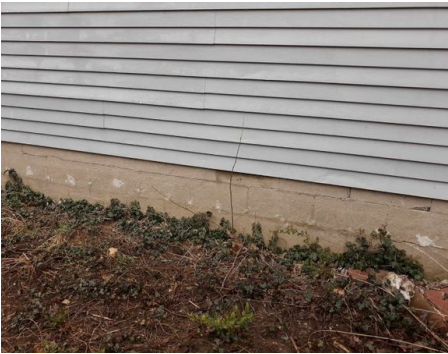
Foundation: Foundation Cracks - Minor

Minor cracking was noted at the foundation. This is common as concrete ages and building settles causing surface cracks are normal. Recommend monitoring for pooling water near the foundation that causes accelerated settlement or decay. Maintain downspout extensions to displace water away from the structure. The crack looked as normal settlement because of the age of the home. No recommended action at this time.

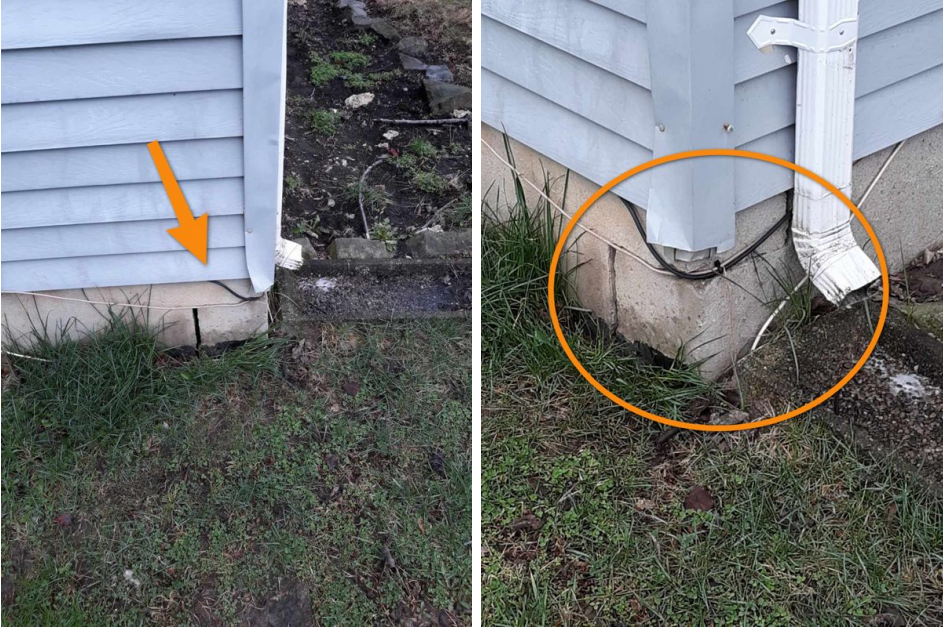
FOUNDATION CRACKS - FURTHER EVALUATION

The foundation is showing signs of shifting. This is typically consistent with soil movement and could lead to damage to structural components, foundation. Recommend further evaluation.

Contact a qualified professional.

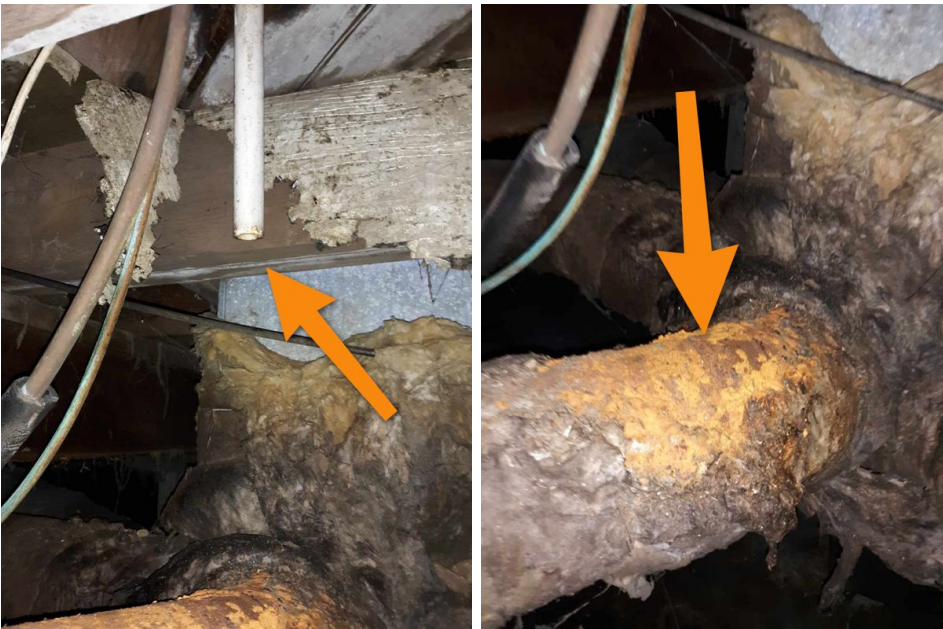
CONDENSATE-CRAWL SPACE

The condensate line from the ventilation system is draining into the crawl space and on to supply vent causing corrosion.. Its recommended adding a condensate pump or have the drain directed to a drain with a water trap. Recommend a HVAC or plumbing contractor to correct.

Contact a qualified plumbing contractor.

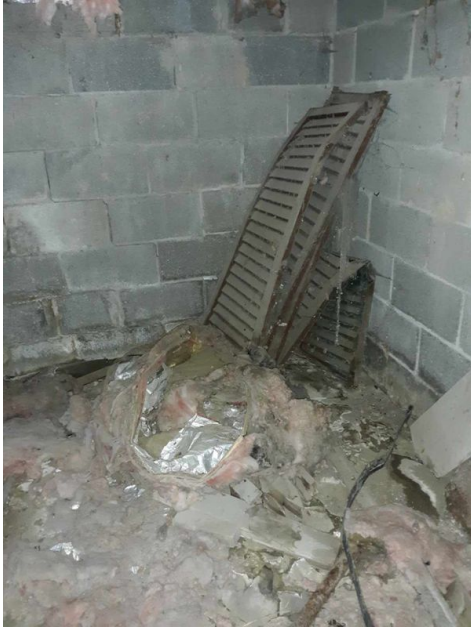
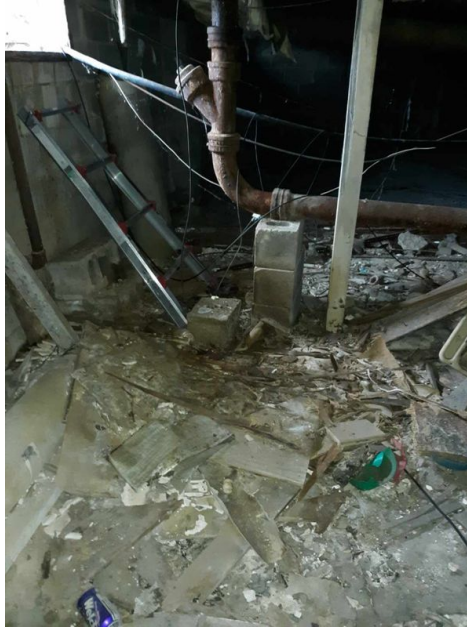
DEBRIS IN CRAWL

The crawl space has scrap and removed wood debris. This is recommended for removal for safe access and prevention of wood destroying insects. The area had limited access due to debris and mechanical equipment. Its recommended you have the area clear of unnecessary materials and debris.

Contact a handyman or DIY project

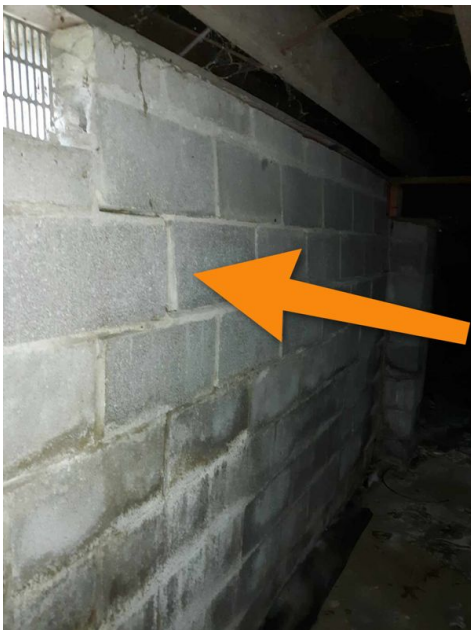
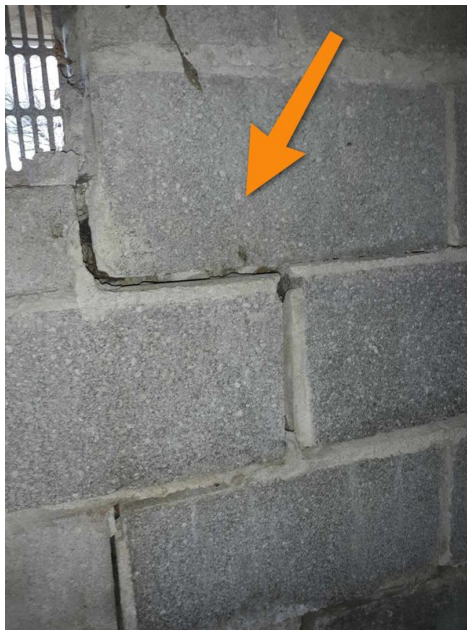
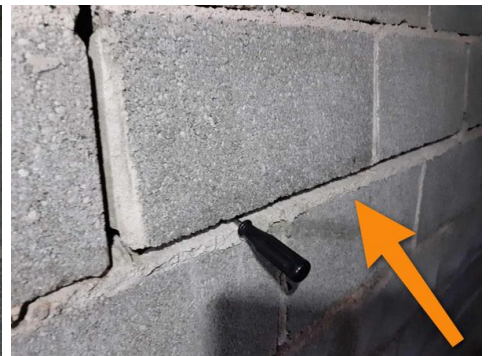
HEAVING

EAST FOUNDATION WALL, SOUTH (REAR) OF HOME

The foundation shows movement or heaving due to soil expansion. This can compromise the structural integrity of the area and requires further evaluation by qualified structural engineer or foundation contractor on how to remedy.

Contact a qualified structural engineer.

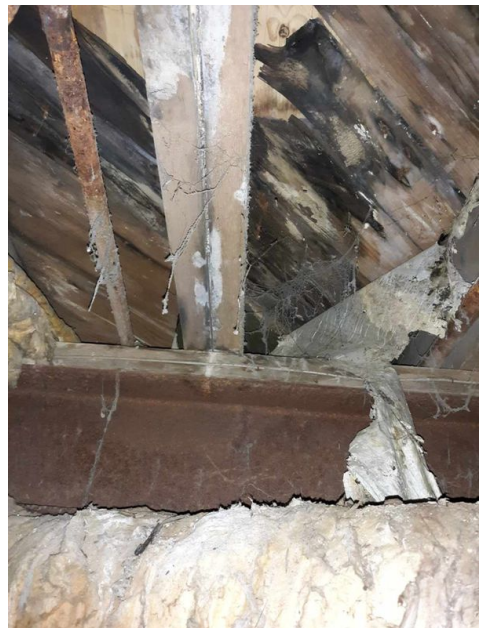
MICROBIAL GROWTH

The floor structure has stains consistent microbial growth. The growth occurs because prolonged exposure to water or elevated humidity. We recommend having an air quality test performed and/or sampling areas for identification of active cells.

A water proofing contractor is recommended for further evaluation to control ground and/or storm water entry allowing for wet and humid conditions.

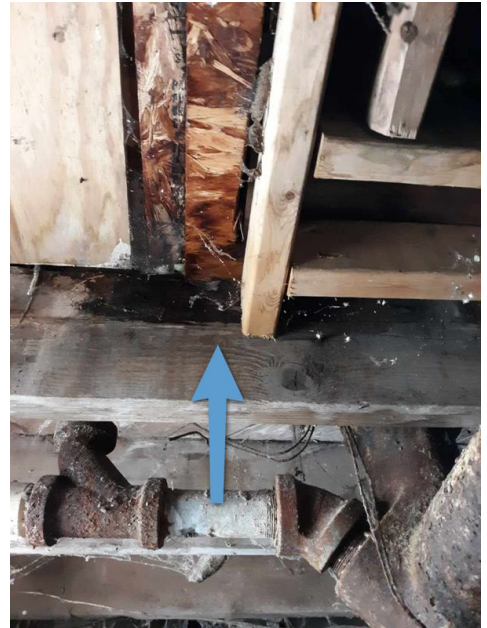
WATER MARKS-WET

The floor framing and/or sub floor surface was noted with water marks. The area was tested and measured wet. Recommend further evaluation to determine source and correct.

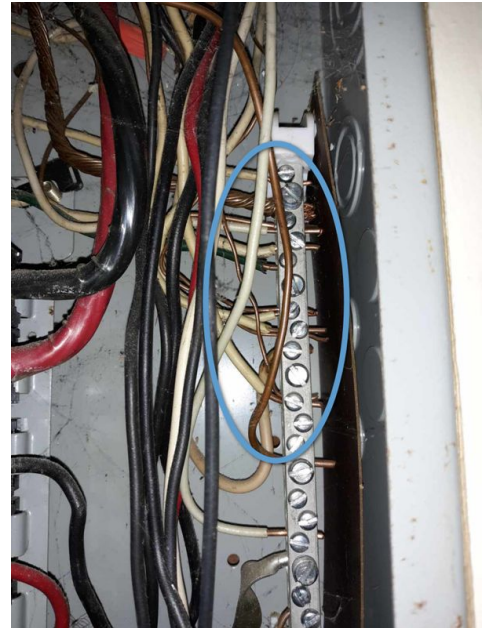
6.2.1 Electrical Panel

The neutral (white) and ground (bare copper) wires were found together under the same screw. This was an acceptable wiring practice when the house was built or panel replaced. Recommendation is to have the circuits evaluated for separation by electrical contractor when other electrical service is needed. At the time of inspection, the components and wires were visually inspected with no arcing or overheating visible. This is for your information.

Contact a qualified electrical contractor.

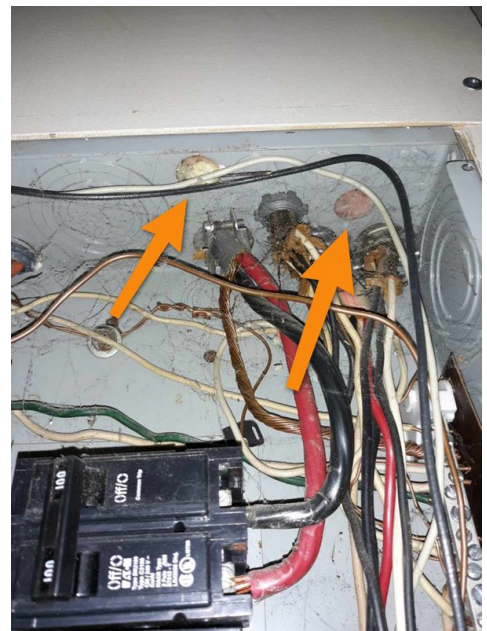
KNOCKOUTS MISSING

The panel cover or cabinet is missing knockouts. Recommend further evaluation by qualified electrical contractor.

Contact a qualified electrical contractor.

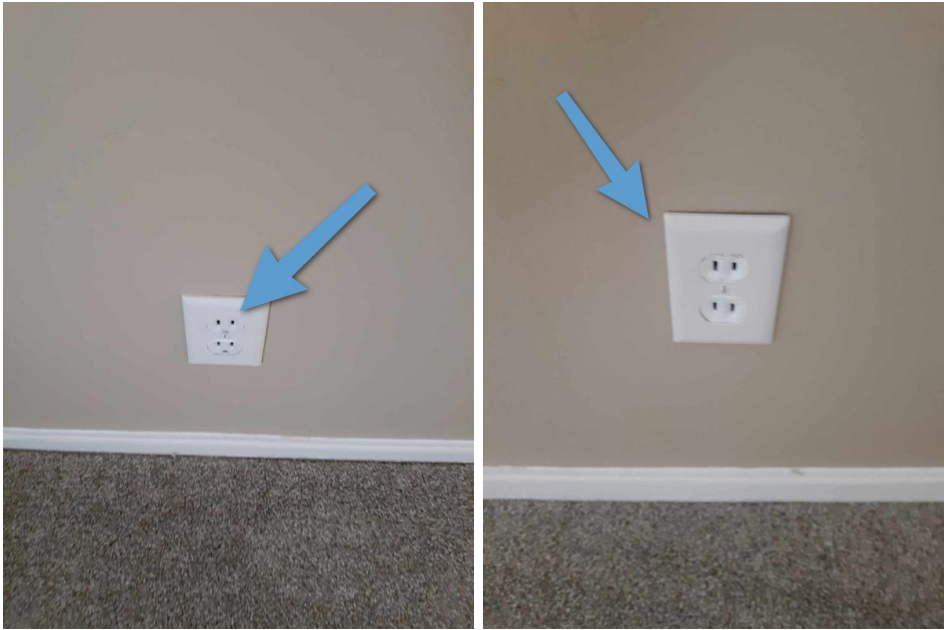
PAINTED OUTLETS

Wall receptacles were found painted. The paint can cause poor electrical connections with loose paint chips. Poor connections can cause heat or cause circuit protection devices to trip. We recommend budgeting for updates by having the outlets changed out by qualified electrical contractor.

Contact a qualified electrical contractor.

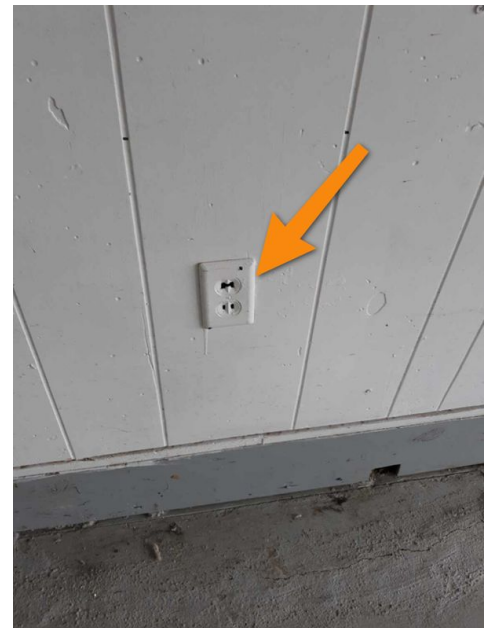
DAMAGED OUTLET

The outlet shows signs of damage. Recommend replacement by licensed electrician.

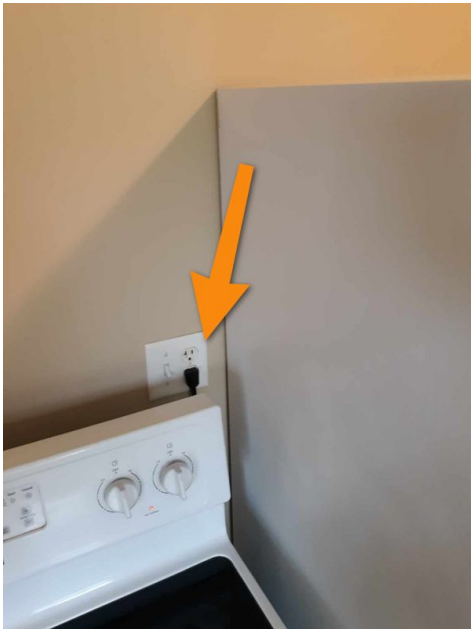
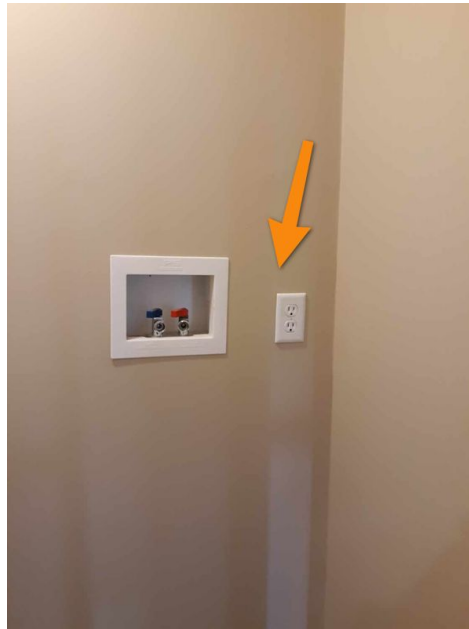
NO GROUNDED OUTLET FOR MAJOR APPLIANCE.

No grounded outlet for use of major appliance. Recommend updates.

Contact a qualified electrical contractor.

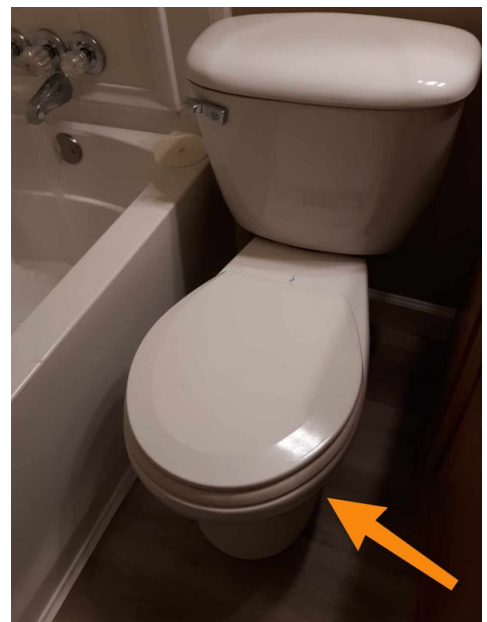
TOILET LOOSE

Toilet was found loose at its base. The cause can range from, possible loose or broken anchor bolt, damaged flange or uneven surface allowing movement. Repairs are recommended, and may involve replacing wax ring, check bolts, flange and reset toilet to prevent any possible leaks in the future.

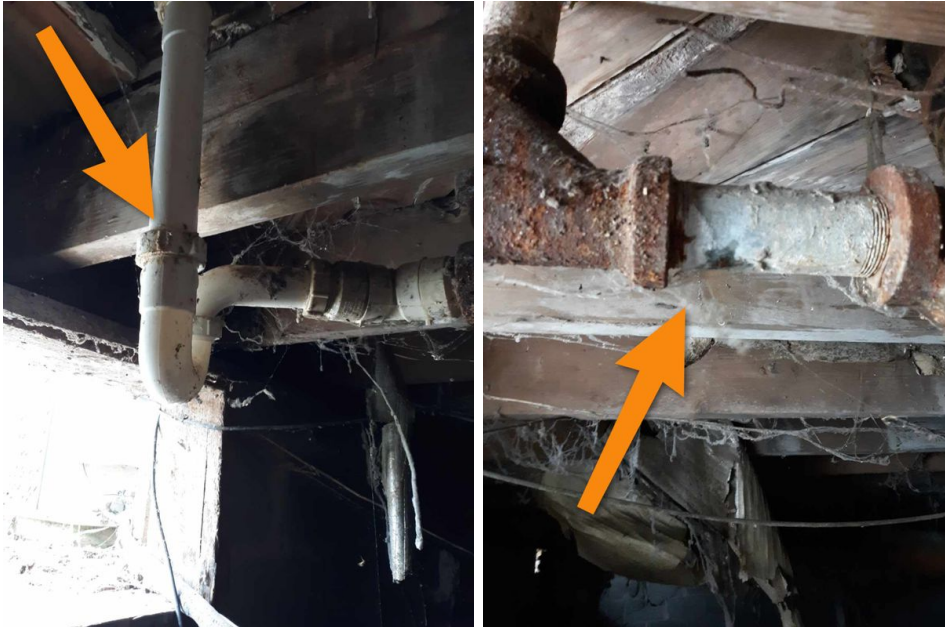
DRAIN LEAK

The drain connections and/or pipes are leaking at the noted location. The pipes and connections are recommended for repair by qualified plumbing contractor to prevent cabinet and property damage.

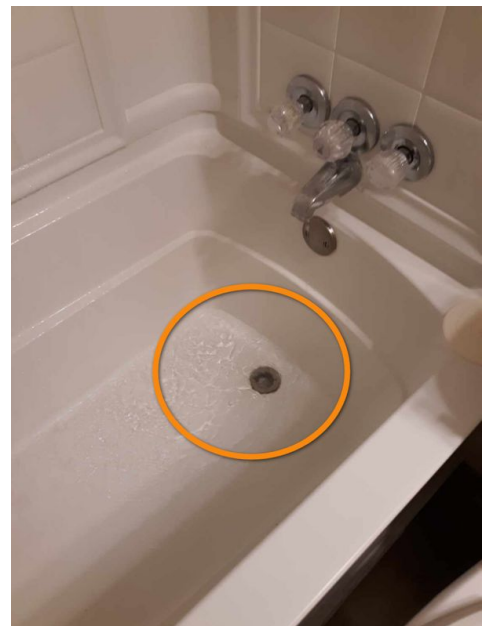
SHOWER - POOR DRAINAGE

Shower had slow/poor drainage. We are unable to determine if this is a trap clog or something more. We recommend a qualified plumber to evaluate and repair.

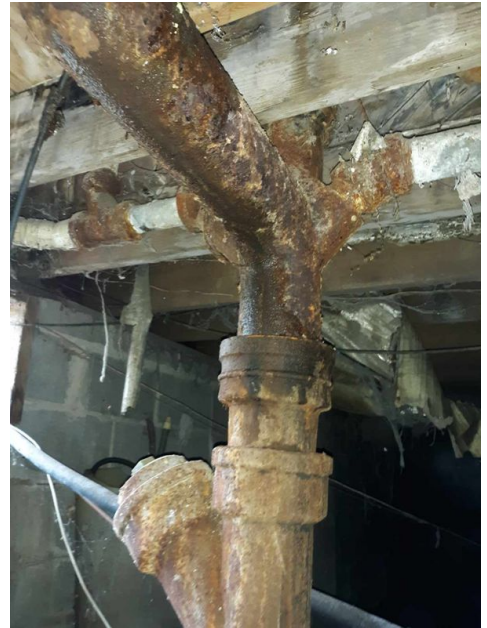
RUSTED WASTELINE

Main wasteline rusted. Water found at exterior of the pipe however appears is from leak from toilet tank and is leaking at floor and on surface of the pipe. Recommend monitoring over time due to age of materials.

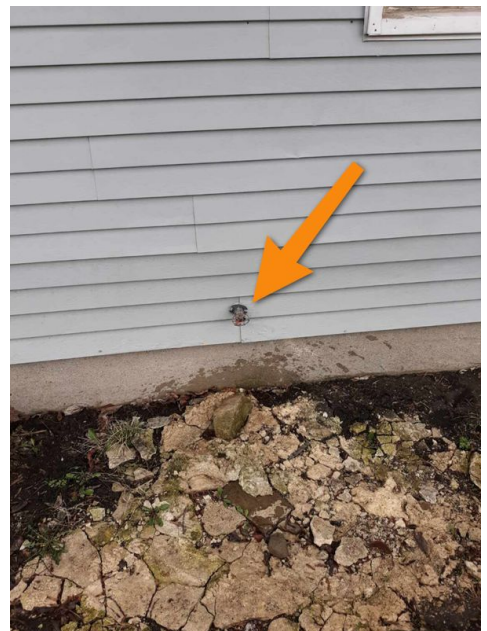
HOSE BIBB-LOOSE

The exterior hose bibb at the noted location is loose. The valve should be secured to the exterior to prevent twisting. This will prevent stress to plumbing connections and reducing chances of leaks. This repair can range from homeowner to handyman.

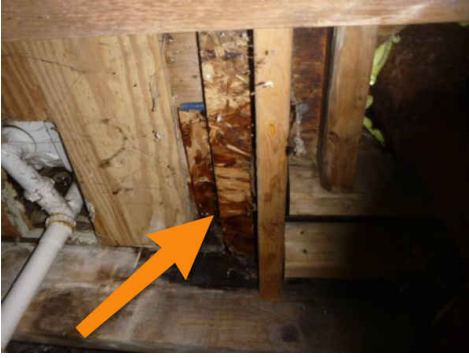
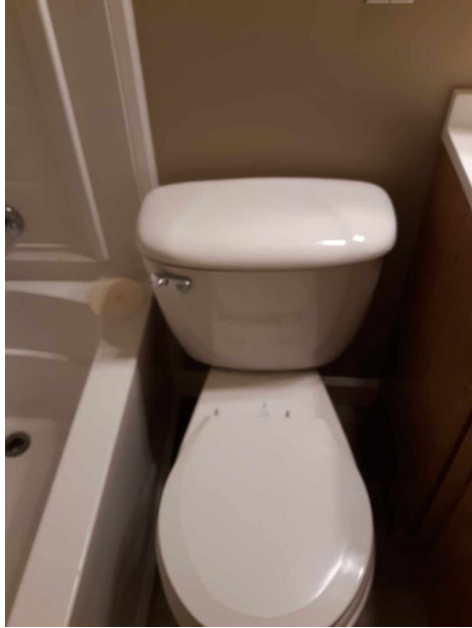
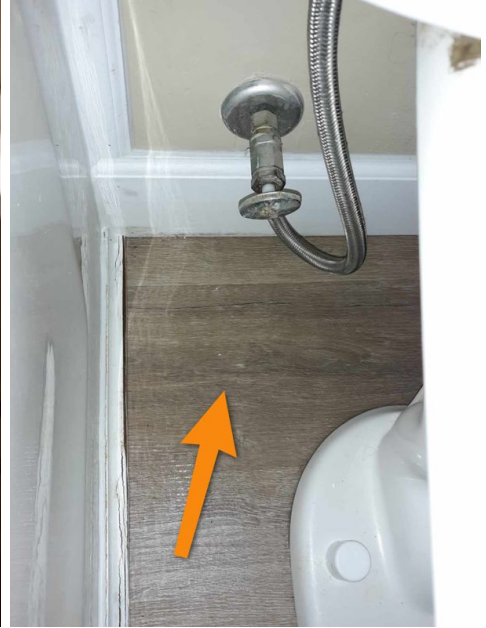
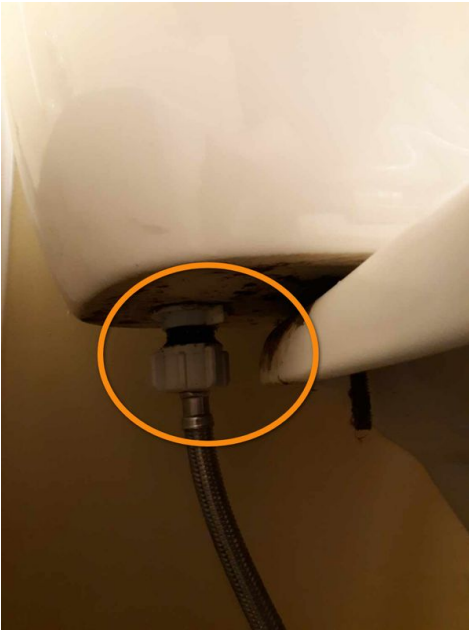
TOILET TANK LEAKING

Toilet tank found leaking and loose at time of inspection. This leak present at the supply connection. Recommend repairs.

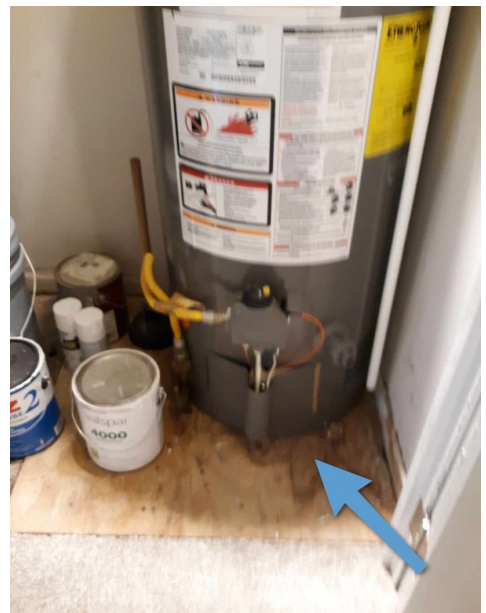
DRIP PAN

The water heater did not have a drip pan installed. It is possible for floor to be damaged if the tank leaks or safety valve drips or activates. Drip pan are recommended to help reduce property damage in the event of a leak. This is for your information.

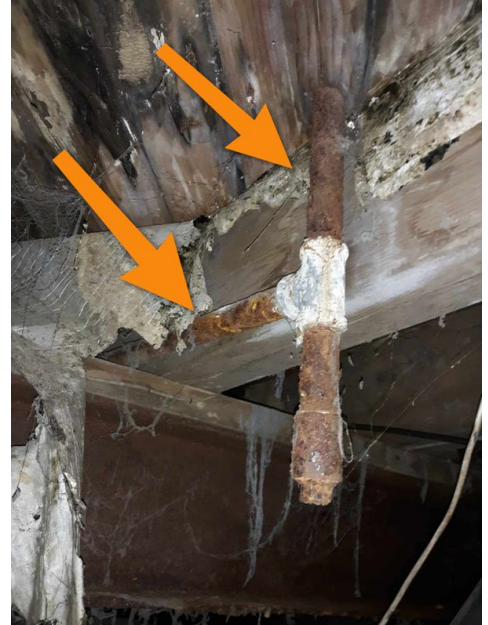
CORROSION

Gas pipes were corroded. This can lead to gas leaks. Recommend contacting local utility company for evaluation and repair.

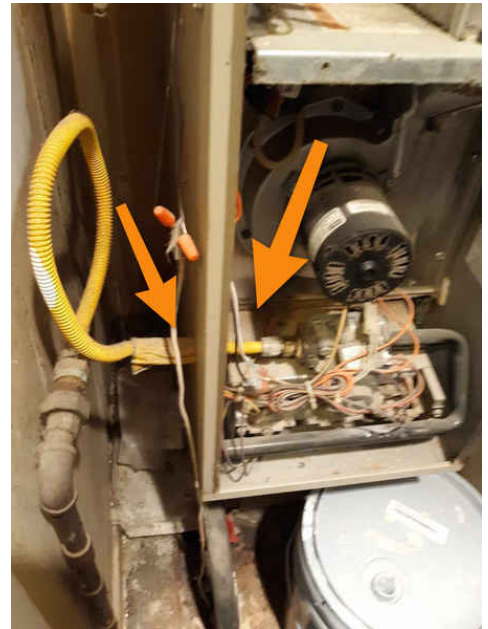
FLEX LINE INTO FURNACE

The flexible gas line going into the furnace cabinet is a safety concern. Hard-line black pipe is recommended. We recommend having a plumber or HVAC contractor to repair.

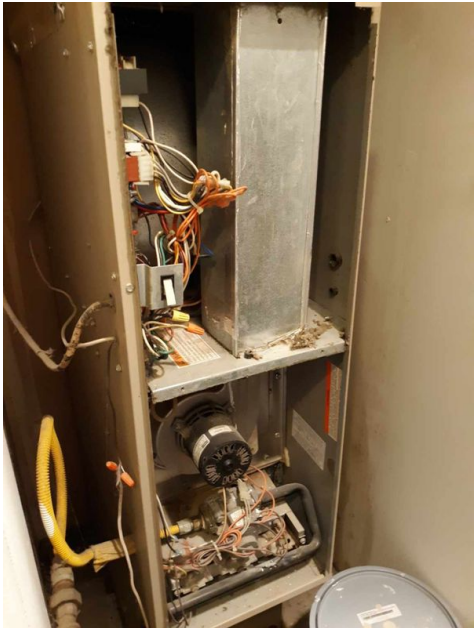
8.1.1 Equipment

The furnace is in need of cleaning and maintenance / tuneup. Debris and dust found within the furnace compartment upon inspection. Recommend evaluation by a qualified contractor.

Recommendation
Contact a qualified HVAC professional.

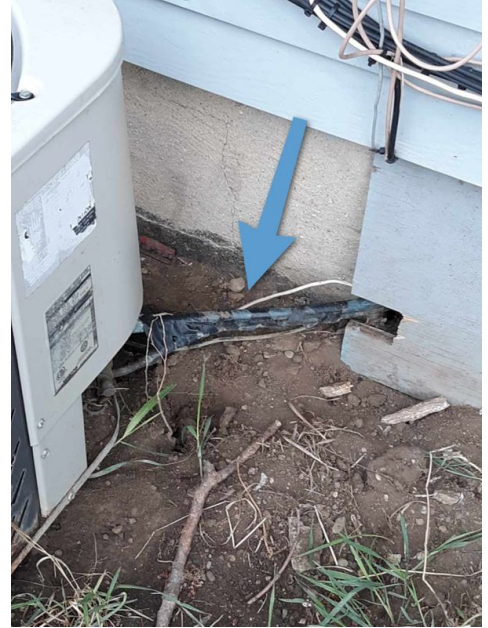
INSULATION MISSING OR DAMAGED

The insulation on air conditioner line is missing or deteriorated due to age and/or weather. This can reduce efficiency and increase condensation. Update as needed.

Contact a qualified heating and cooling contractor

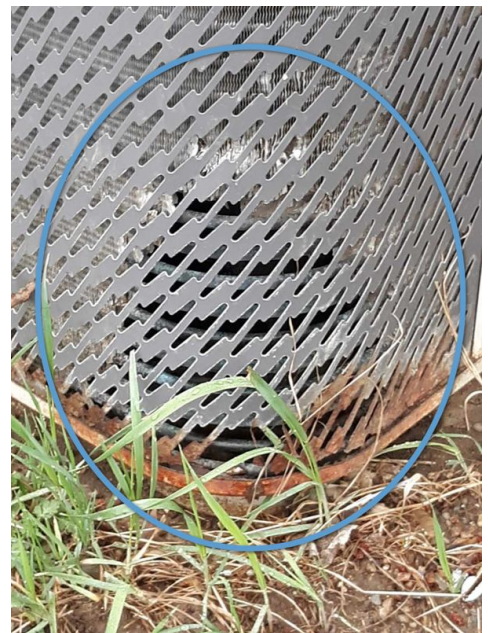
PET CORROSION

Outside compressor unit has extensive decay to the lower corner(s) of the cooling fins which is commonly from dog urine. This corrosion eats away at the aluminum/copper cooling fins over time. Recommend having the unit cleaned and evaluated by qualified HVAC contractor when weather permits.

Contact a qualified heating and cooling contractor

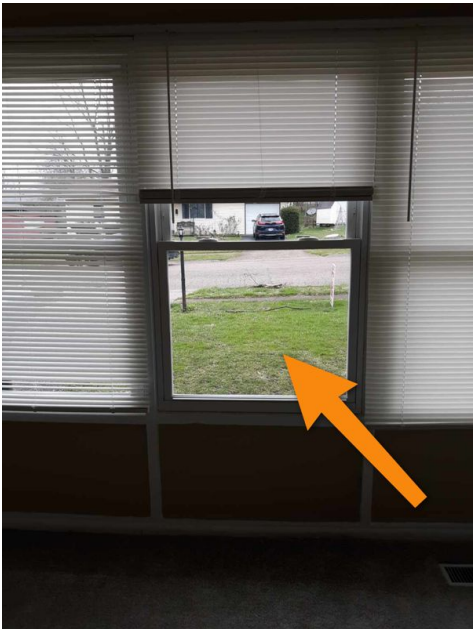
FAILED BALANCE

The window(s) at the noted location will not stay open because of disconnected or broken balance. We recommend repairs or adjustments needed by a window contractor.

Contact a qualified window repair/installation contractor.

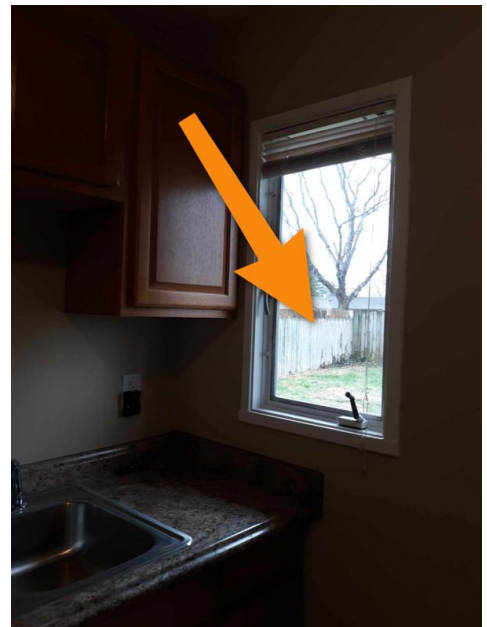
MECHANICAL DEFECT

The window(s) at the noted location could not be operated by inspector. We recommend qualified professional to evaluate for adjusting or repair.

Contact a qualified window repair/installation contractor.

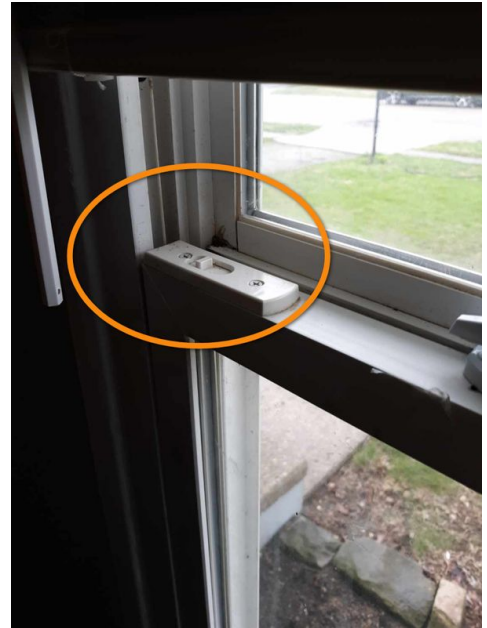
TILT HARDWARE

Tilt hardware found damaged at time of inspection. This does not allow the window to stay locked in place as should. Recommend repairs.

Contact a qualified window repair/installation contractor.

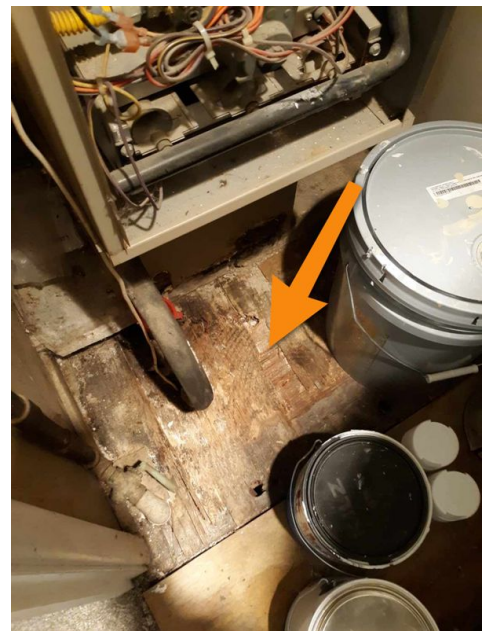
MOISTURE DAMAGE

Floors had areas of visible moisture damage. Recommend a qualified flooring contractor evaluate.

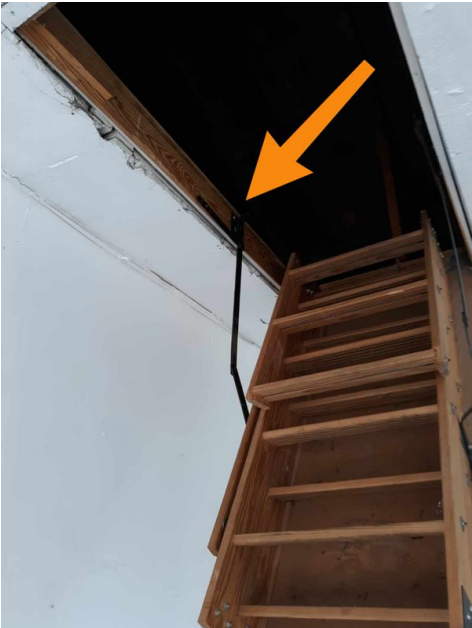
ATTIC LADDER

Attic ladder is missing spring at its hardware. Recommend repairs be completed for safe use.

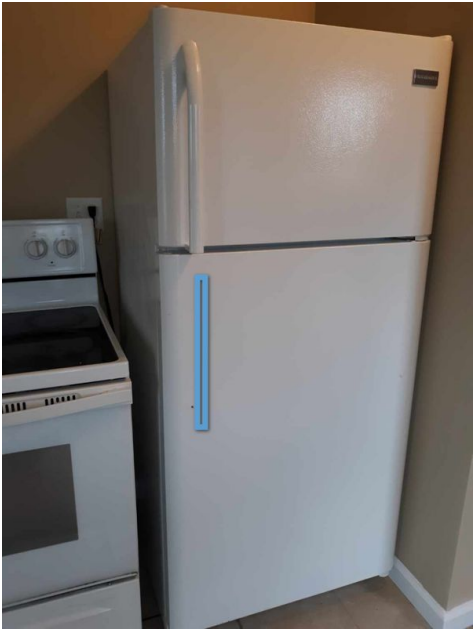
MISSING HANDLE

Refrigerator on site is missing handle. Recommend updates to allow for proper operation.

Contact a qualified appliance repair professional.

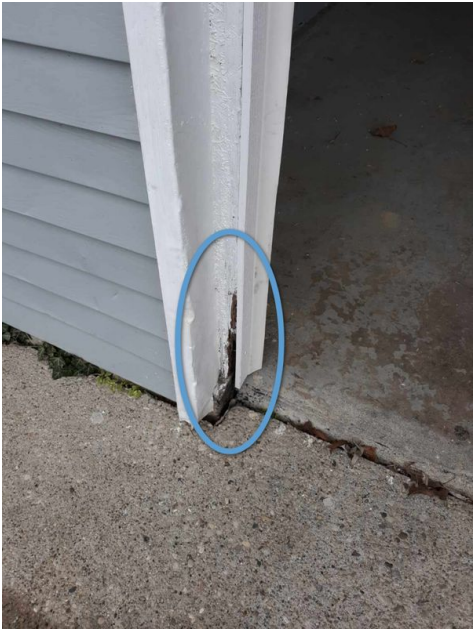
Overhead door trim at garage found with wood rot. Recommend repairs.

Recommendation
Contact a qualified professional.
