Underground Storage Tank  
Closure Assessment  
of  
Former Service Station  
10174 Avon Lake Road  
Lodi, Ohio  
Medina County

BUSTR Facility #52010881

Flynn Project #09-025

Report Date:  
October 21, 2009

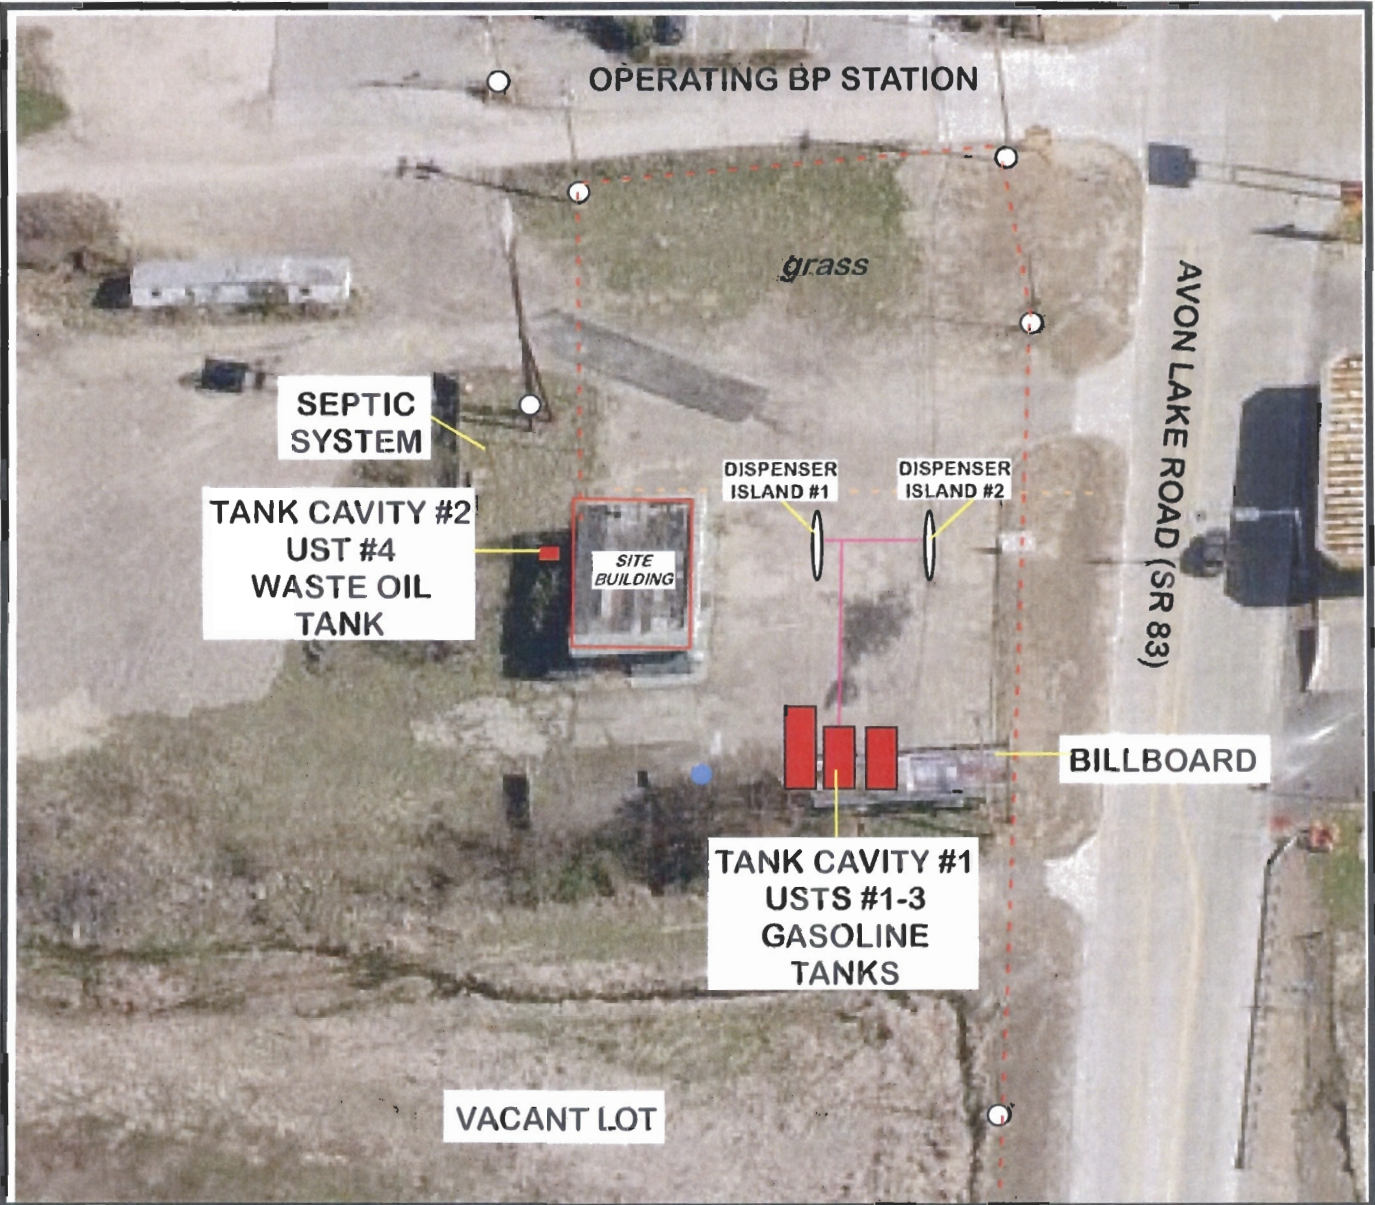
FIGURE 2  
SITE MAP

The site is located on the west side of Avon Lake Road (State Route 83) just south of the BP station and Interstate 71 in Lodi, Ohio (see Figures 1 and 2). The site is located in a commercial area. Potable water for the site is provided by a water well located approximately 20 feet west of tank cavity #1.

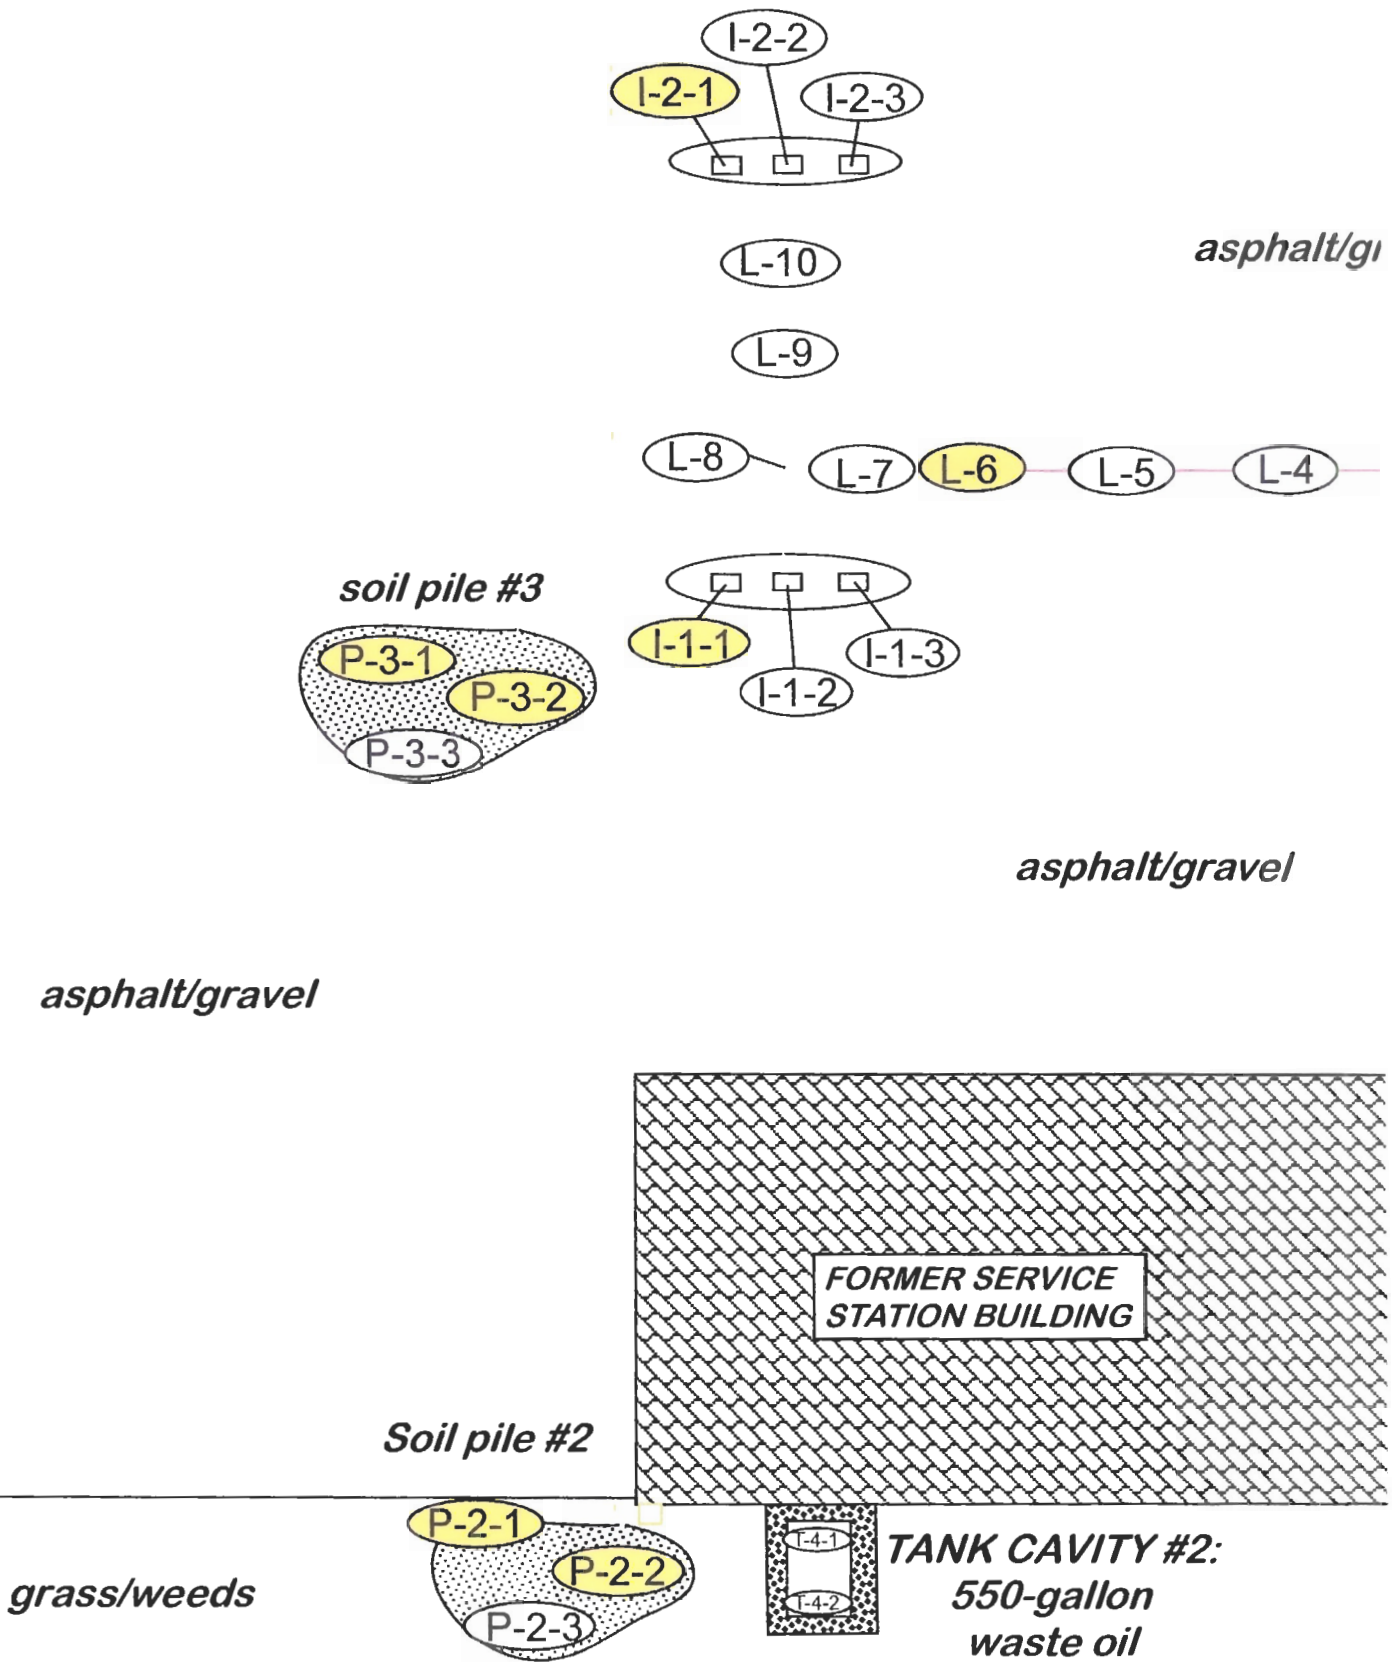
**FIGURE 5**

SAMPLING EQUIPMENT: A hand-held three-inch (3") AMS Core Sampler was used to collect soil samples from the excavated soil piles, from the sidewall of tank cavity #2, and from the product line and dispenser island cavities. The soil samples collected from the bottoms of each UST excavation as well as from the sidewalls of tank cavity #1 were retrieved by using the bucket of the trackhoe. Clean, dedicated, latex gloves were used for each sample location to prevent cross-contamination. Sidewall sampling locations are shown on Figures 3 and 4 while Figure 5 shows the remaining sampling locations.

**SAMPLE LOCATION MAP**

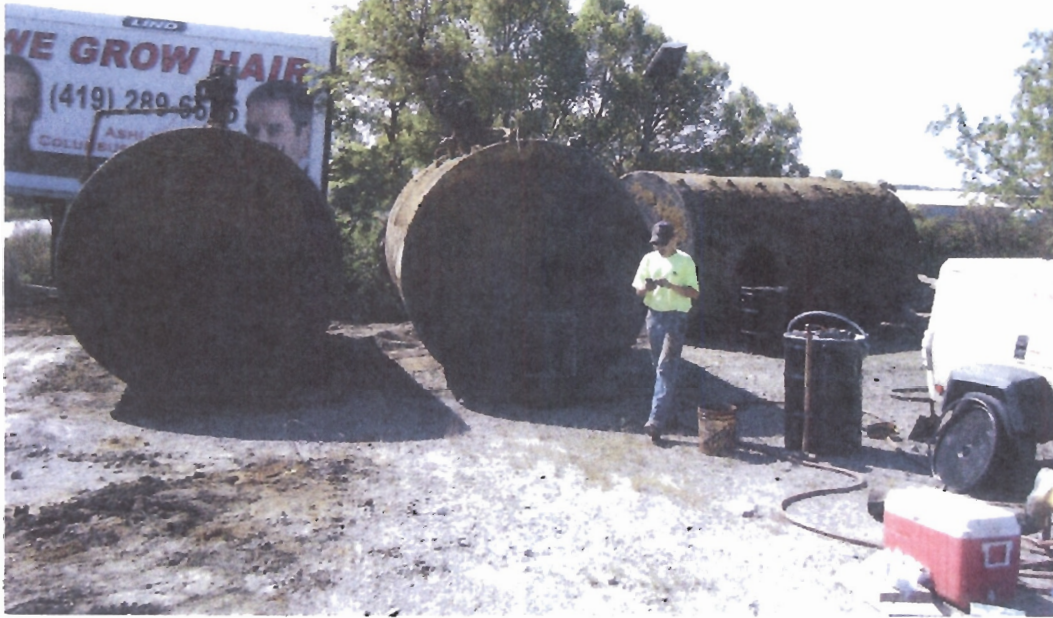
PHOTOGRAPH 1. View of the gasoline USTs #1, #2, and #3 following removal.

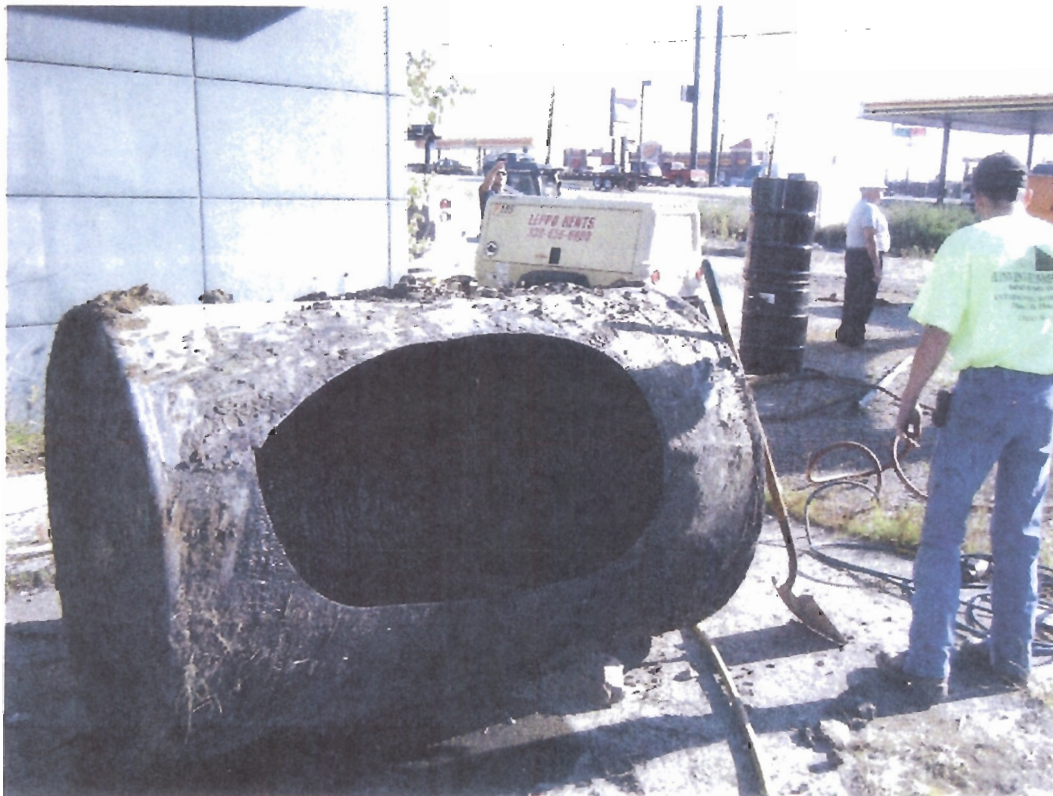
PHOTOGRAPH 2. View of UST #4 following removal.
