Yeoman Group Project No.: 12197

**2.54 acre vacant lot-Groveport Road
Obetz, Ohio**

**Proprietary and Confidential
ASTM and AAI
Phase I Environmental Site Assessment**

PHASE I ENVIRONMENTAL SITE ASSESSMENT

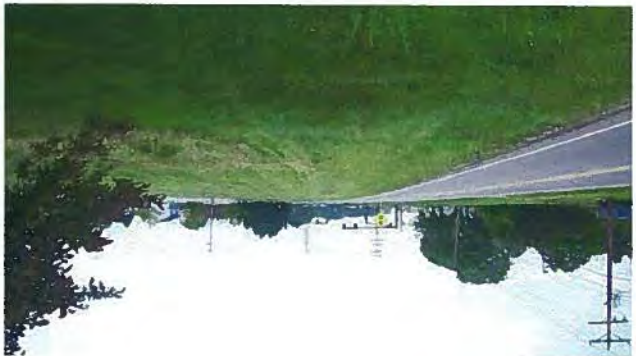
Photo No 1: Groveport Road frontage

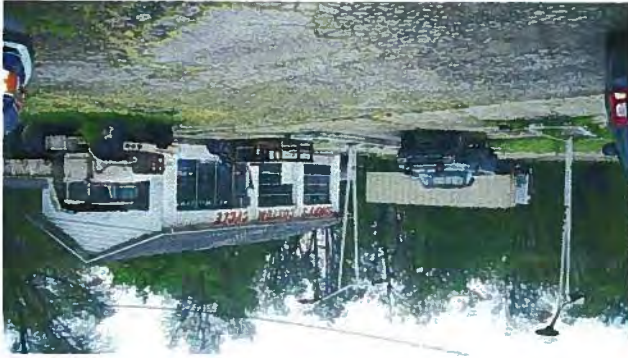
Direction	Use
North -	possibly vacant vehicle repair/salvage business (former gas station)
Northeast	residential/vacant land
East - South	newer residential including a retention pond
West - South	Greenfield Estates Mobile Home Park
Northwest-	residential

Photo No 8: Former gas station adjoining north

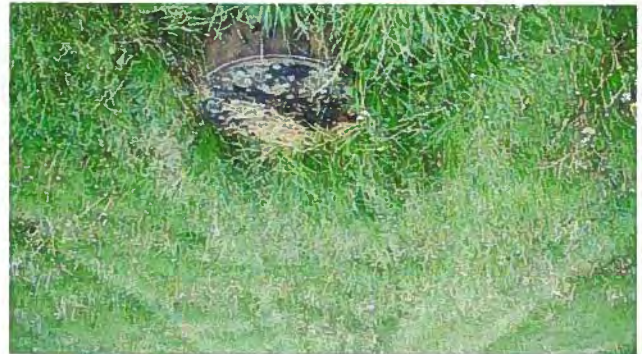
The Study Property consists of a mowed lawn outlot of the Greenfield Estates Mobile Home Park. The soil was observed to be fairly level and stable with no evidence of previous development or infrastructure except for a sanitary sewer riser near the northern boundary. Storm sewer catch basins were located along the edge of the bordering arterial roads. Mobile homes border to the west and southwest. Bottled propane tanks were observed, suggesting no natural gas service to the area.

Photo No 5: Sanitary sewer riser on Study Property

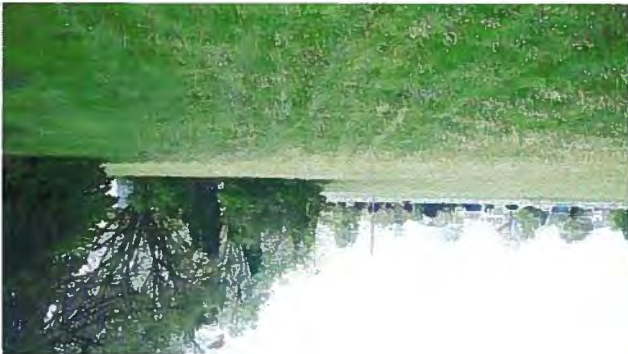
The Study Property was observed to consist of a vacant parcel of land with no distinguishing features. Refer to enclosure (5) for detailed site reconnaissance notes and photographs.

Photo No 6: Approximate south half of Study Property

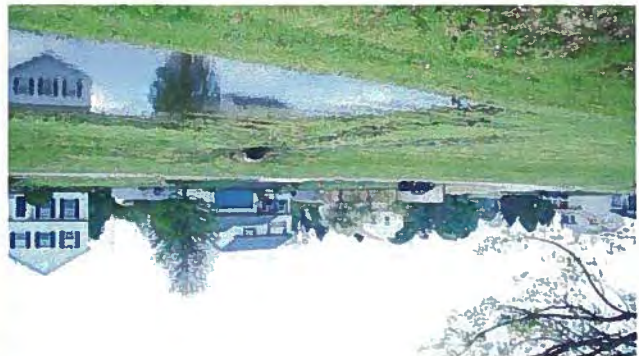
Photo No 9: Retention pond adjoining east
opposite Bixby
