# Home Inspection Report

637 Woodbine Ave SE, Warren, OH 44483

Sunday, April 11, 2021

04112021-03

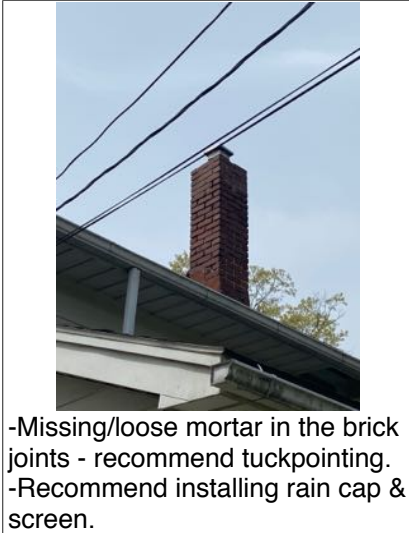
**Location(s)** ☐ None  
**Viewed From** ☐ Roof ☐ Ladder at eaves ☒ Ground (Inspection Limited) ☐ With Binoculars  
**Rain Cap/Spark Arrestor** ☐ Yes ☒ No ☒ Recommended  
**Chase** ☒ Brick ☐ Stone ☐ Metal ☐ Blocks ☐ Framed  
**Evidence of** ☐ Holes in metal ☐ Cracked chimney cap ☒ Loose mortar joints ☐ Flaking ☐ Loose brick ☐ Rust  
☐ No apparent defects  
**Flue** ☒ Tile ☐ Metal ☐ Unlined ☐ Not Visible  
**Evidence of** ☐ Scaling ☐ Cracks ☐ Creosote ☐ Not evaluated ☐ Have flue(s) cleaned and re-evaluated  
☐ Recommend Cricket/Saddle/Flashing ☒ No apparent defects  
**Condition** ☒ Satisfactory ☐ Marginal ☐ Poor ☐ Recommend Repair  
**Comments** -Missing/loose mortar in the brick joints - recommend tuckpointing.  
 -Recommend installing rain cap & screen.

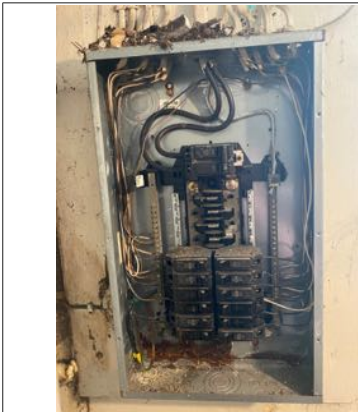
**Comments** -Evidence of rust in panel. Further review from a licensed electrician is recommended.

Open main electrical panel

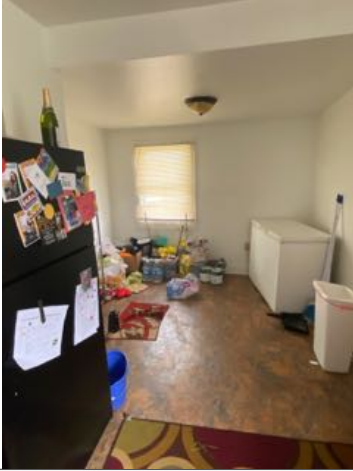
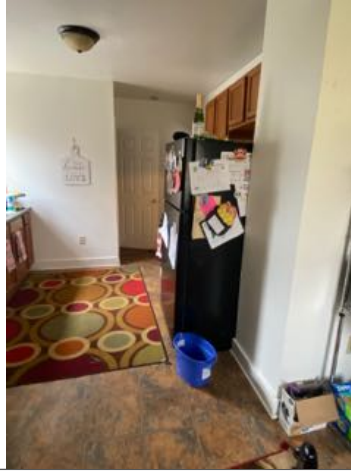
-Outlets at the kitchen wall and counter are not functional. Repairs/replacement recommended.

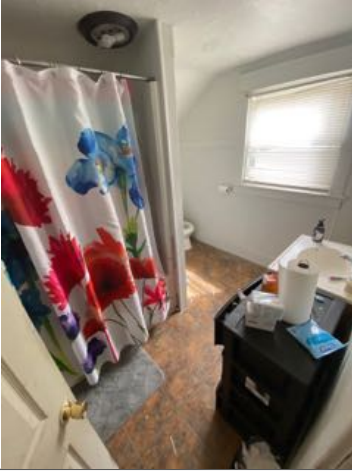
-The bathroom outlet was not functional. Repairs/replacement recommended.
