April 29, 2021

RE: Basement CMU Wall Bowing
220 North Maple Ave, Fairborn, Ohio 45324
Tri-Tech Job Number: 21706E

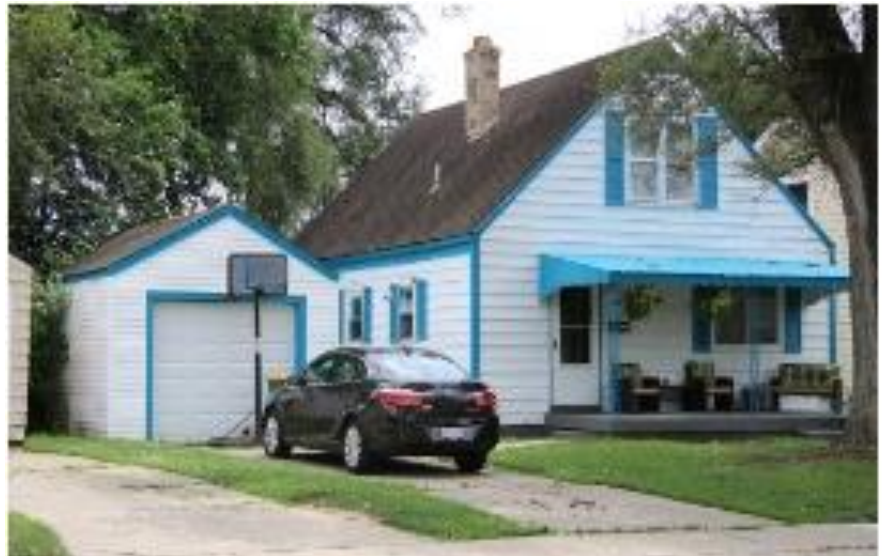
Per our phone conversation, the home is part of an estate and is to be sold to allow the estate to be closed. The home is a wood framed Cape Cod style home built in 1940. The home is a story and a half over a full basement and faces west. The basement is constructed of concrete masonry units (CMU's, concrete block).
