Disclosure Packet

**Included are all known reports and disclosures
for 7860 Jonell Square, New Albany, Ohio**

**7860 Jonell Square
New Albany, OH 43054**

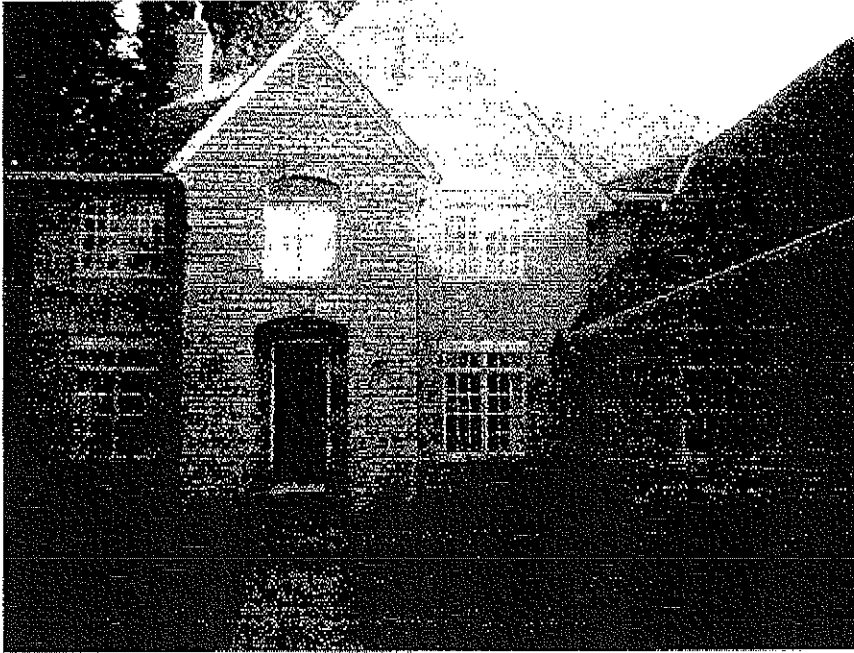
Front view

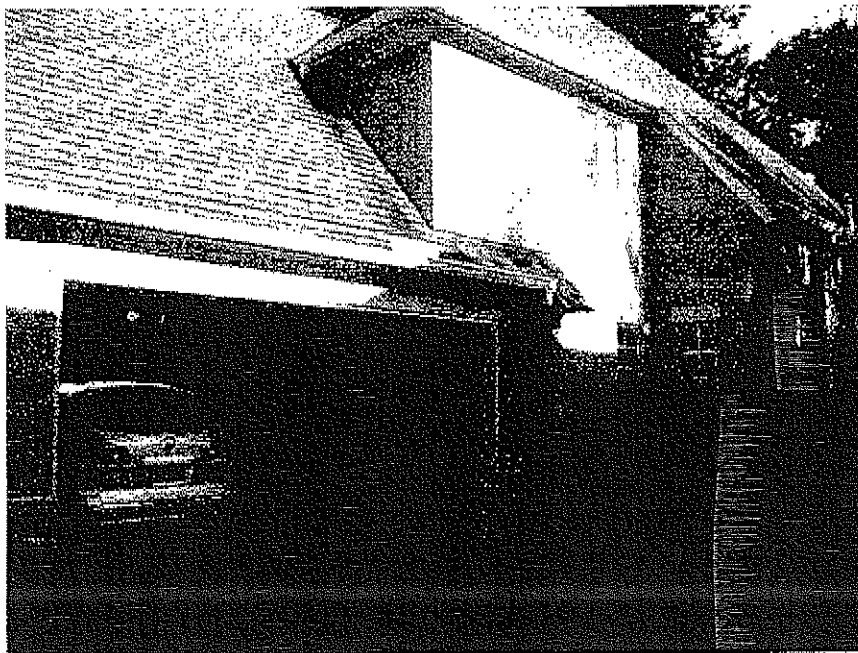
Description:
Right view

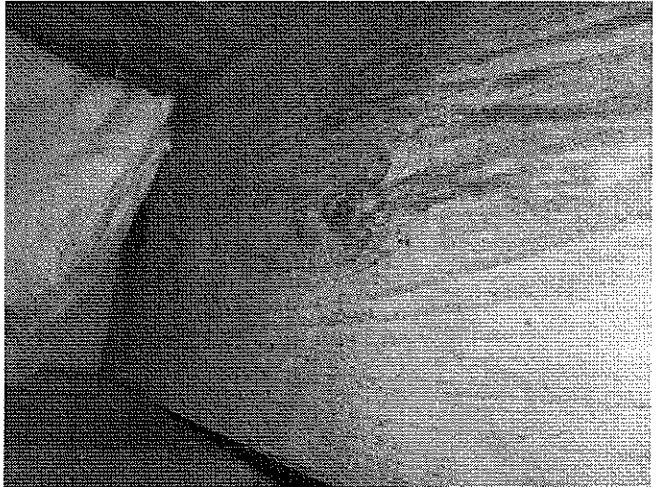
Item 7. Areas of mold on floor joist in basemetn area.

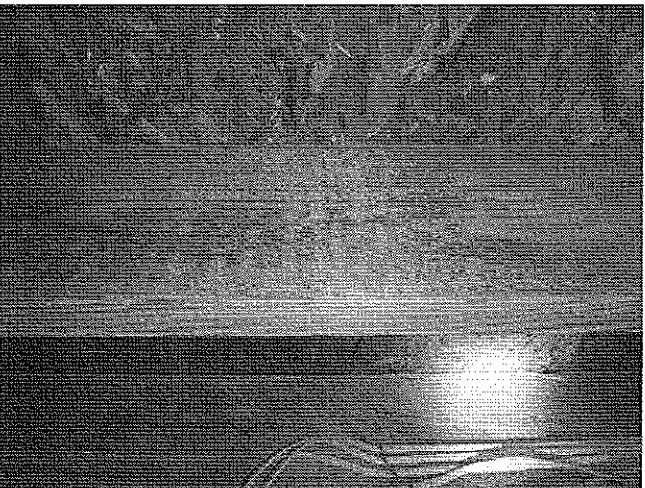
Item 7. Areas of mold on floor joist in basemetn area.

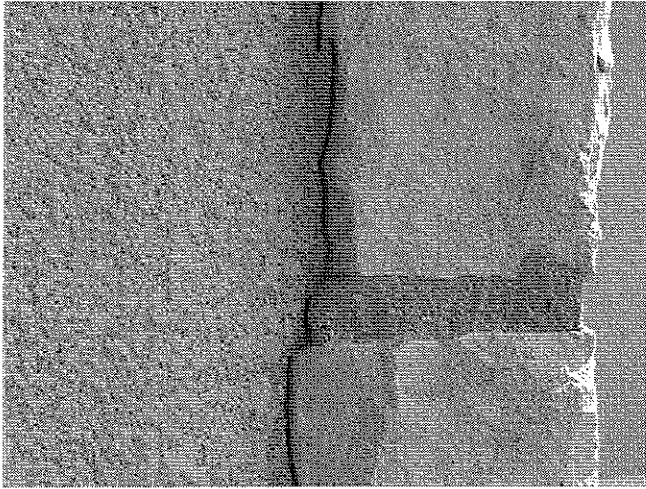
Photo # 7 / Typical cement stucco termination at stone veneer.

- Note that the cement stucco has been terminated at dissimilar materials and stone veneer without proper backer rod and sealant.

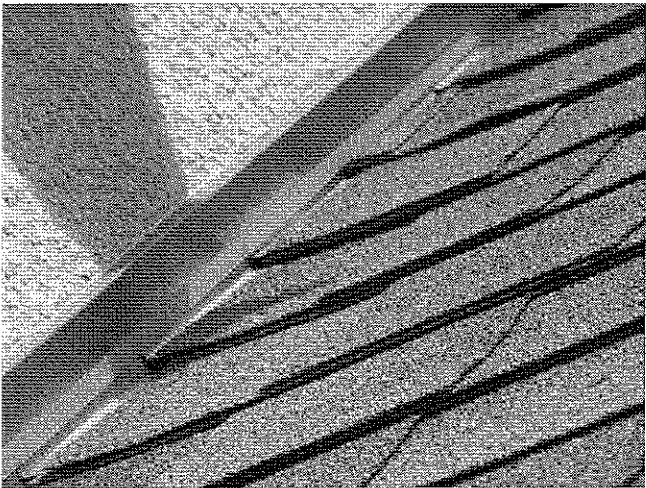
Photo # 8 / Typical cement stucco terminations at roofing.

- Note that the cement stucco has been terminated above the roofing as required.

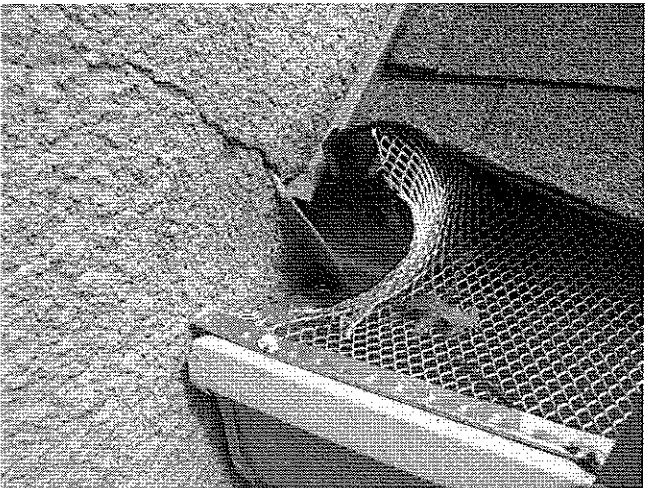
Photo # 9 / Roofing to vertical wall junctures.

- Note that the diverter flashing at the front elevation roofing to vertical wall juncture is undersized and not sealed as required.
10. Photo # 10 / Roofing to vertical wall junctures.

- Note that the diverter flashing at the front elevation roofing to vertical wall juncture is undersized and not sealed as required.

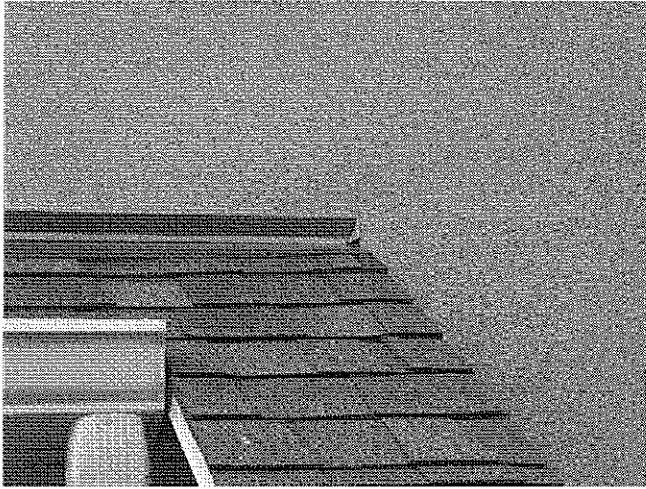
Photo # 10 / Roofing to vertical wall junctures.

- Note that the diverter flashing at the right elevation roofing to vertical wall juncture is undersized and not sealed as required.

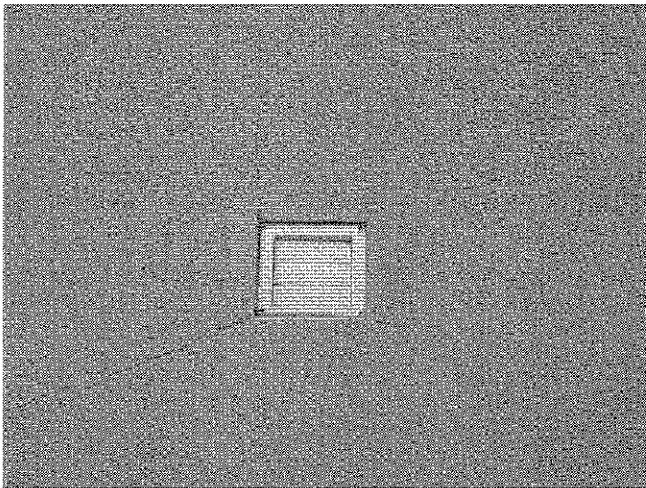
Photo # 14 / Rear elevation vent penetration.

- Note that proper flashing has not been installed at top of vent penetration as required.
- Note that proper backer rod and sealant has not been installed at penetration.

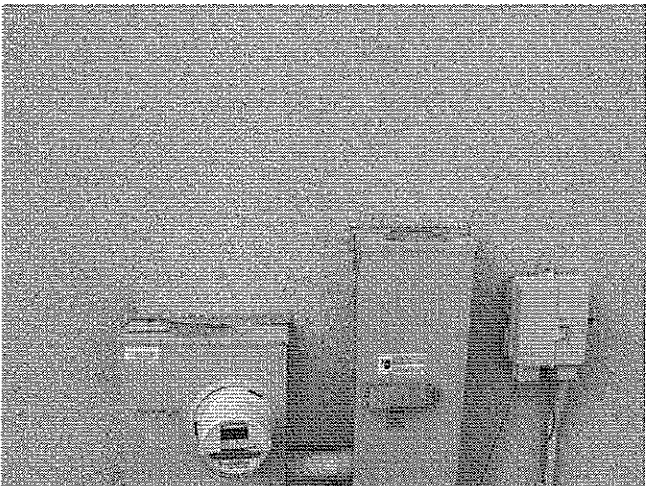
Photo # 15 / Rear elevation electrical service penetrations.

- Note that proper backer rod and sealant has not been installed at penetrations.

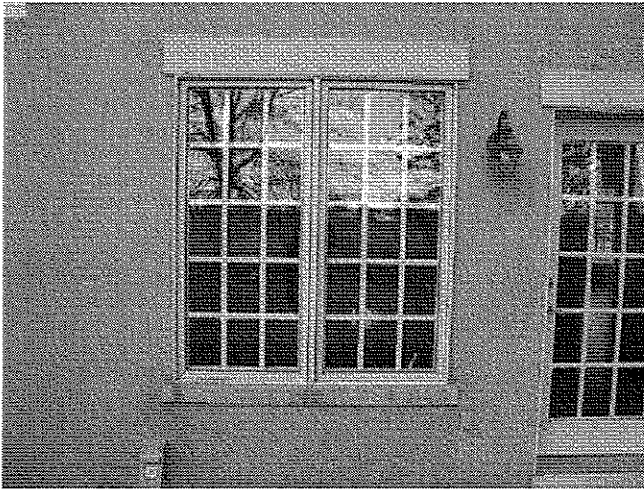
Photo # 16 / Rear elevation 1st floor window.

- Note that proper cement stucco terminations, backer rod and sealant have not been installed at window and door penetrations on all elevations.

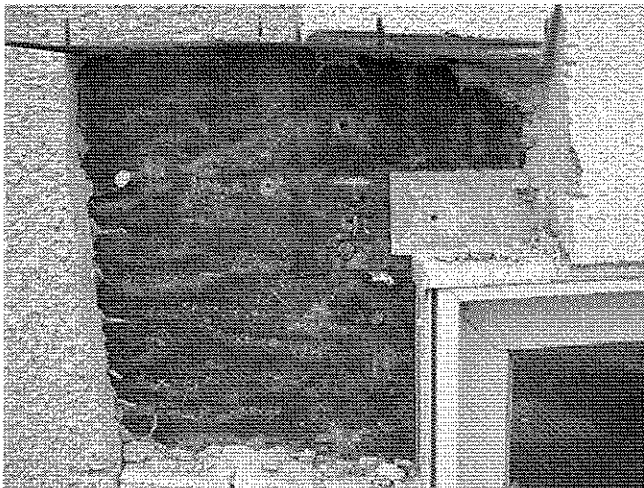
17. Photo # 17 / Rear elevation 1st floor window head and jamb.
 - Note that the single layer 15# building paper has been incorrectly extended over the window head and window jamb nailing fins.

- Note that the single layer 15# building paper has been incorrectly extended over the window head and window jamb nailing fins.
- Note that the window head galvanized metal flashing has been incorrectly installed over the 15# building paper.

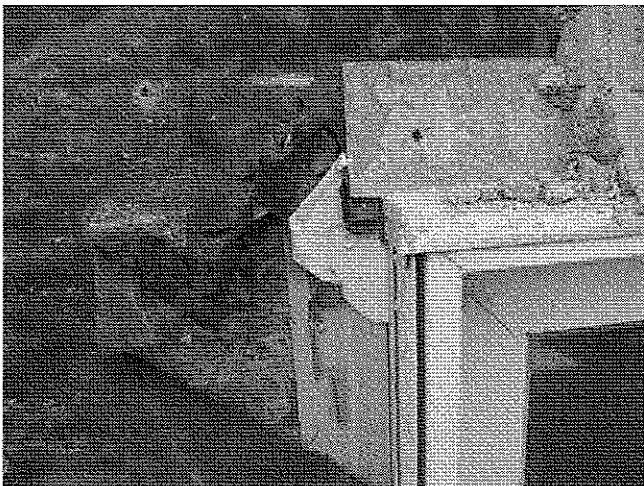
Photo #18 / Rear elevation 1st floor window head and jamb.

- Note that the single layer 15# building paper has not been returned into the window jamb rough opening per the manufacturer's installation instructions as required.
- Note that self adhesive corner pads have been installed at outside nailing fin corners.
- Note that there are no sealants visible at nailing flange and nailing flange holes as required by the manufacturer's installation instructions.
